Ricky Gowan  
Imlay Compliance Manager  
AFFCO NZ Ltd  
PO Box 425  
Whanganui

## **Results of Odour Extraction system Inspection**

This email summarises results from our inspection of the Rendering Plant air extraction system at the Imlay meat works on 16 March 2015.

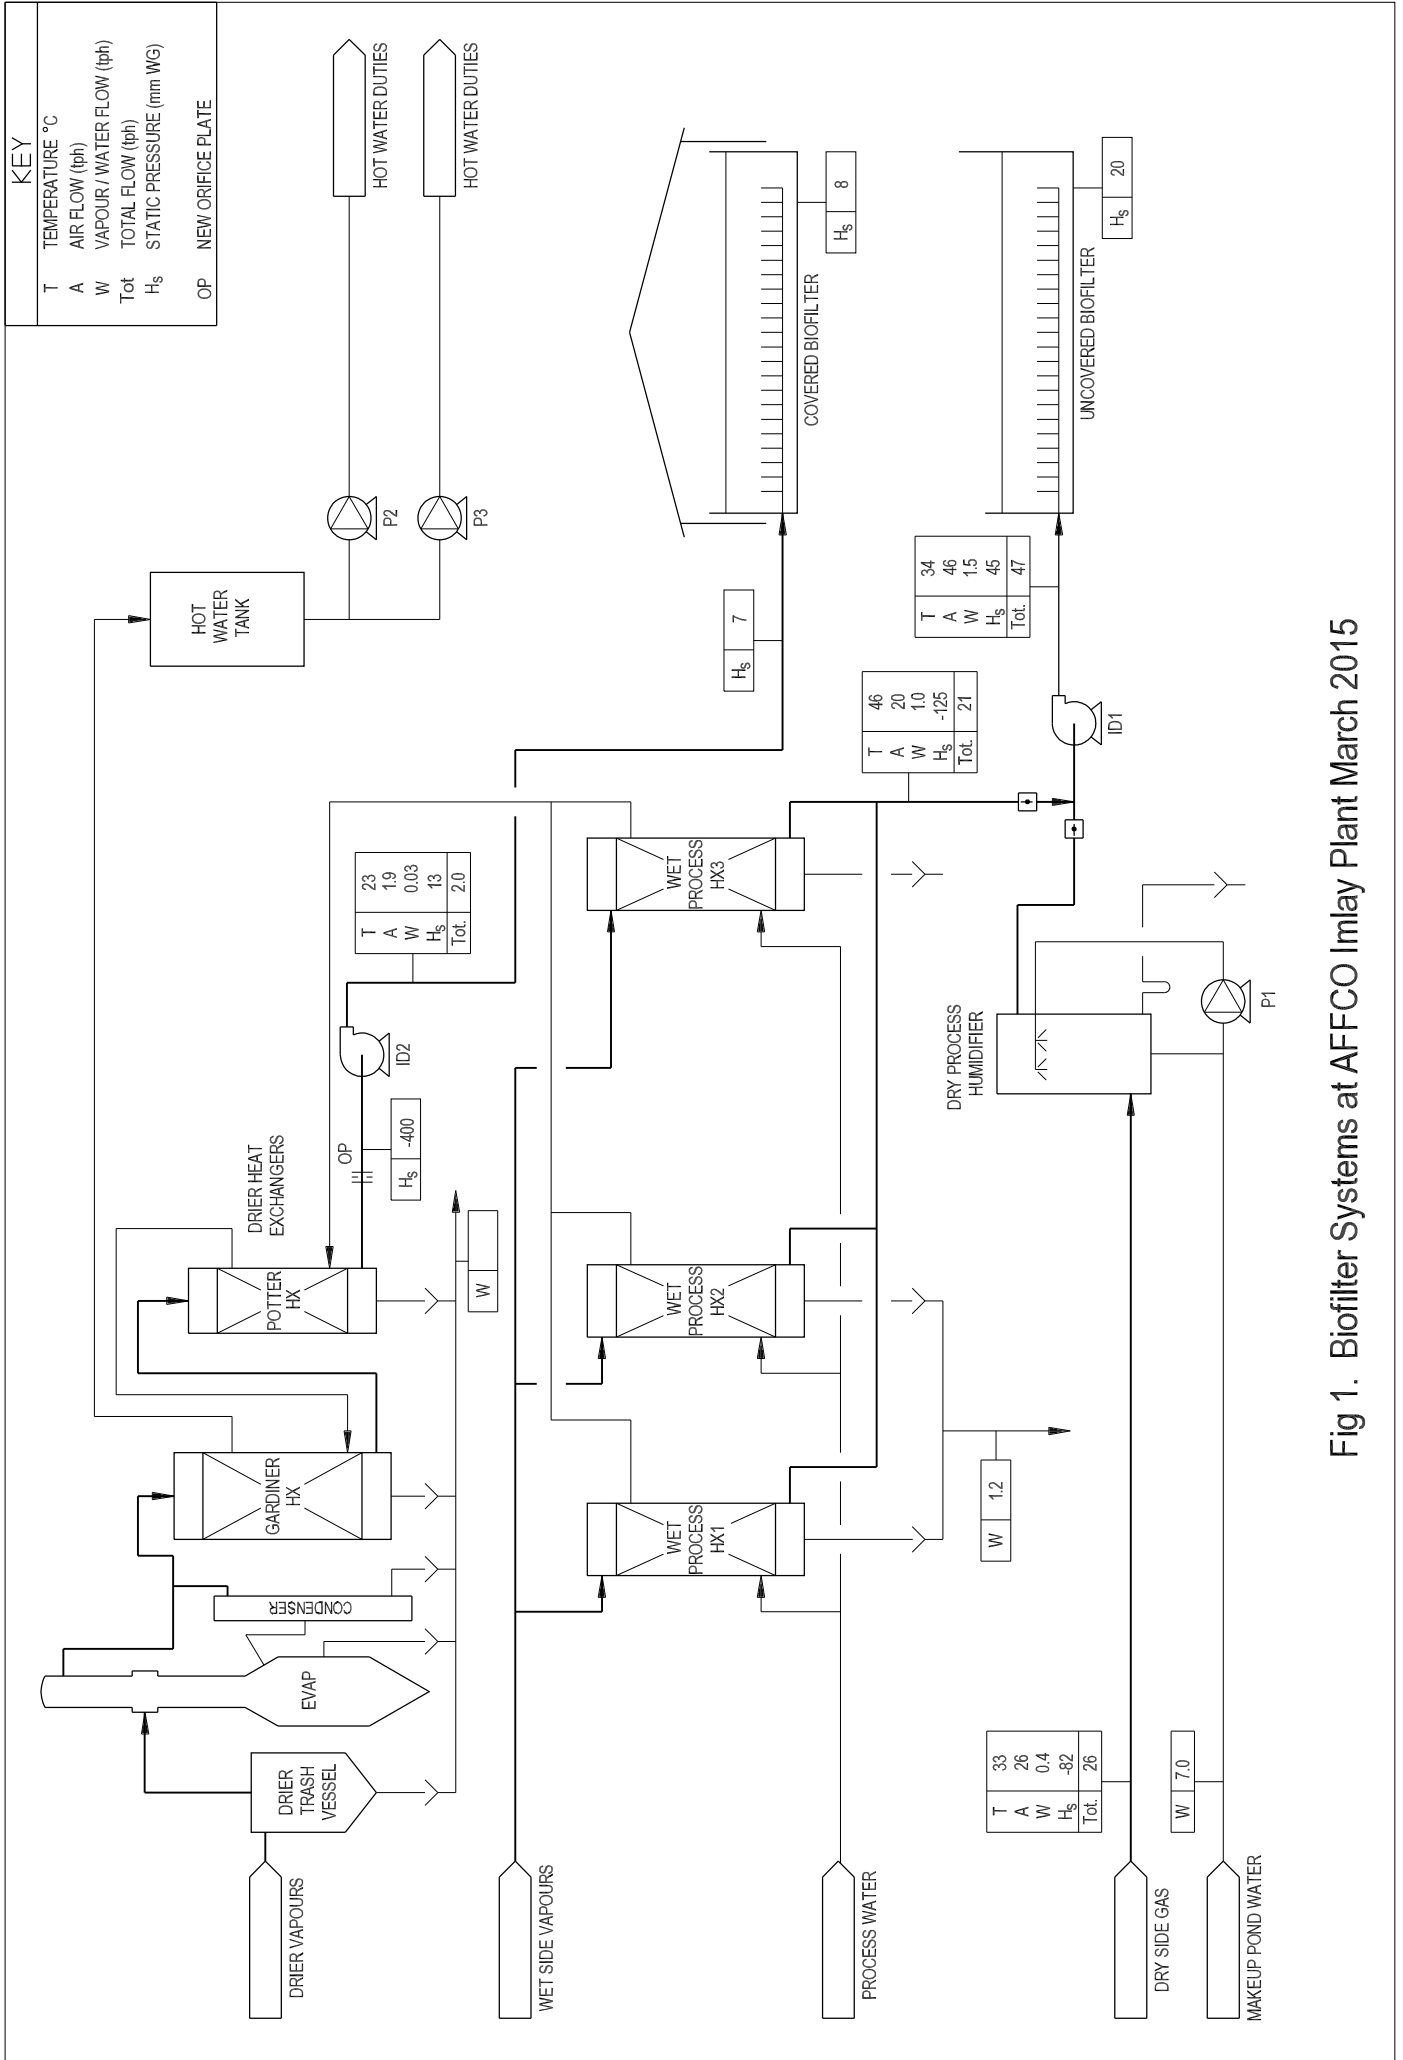
Fig 1. Biofilter Systems at AFFCO Imlay Plant March 2015

- a) Dry Side gas passes through a spray tower (known as the Dry Process heat exchanger or Dry Process Humidifier in Fig 1) to a common induced draught fan (ID1) which discharges into the uncovered biofilter. The primary function of the spray tower is the humidification of the Dry Side gas flow that might otherwise dehydrate the biofilter and reduce biological activity.
- b) Wet Side gas and vapour is cooled in the Wet Process heat exchangers; i.e. Wet Process HX1, HX2 and HX3. After cooling and some water removal, the Wet Side gas passes to the common ID1 fan which discharges into the uncovered biofilter.
- c) Drier gas and vapour passes through the Drier Trash Vessel which removes entrained water and then to a newly installed stickwater waste heat evaporator. The cooled Drier gases and non-condensable gases from the evaporator vacuum pump then pass through two heat exchangers

(Gardiner HX and Potter HX) which further cool the gas and vapour and remove condensed water from the gas stream. After cooling and water removal the Drier gas passes to induced draught fan ID2 which discharges to the covered biofilter. As pressure in the evaporator non-condensable gas discharge duct is to be -10 to -20mm wg an orifice plate OP has been inserted in the duct exiting the Potter heat exchanger to moderate the vacuum.

- d) Water in the Dry Process humidifier (previously called the Dry Process heat exchanger) is recirculated by a pump (P1) with water make up from the adjacent pond.

Figure 1 an average total flow of around 47 tph was made up of 20 tph of Wet Side vapour and 27 tph of Dry Side Gas. The Wet Side vapour flow is similar to what it was in May 2013 as also was the Dry Side Gas. After the fire (December 2013) some of the ducting had distorted resulting in ambient air being drawn into the ducting upstream of the ID1 fan. With the ducting now fixed some airflow reduction would be expected and this perhaps is the reason for the slightly reduced total airflow to the uncovered biofilter compared to the previous two measurements. This slight reduction in total gas airflow is not thought to have contributed to any of the recent odour issues. No change to the total airflow is needed nor any change in the airflow split between dry and wet side.
