Report No.	13-152
<b>Decision Required</b>

## **UPPER WHANGANUI SCHEME - WHANGANUI RIVER AT MATAPUNA - CHANNEL MANAGEMENT (PRD 05 32)**

14 August 2013

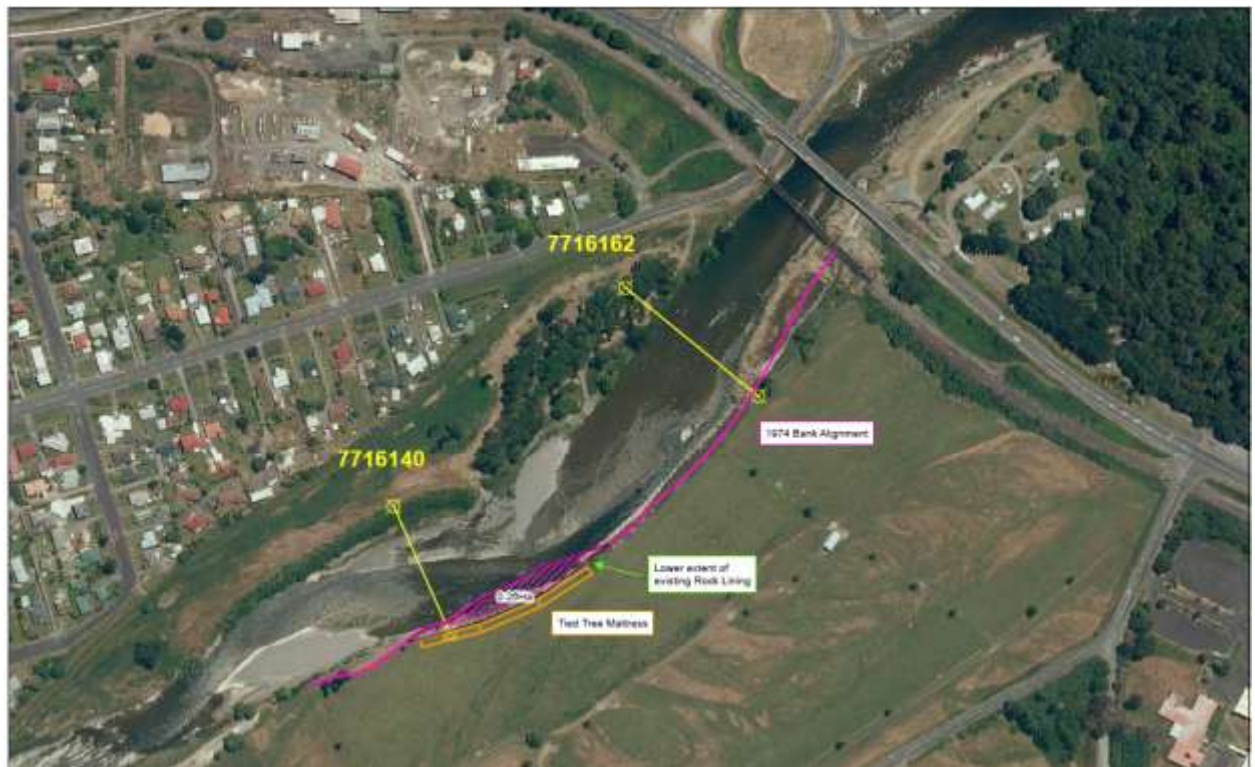
- 5.5. An area of erosion on the true left bank is quietly active, commencing around 350 m downstream of the Matapuna railway bridge and extending for 150 m. However, contrary to some perceptions, there has been minimal loss of land since the scheme's inception. An examination of aerial photographs confirms, that over the 37 year period, up until the latest aerial photography in 2011, no more than 0.26 ha of land was lost in this area (refer aerial photo at Annex A). Furthermore, an analysis of cross sections confirms that was essentially all lost prior to the establishment of the scheme in 2003. From 2011 to the present time, there has been no more than 2-3 m lost to erosion at the worst point around the bend.

- 6.2. The erosion extends from approximately 50 m downstream of cross-section 7716140 to 100 m upstream, as shown on the photomap below.

- 6.14. The recommended option for addressing the gradual erosion immediately downstream of the rock lining is to revert to a variation of the original proposal for this particular reach. That would involve battering back the steeper sections of river bank within a total length of approximately 150 m and establishing a willow mattress on that batter. The location and extent of that recommended work is shown on the photomap above. These works would require the permanent retirement and fencing off of a buffer width of approximately 4 m, which would still fit within the original buffer zone footprint. The estimated cost is \$25,000. A lower-cost option of unsecured pole planting would have little prospect of success at this site, given the dry and loose gravel material on the 4 m high river bank and the immediate exposure to river flow.
