**Kowhai Park Stopbank Upgrading**

**Whanganui River**

**Geotechnical Assessment**

**Horizons Regional Council**

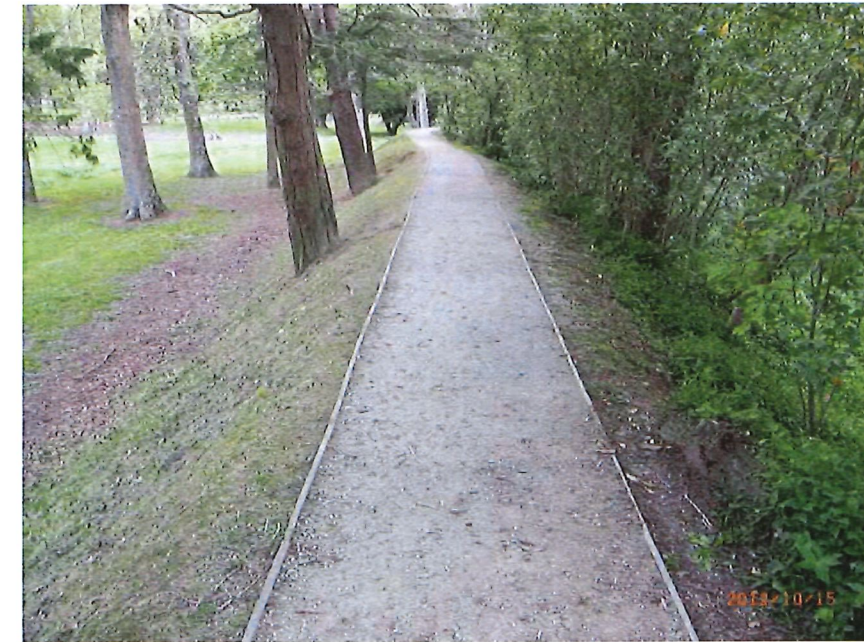
This downstream length of stopbank lies within the Arboretum and most of it runs along the left bank of the Matarawa Stream. There is a narrow gravel path running along the top of the stopbank except for at the most downstream 35m which turns to join the higher ground at Anzac Parade. The stopbank is typically less than 1.5m high and has to be lifted up to 0.8m to reach the 50 year return period flood level. As the stopbank has been built between trees in places it has side batters as steep as 1H:1V and is as narrow as 1.4m at the crest.

**Photo 1:** Typical Arboretum section

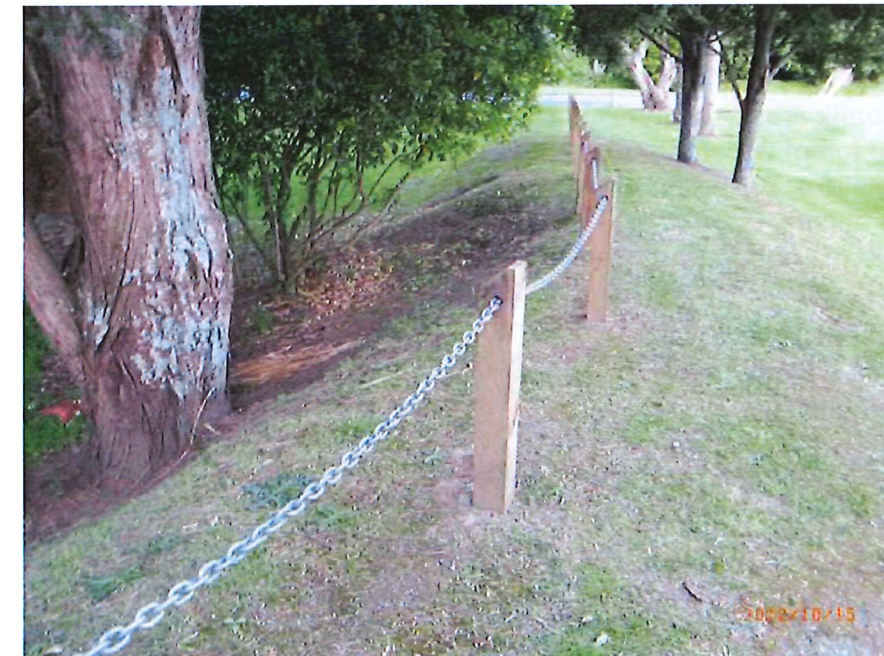
**Photo 2:** Downstream section joining Anzac Parade

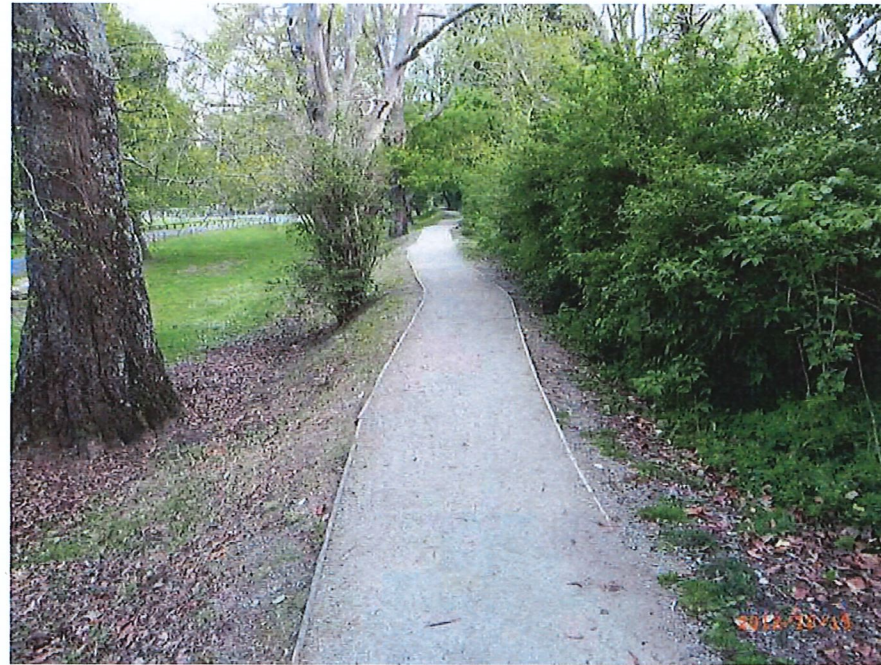
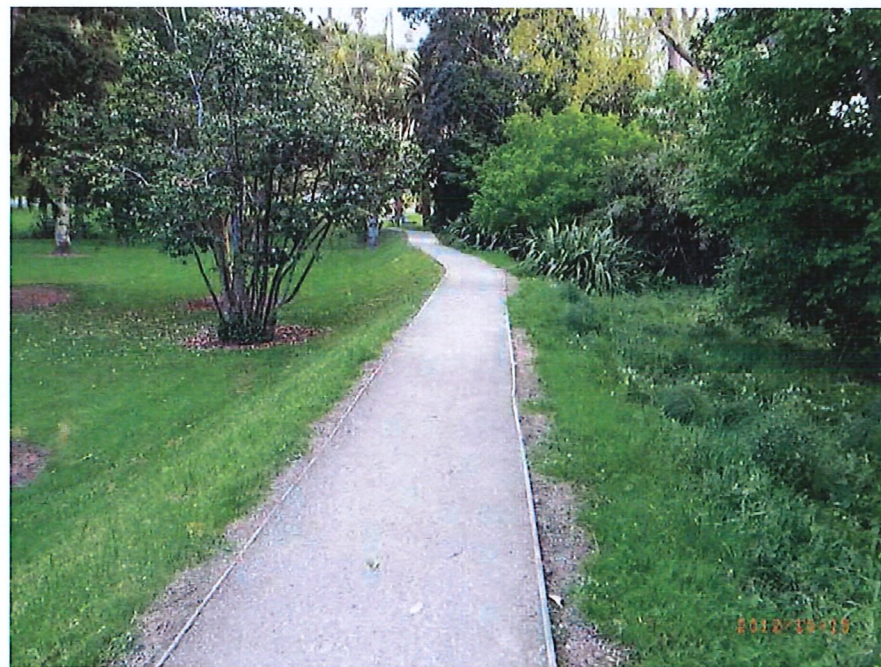
Over much of this length there is rough vegetation, including bamboo, along the river or stream side of the stopbank. It is proposed that most of the stopbank widening work should be carried out on this side to minimise disturbance to the Arboretum trees. Where there are valuable trees on both sides of the stopbank it is proposed that the stopbank level be lifted with planter box type construction.

**Photo 3:** Typical stream bank vegetation

**Photo 4:** Typical stream bank vegetation

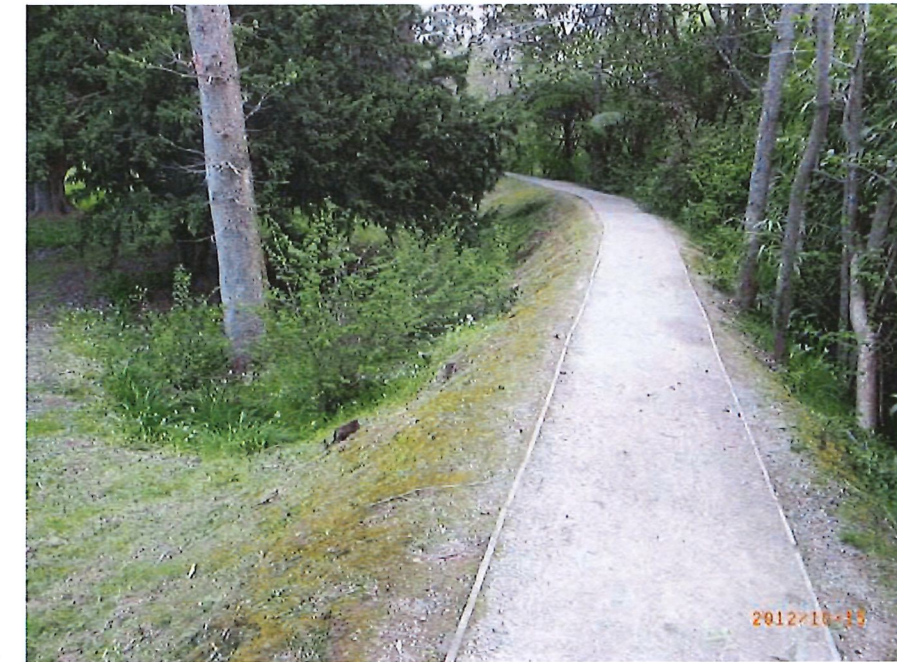
In some areas the ground on the inside of the stopbank is very wet and some shallow drainage swales and sumps have been installed. There are also hollows in the ground near the stopbank which could be the result of old stumps rotting beneath the ground surface. If there are old stumps which reach down to sand layer they could create a short circuit beneath the stopbank by allowing water to flow along the sand layer and up the hole left by the stump.

**Photo 5:** Very steep section due to the proximity of trees

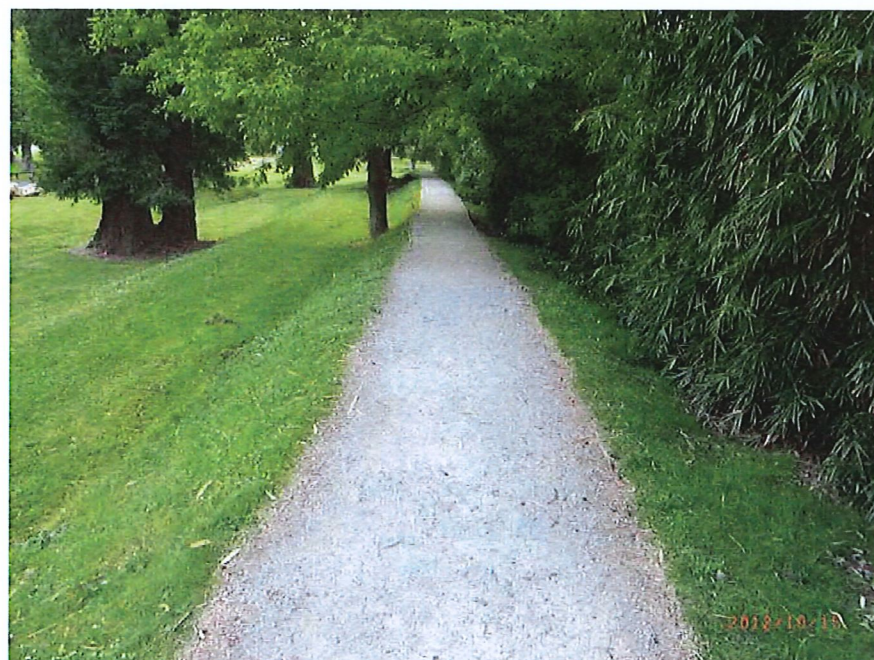
**Photo 6:** Buttress section with bamboo

Horizons surveyed one cross section through this buttress section and from comparison to the Opus design drawings it appears that the buttress has settled about 100mm in the last 10 years. There is a reasonable thickness of clayey silt in this area, as can be seen by water ponding at the ground surface. Most of the settlement is considered to be due to consolidation of this soil.

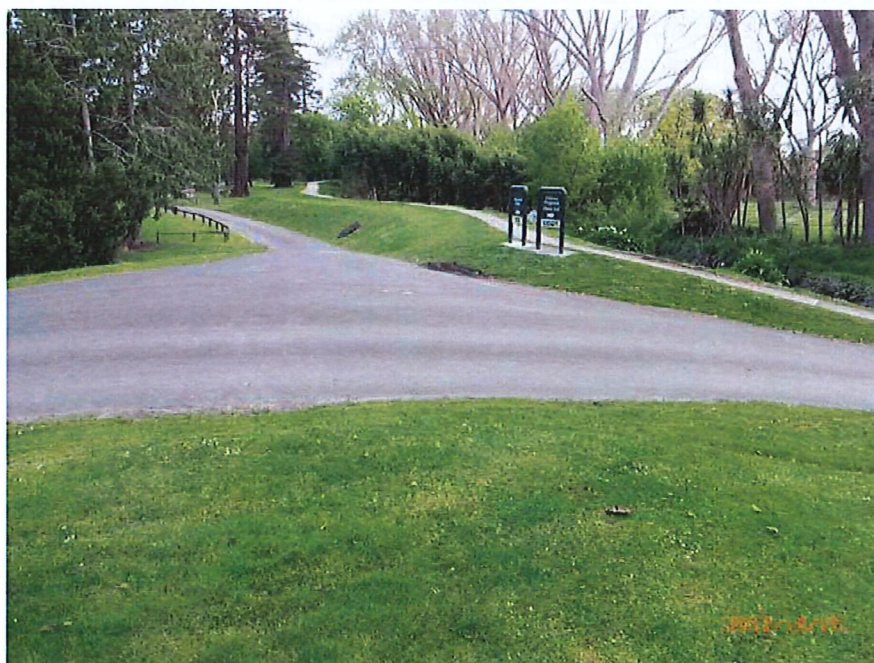
The crest level of the stopbank drops beyond 664m and there is no buttress due to there being no space between the stopbank and the road (Photo 7). The crest of the stopbank is wider here and it should be possible to add sufficient fill on the outside of the stopbank to achieve the required stopbank height and but not a 2.5m wide footpath. According to the Opus drawings the ground is as low as RL2.1 inside this section of stopbank. This is 0.4 to 0.6m lower than elsewhere in the Arboretum.

**Photo 7:** Low area

The road leading to the Matarawa Stream bridge forms the last part of this section of stopbank. The road is up to 0.9m below the design 50 year flood level. It is considered that a water inflated barrier could be placed here across the gap in the stopbank when a flood threatens. Details of this type of barrier are given in Appendix D. The barrier would have to be about 30m long.

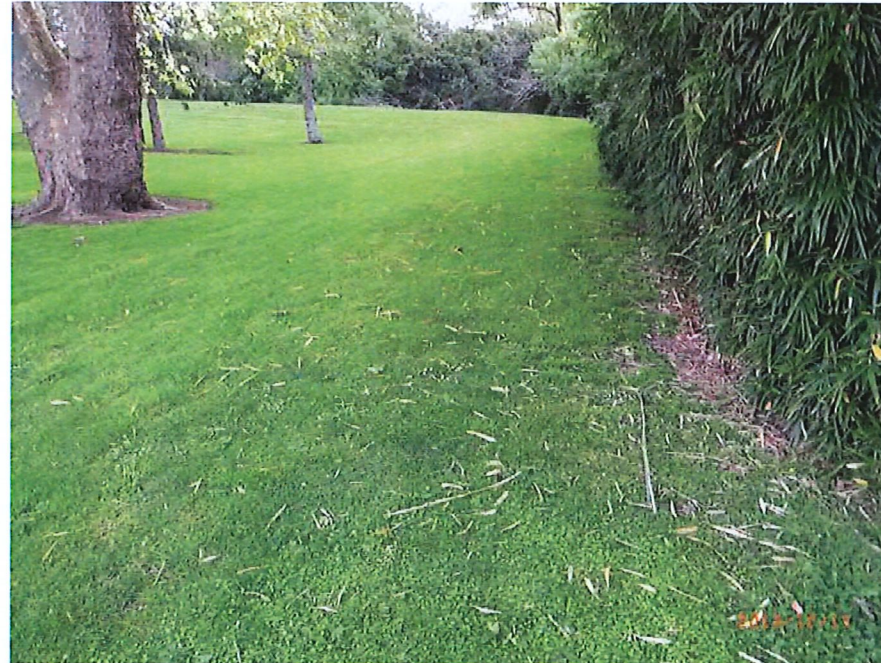
The stopbank on the left bank of this section of the Matarawa Stream needs to be raised by up to 600mm to reach the 50 year return period flood level. It has a broad rounded profile and there is room for fill on the inland side.

Photo 8: Left bank Matarawa Stream

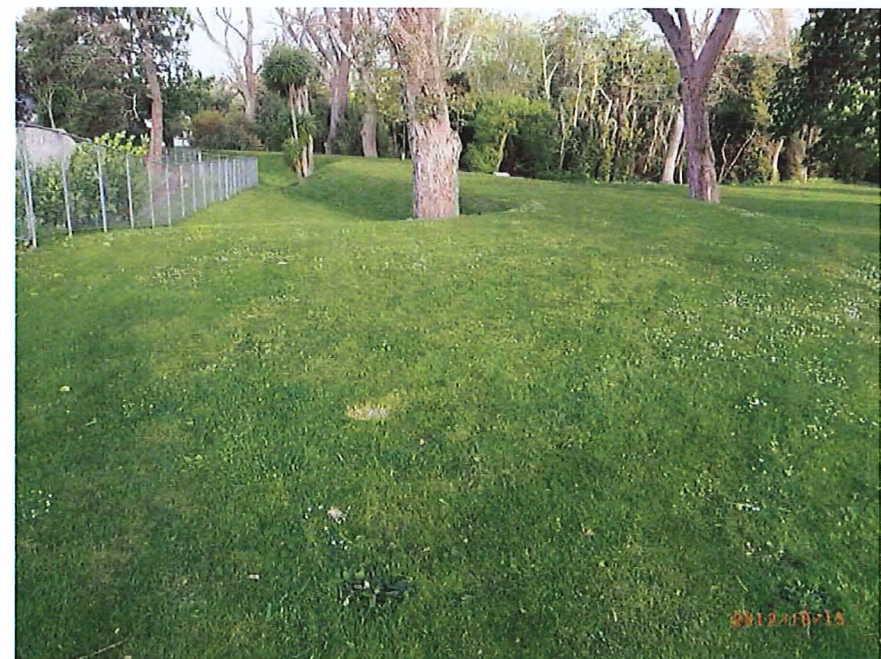
Photo 9: Right bank Matarawa Stream

The right stopbank has a much more formal profile having been built in 2001. It was designed to curve around trees and there is a drainage sump between the stopbank and the Tot Town fence. This section needs to be raised by up to 400mm. The crest width of the stopbank is sufficient to allow raising without placing fill on the sides of the stopbank.

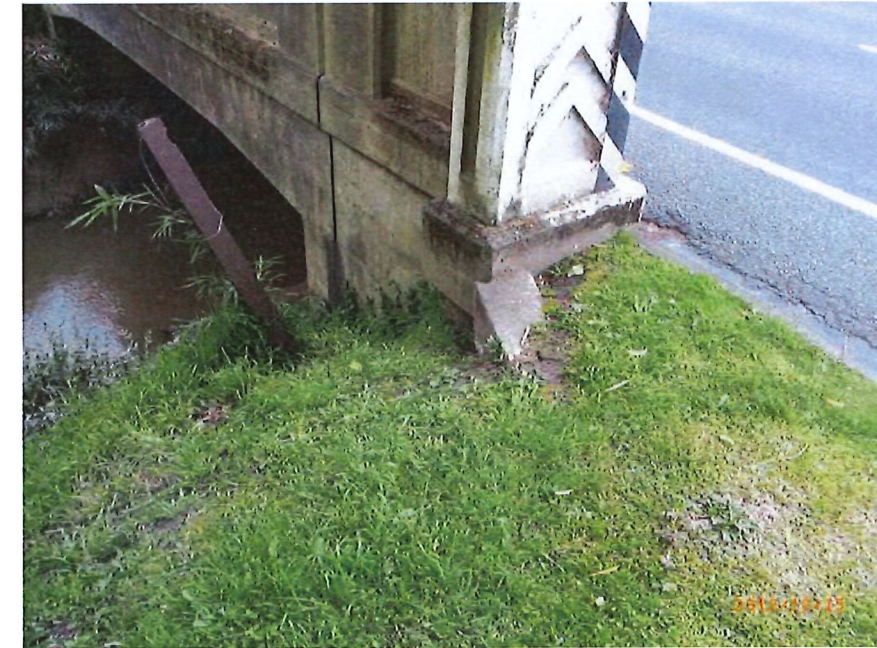
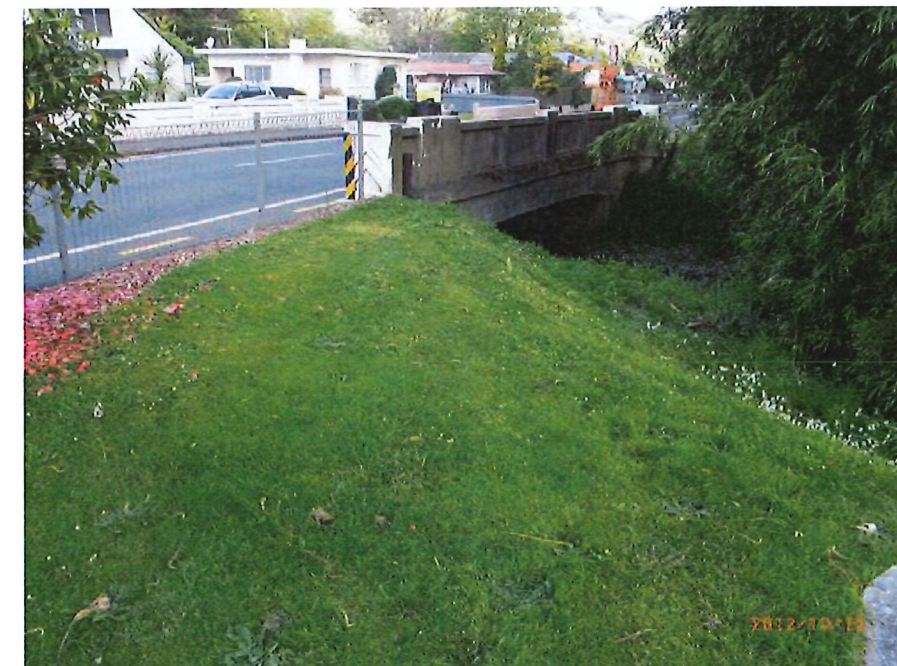
The stopbanks will have to be raised by 600mm where they butt into the Anzac Parade bridge abutments.

**Photo 10:** Anzac Parade Bridge left abutment

**Photo 11:** Anzac Parade Bridge right abutment

There will be a very short seepage path at the bridge abutments therefore it is recommended that 3m long concrete wingwall be cast onto the ends of the solid bridge rail and buried in the stopbank.

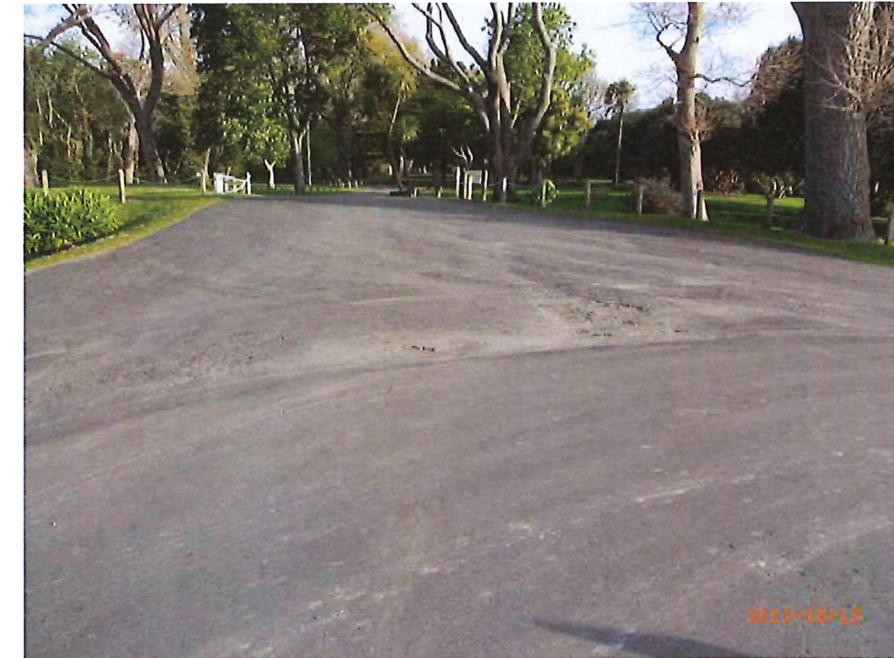
As the road drops down to the riverbank it will need to be lifted by 600mm. This section of road forms part of a speed skating circuit so changing the road profile is unlikely to be popular.

**Photo 12:** Matarawa Stream transition

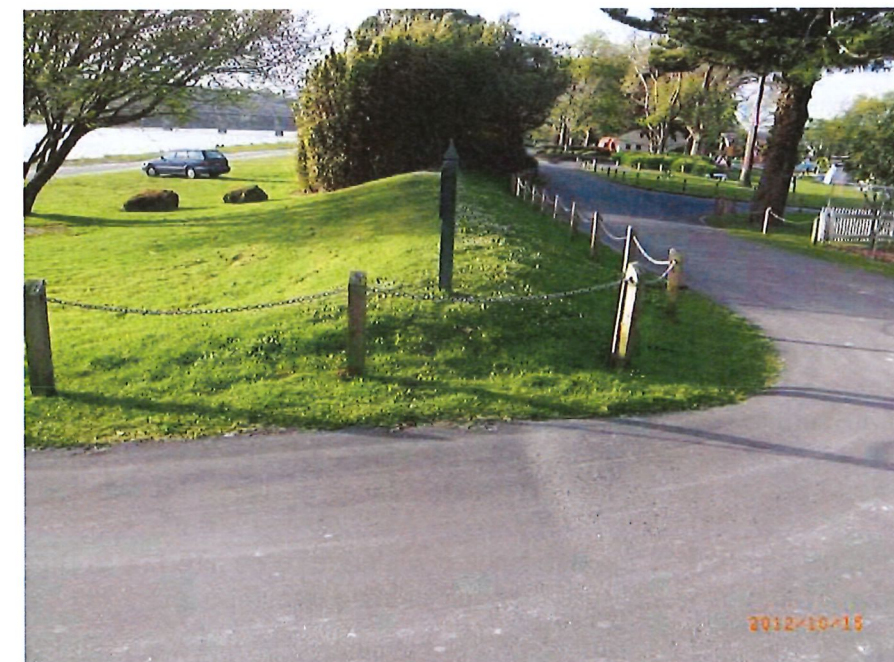
There is a short length of low narrow grassed stopbank beyond the river bank access road, then the stopbank crest is formed by the car park and adjacent plantings. The stopbank level needs to be raised by up to 1.0m along this length. At the far end of the carpark there is another access road, also part of the skating circuit, where the level needs to be raised by nearly 600mm.

**Photo 13:** Skating track and short grassed stopbank

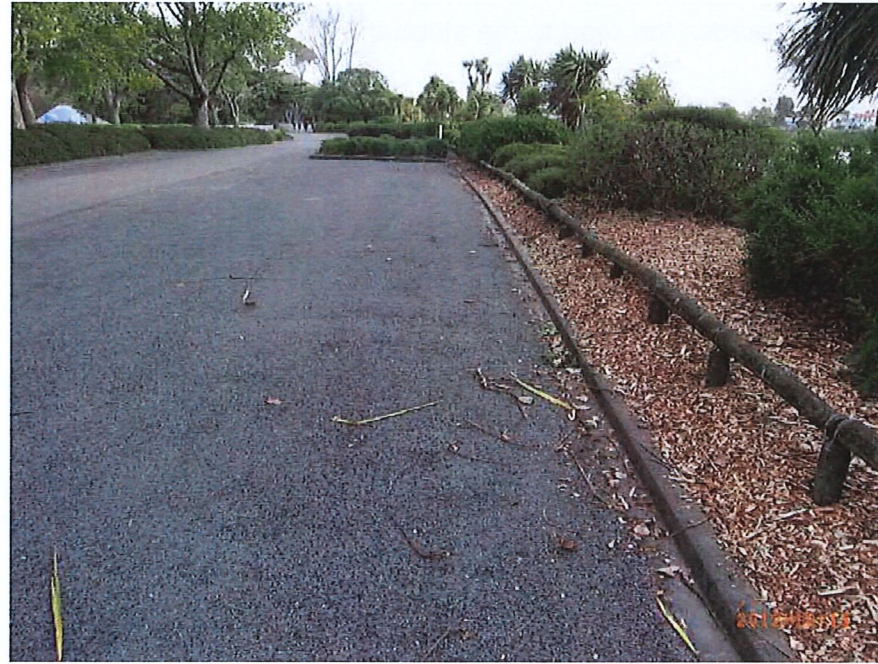
**Photo 14:** Main carpark

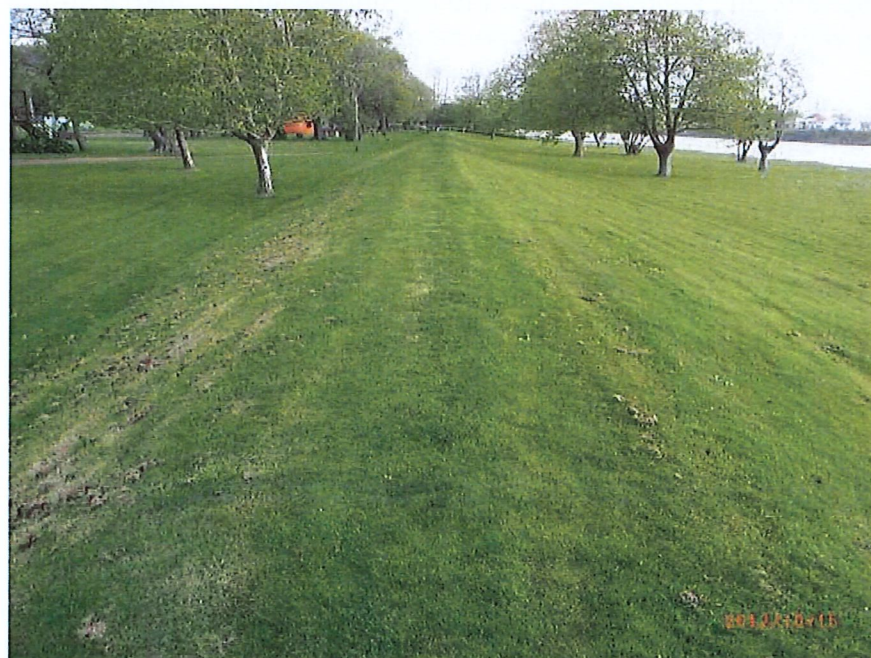
**Photo 15 :** Grass covered stopbank

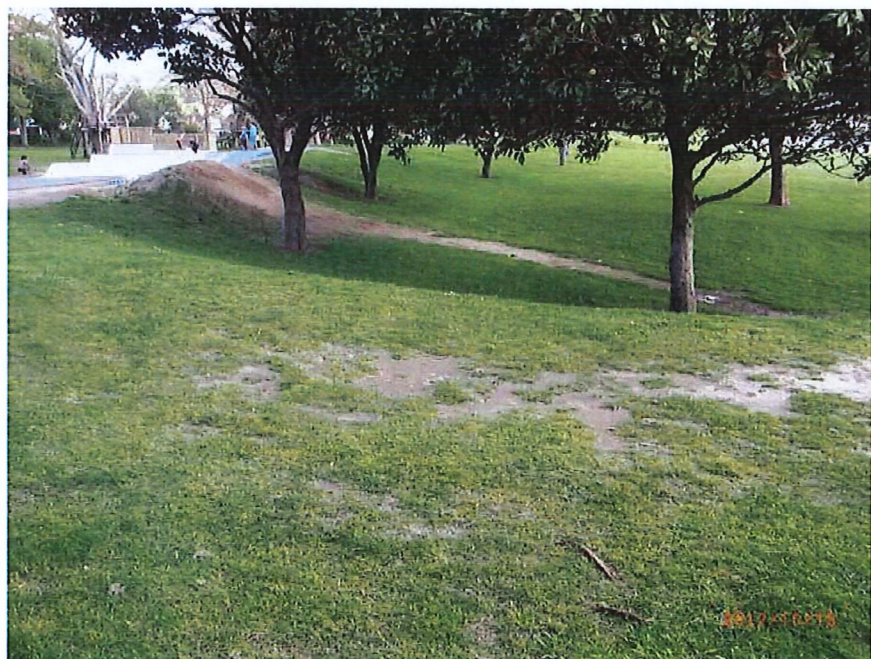
**Photo 16:** Stopbank damage near skateboard park

At the skateboard park the stopbank crest should be moved slightly towards the river, and the whole stopbank crest and face of the stopbank covered with a cohesive soil and a geofabric such as Enkamat to promote good grass root structure (Figure 4).

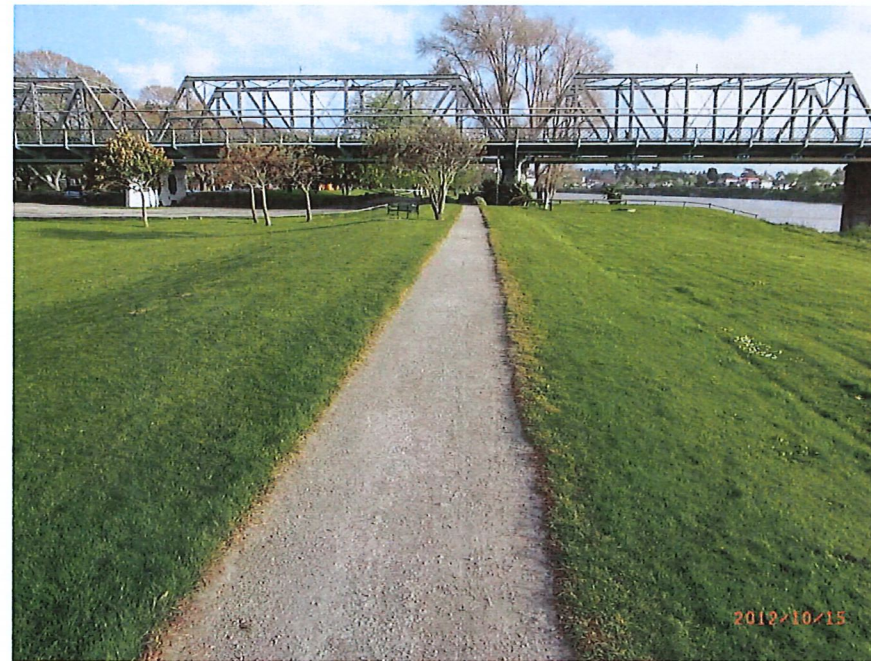
Photo 17: Dublin Street Bridge crossing

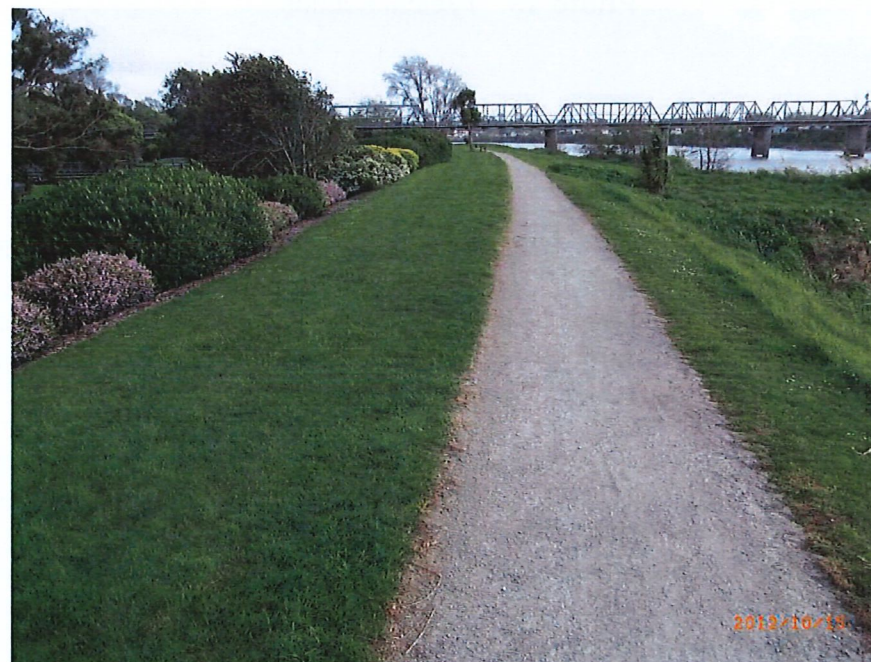
Photo 18: Garden section

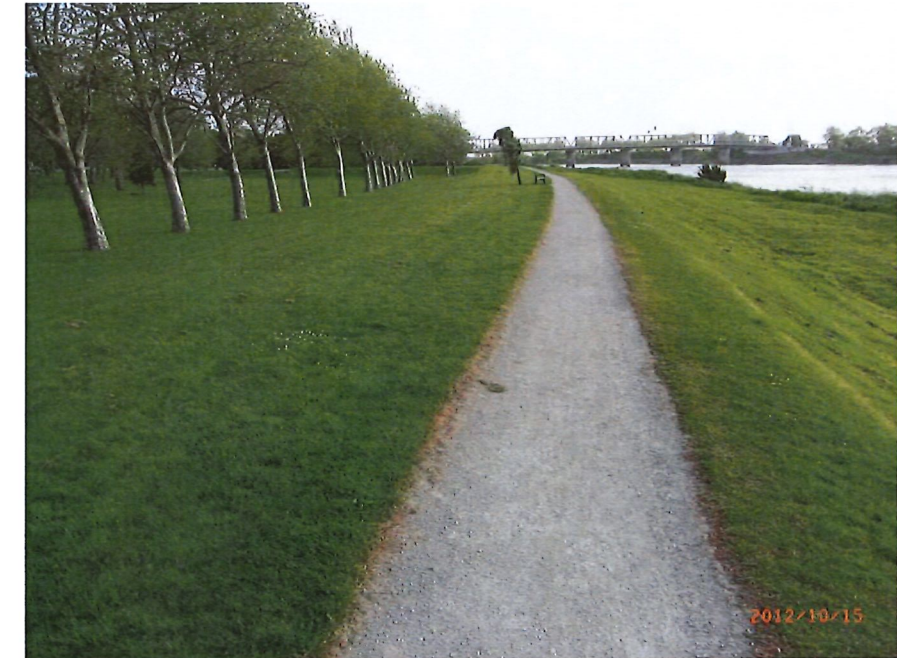
**Photo 19:** Typical section

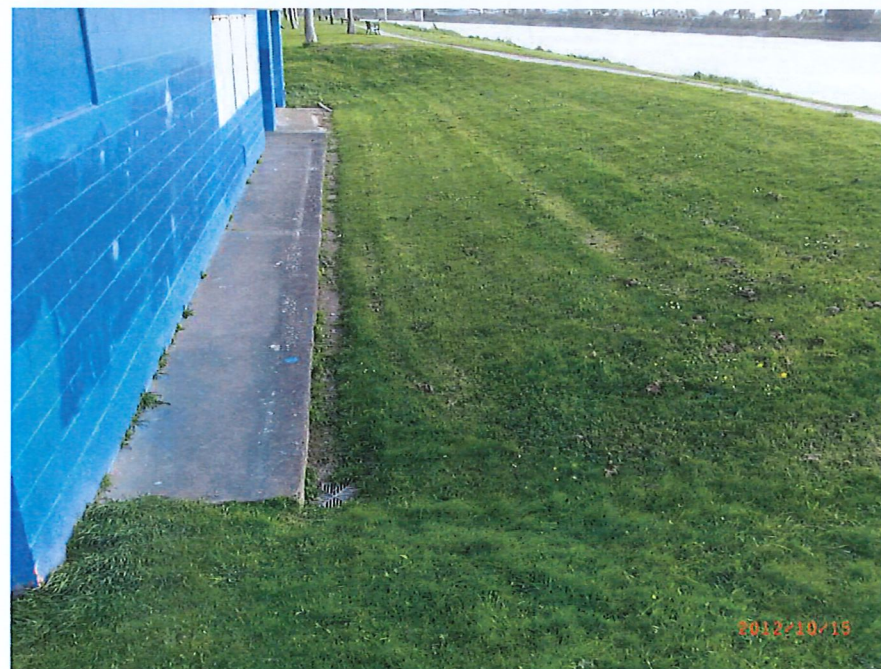
This section of stopbank is complicated by the Motor Boat and Multi Sport club buildings and a boat ramp. Photo 20 shows the proximity of the Motor Boat Club building to the stopbank. It can be seen that there are small drainage sumps at each end of the concrete slab. The building is effectively in a hole surrounded by stopbanks and pavement (Photo 21). There is little room between the stopbank crest and the river bank and erosion is occurring in this area (Photo 22). It is not known if this erosion is due to turbulence created by the adjacent boat ramp or by boat wash. It is considered that some erosion protection work should be carried out here before the stopbank is compromised.

**Photo 20:** Motorboat Club building

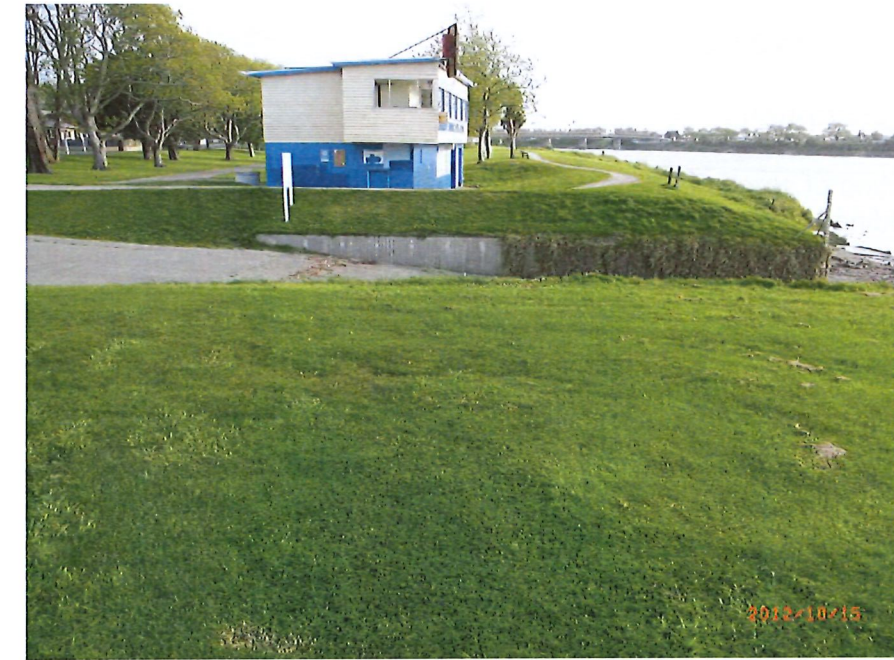
The inland end of the boat ramp is below the design flood level by about 1m. Several options to provide flood protection to the design level are discussed in Section 6.7.3.

**Photo 21:** Motorboat Club and boat ramp

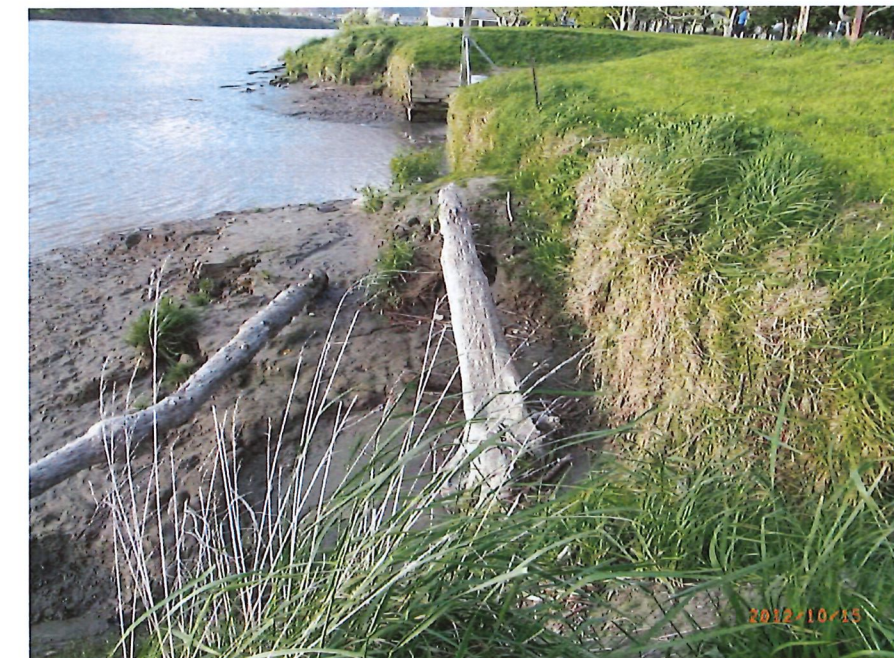
**Photo 22:** River bank erosion in near boat ramp

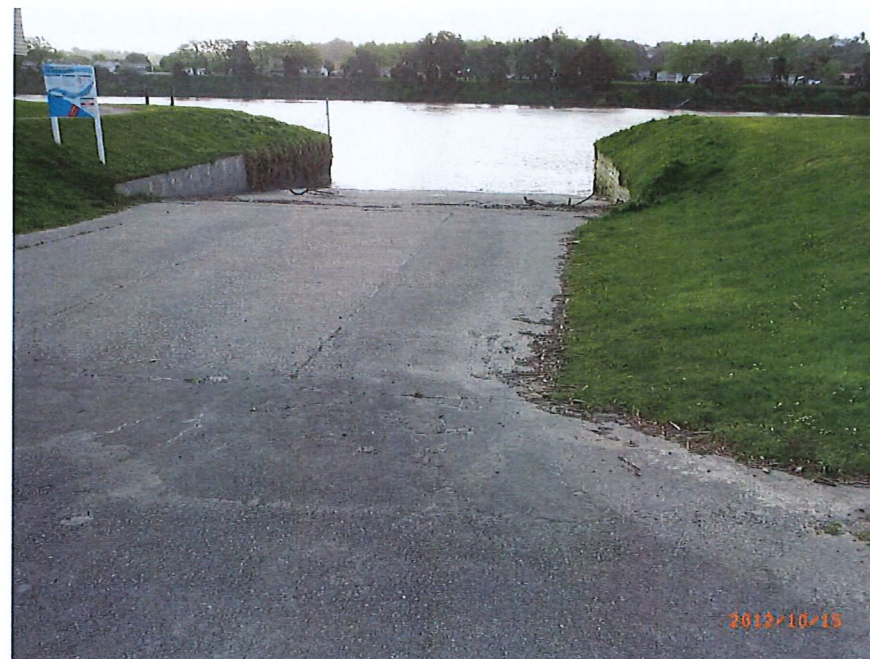
**Photo 23:** Boat ramp

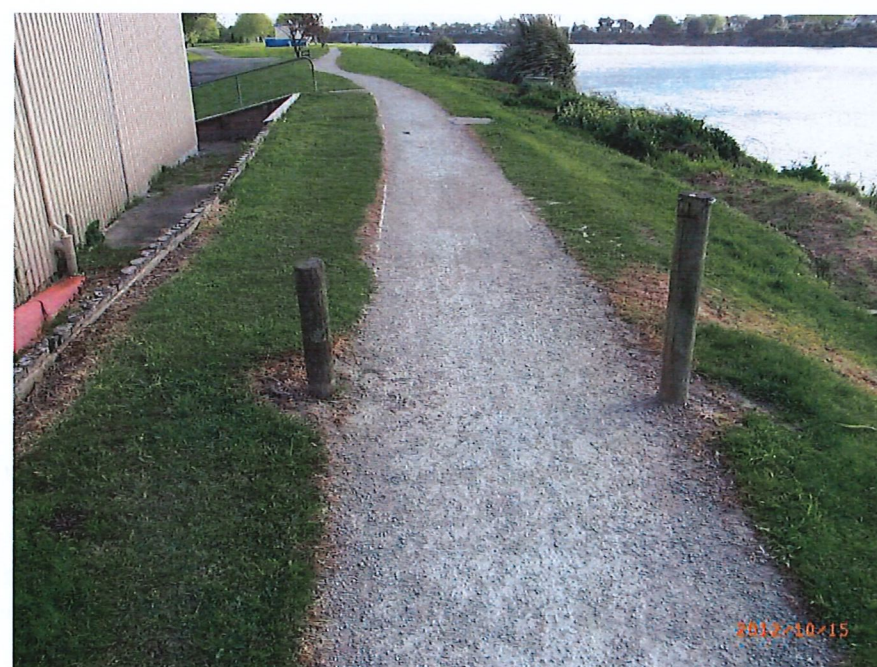
**Photo 24:** Multi Sport Club Building

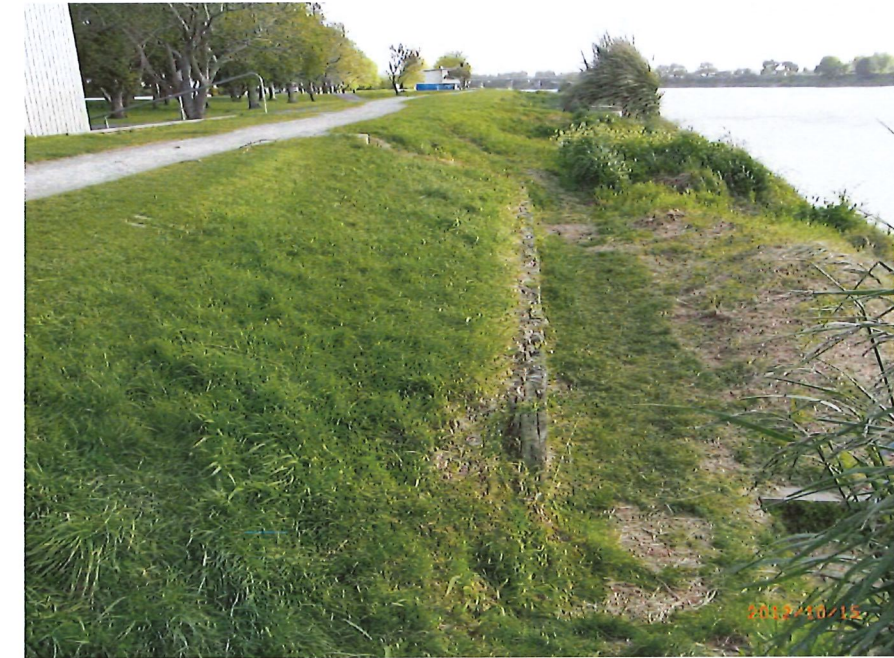
Beyond the Multi Sport building the stopbank swings towards Anzac Parade, which is at the design flood level at this point.

**Photo 25:** Multi Sport building river access
