Mt Munro Wind Farm

Civil Engineering Report

Prepared for
Meridian Energy Limited

Prepared by
Tonkin & Taylor Ltd

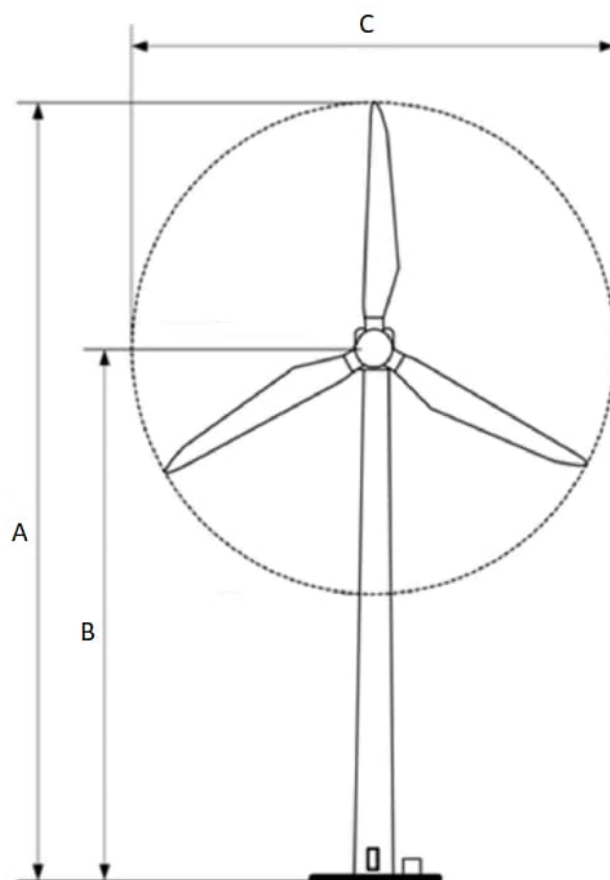
Figure 5.2: Indicative Wind Turbine Dimensions (A = Tip Height, B = Hub Height, C = Blade Diameter)

For the purposes of hardstand and foundation design, and for transportation, a turbine blade diameter of up to 136 m, and tip height of up to 160 m has been used for this preliminary design.

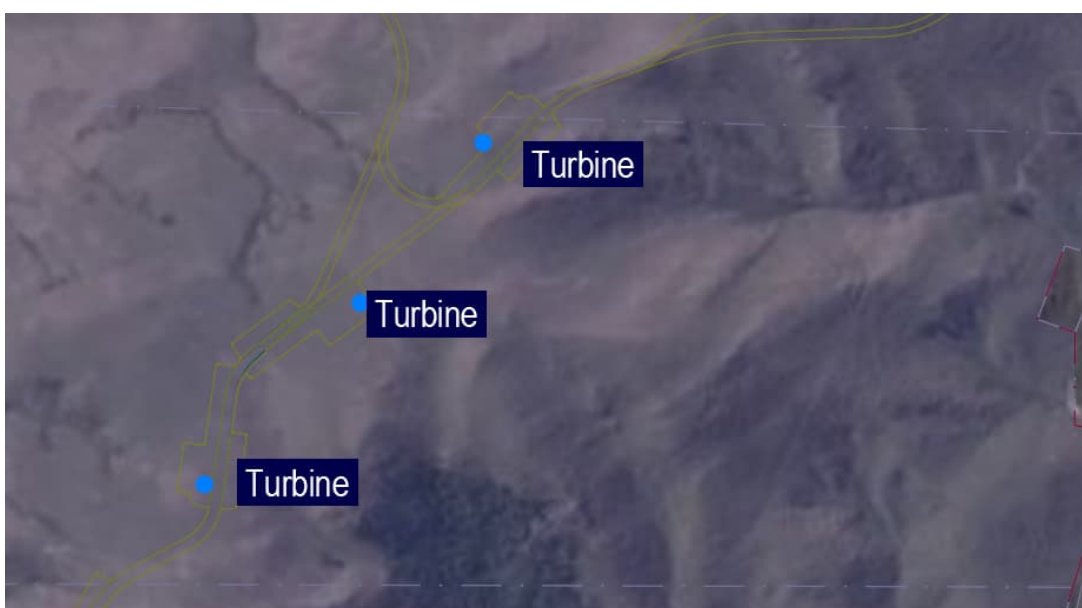
Figure 5.4: Typical turbine access via central wind farm road or spur road.

Access to each turbine is either directly off the wind farm central road or from a spur road. Spur roads are required when a turbine location can't easily be accessed by the central wind farm road. Figure 5.4 below illustrates the difference between the two. The project will use a mixture of spur roads and through roads.

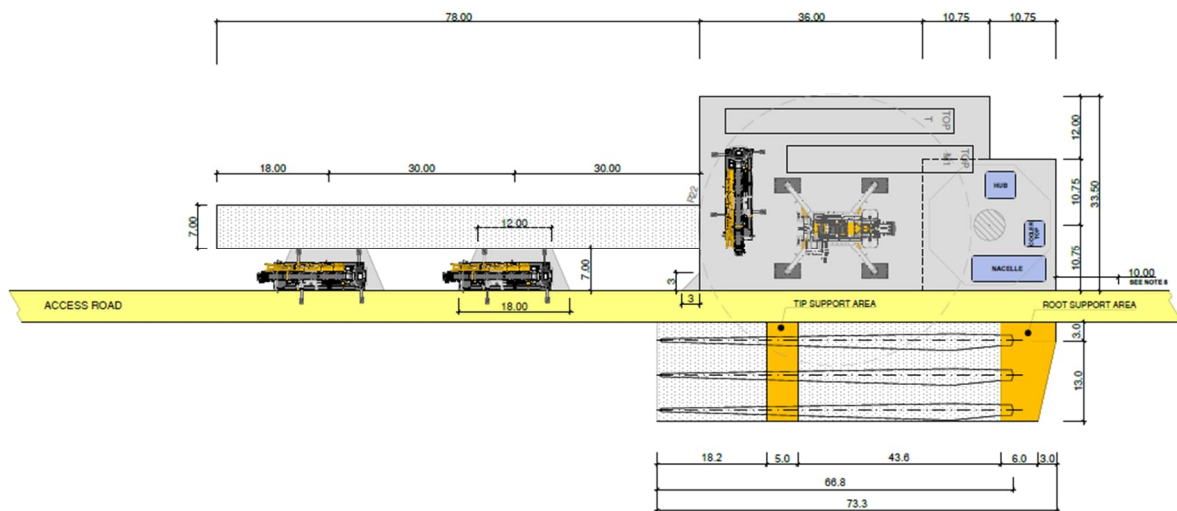
Figure 5.5: Typical hardstand layout

The hardstand platforms vary in configuration depending on the component sizes, topography of the surrounding area, and whether the access is on the central road or a spur road. Figure 5.5 below shows an example of a foundation, crane pad, and storage area, for a V136 wind turbine, where the access is on the central road. This example is non-uniform in size and approximately 125 m at its longest point, and 60 m at it widest. The hardstand needs to be level and sound so to provide a stable working platform for the cranes.

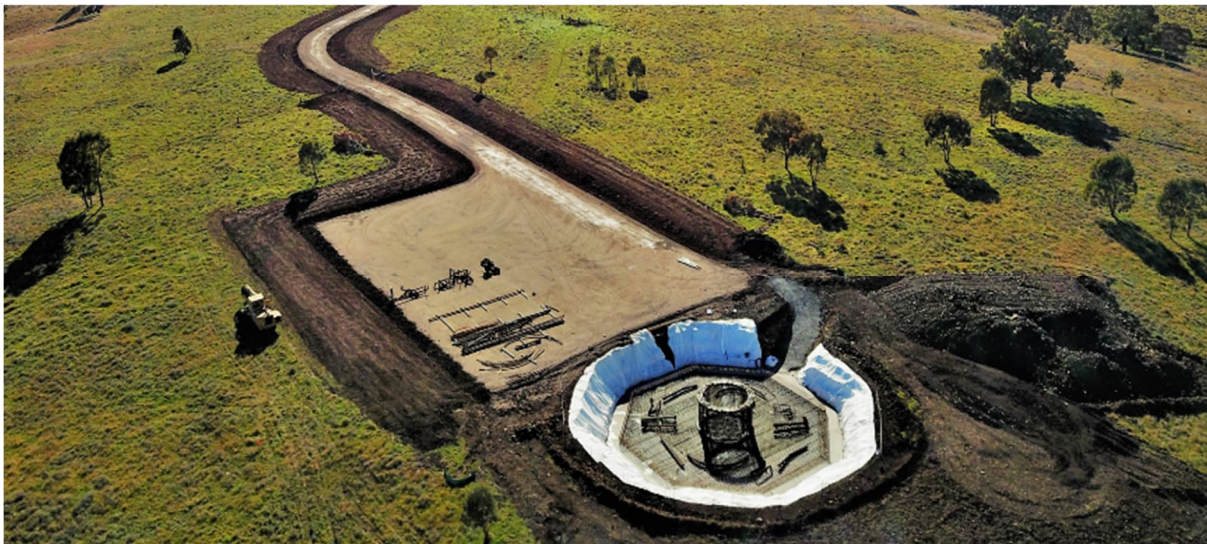
Photograph 5.6: Photo of a hardstand area, foundation and integrated crane pad and blade assembly area, with access via a spur road.

At each wind turbine location, a foundation and hardstand area is needed (refer to WSP Turbine Design Report for foundation details). The foundation supports the erected wind turbine, and the hardstand area provides a crane-pad for cranes to assemble and lift the large heavy components, and an area for storing these components prior to assembly.

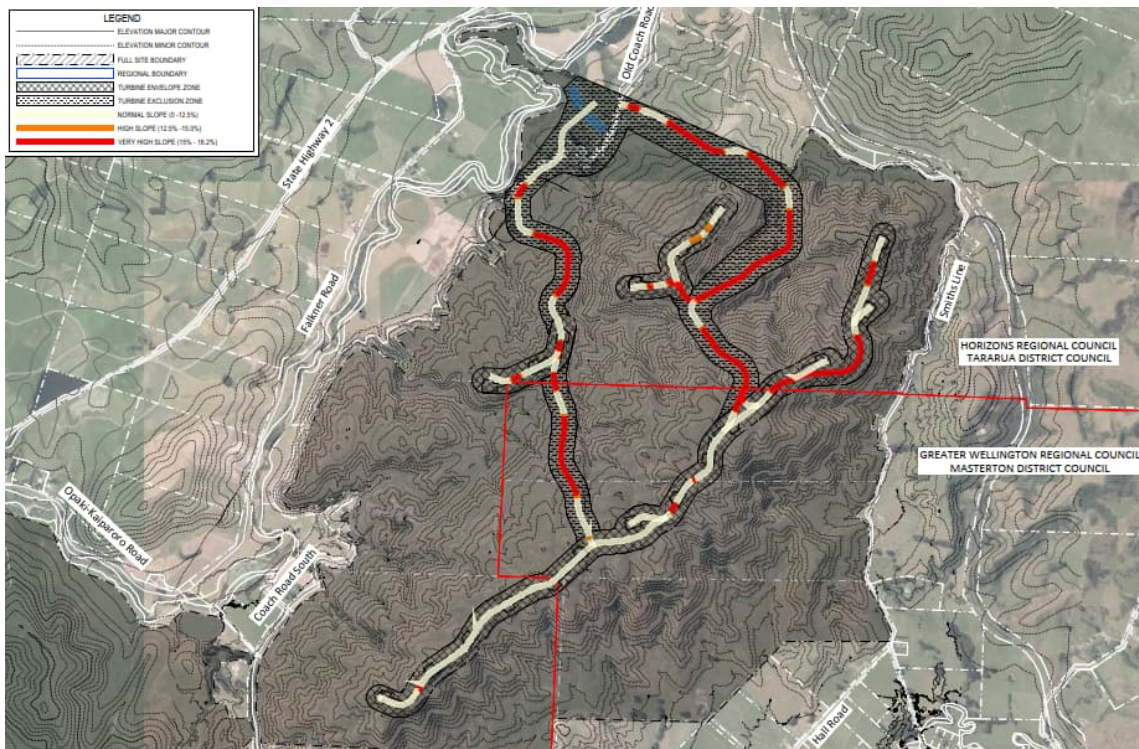
Figure 6.2: Wind farm roading layout

The preliminary road alignment is shown in Appendix A8 “Internal Roding Plan” and summarised in Figure 6.2 below. Note that the iterative process of this design, also fed back into the envelope zones, such that the roads are centred on these zones.

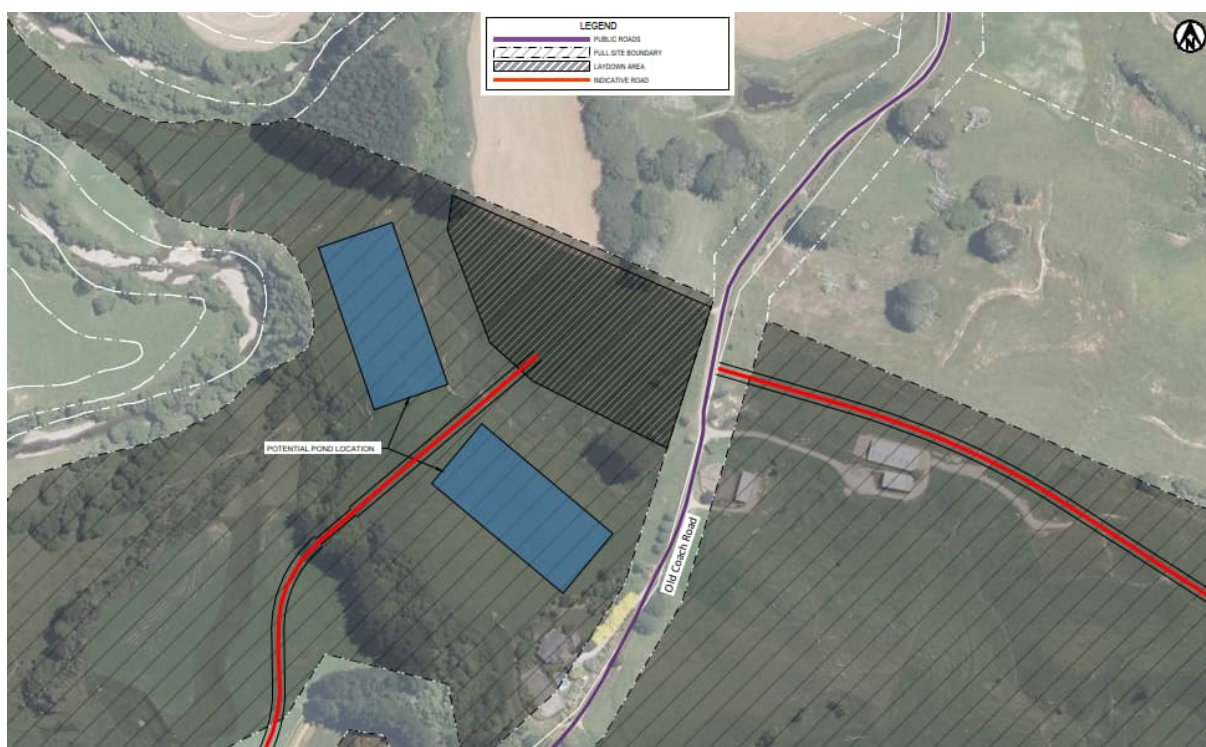
Figure 7.1: Laydown location

The preferred option for the main storage laydown area, is 1.4 hectares on the western side of Old Coach Road, opposite the wind farm Site Entrance as indicated on Appendix B "Laydown Location Plan" and in Figure 7.1 below.

This area is relatively flat and will require minimal earthworks to establish. The yard formation will be constructed by stripping topsoil from the full extent of the laydown area and stockpiling on site. A granular hardfill layer will be placed to provide a sound working surface. The size of the laydown area required will depend on the project construction schedule, the number of turbines, the actual turbines selected, turbine servicing, crane availability, the requirements for any pre-erection activities such as preliminary work on the nacelles and the Contractor's site office location and layout.

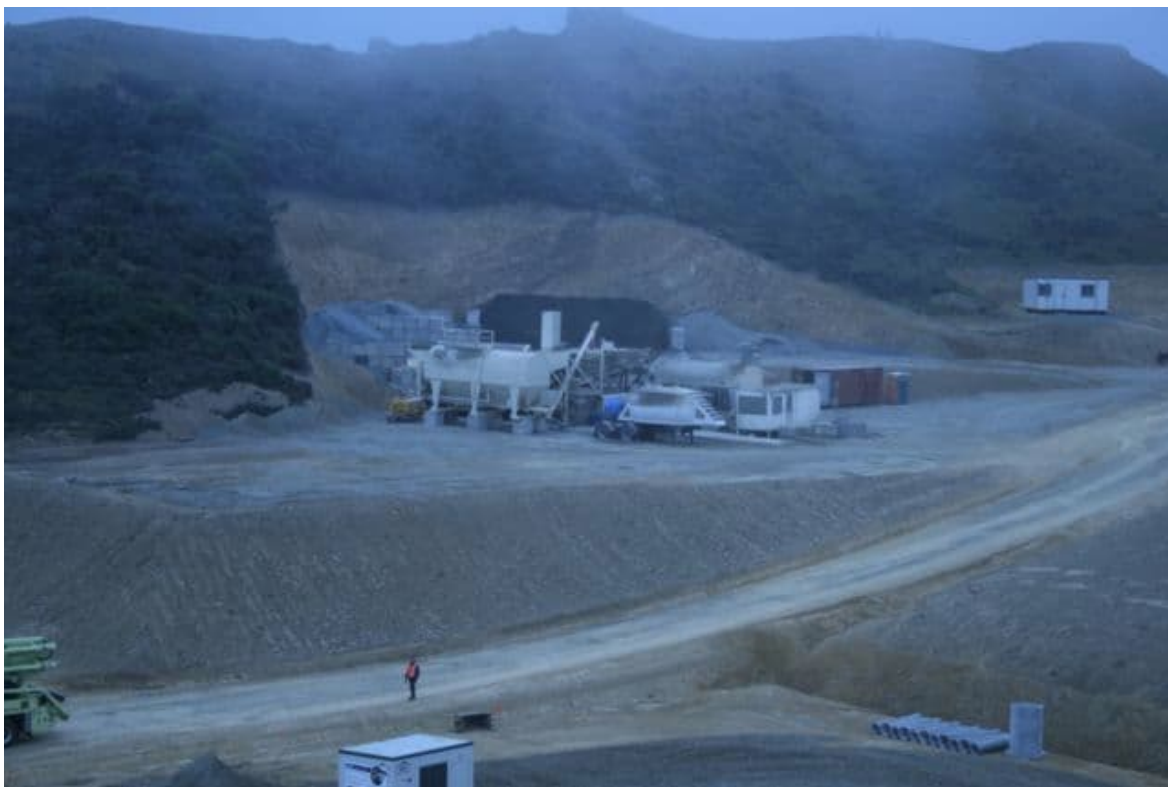
Photograph 8.1: Typical mobile concrete batching plant

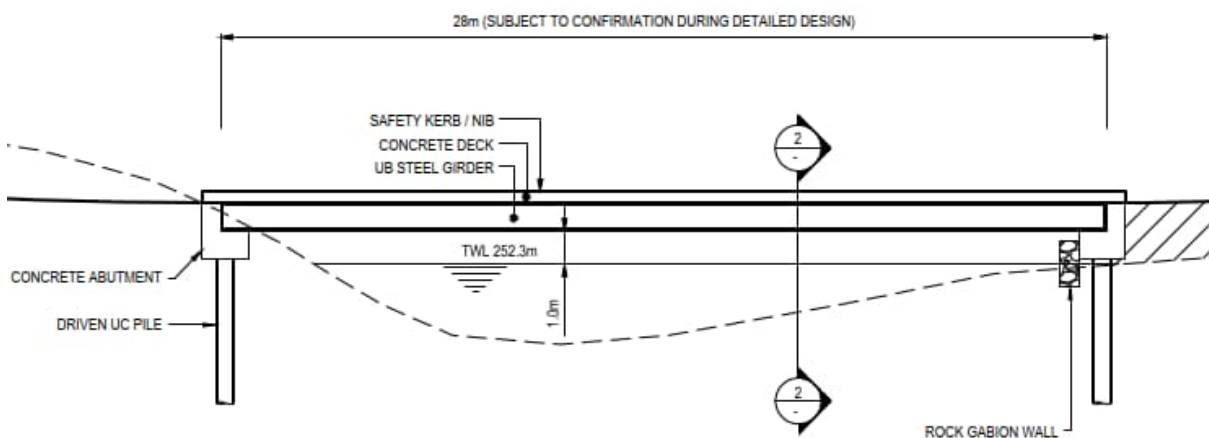
Figure 12.5: Typical bridge elevation

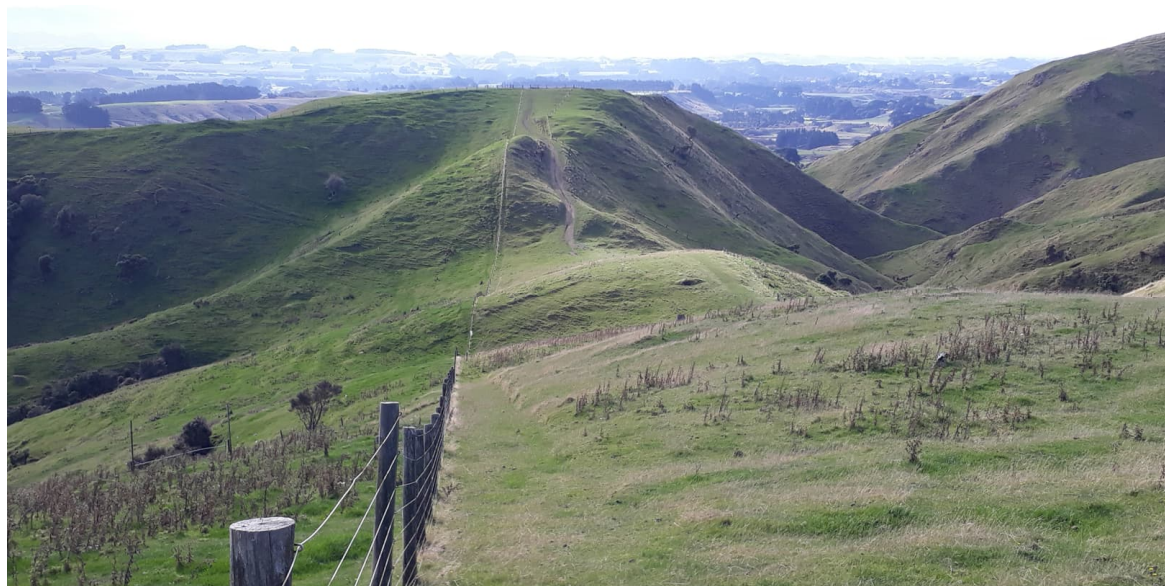
The site is characterised by steep hills and relatively flat plateau areas on top. The hills have a prominent ridge and gully structure. The hillslopes are generally quite steep and high within the project area, with more gentle lower hillslopes to the east. The site is located on active farmland, which is used primarily for sheep grazing.

Photograph 2.2: Steep hillslopes typical of the windfarm area

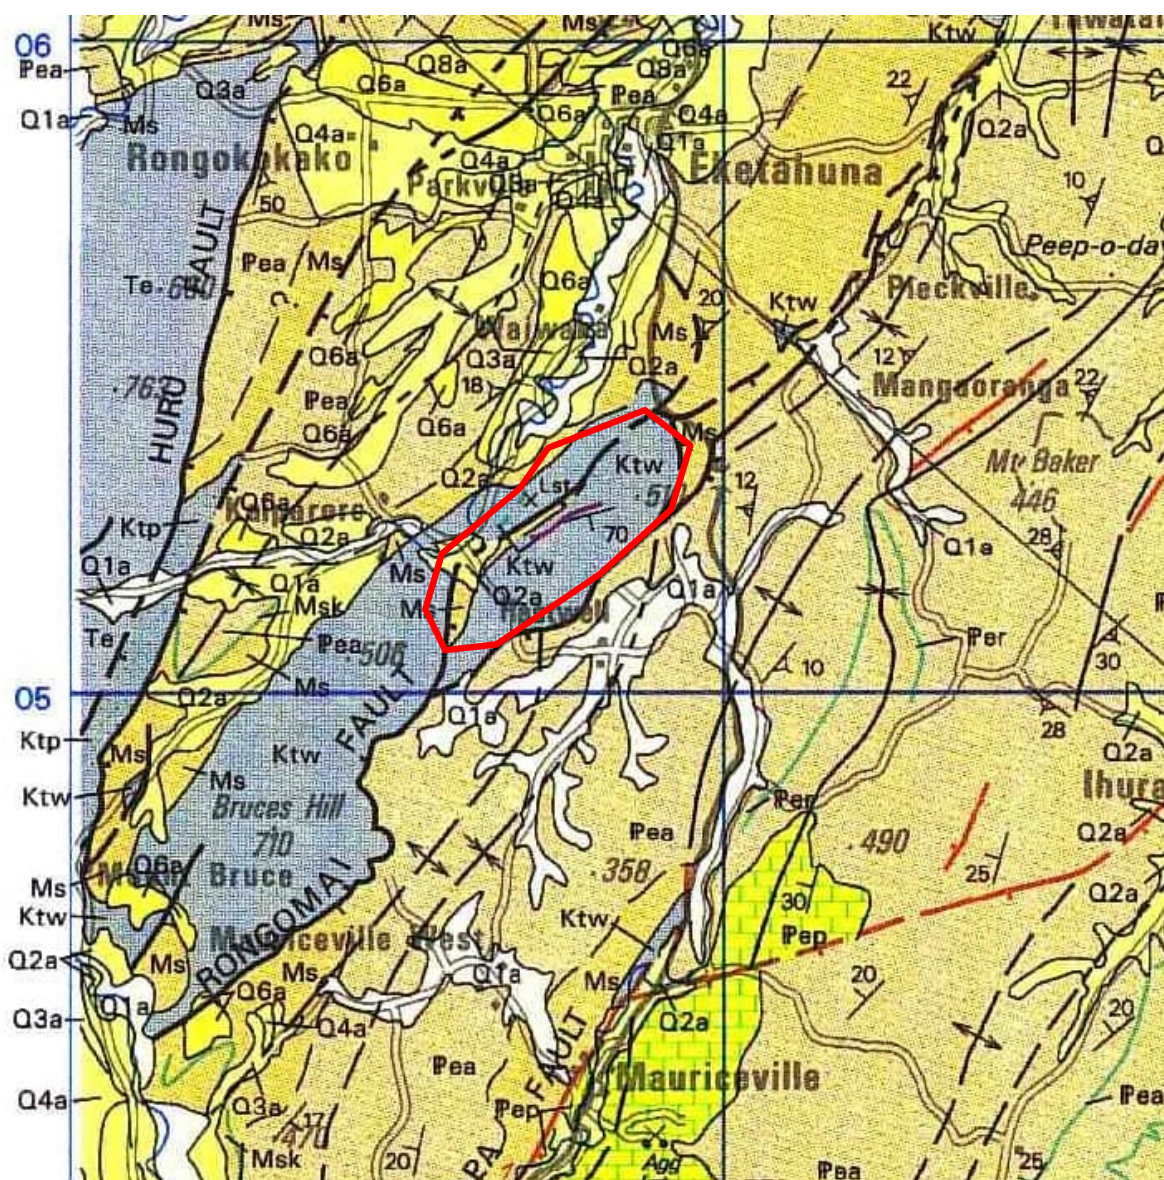
Figure 4.1: Geological map of the site¹ and the surrounding area. The site area is approximately outlined in red. Older Greywacke rock is shown in dark grey. Younger Tertiary aged rock is beige and bricked yellow (around Mauriceville), and recent alluvium deposits are shown in yellow and white.

The geology observed at Mount Munro is consistent with the published geological map. It is dominated by older stronger greywacke rock with younger Tertiary rocks dominating to the east and north of the site and deposits of recent alluvium on the lower lying river terraces to the north and south. High level geological and geomorphological observations made around the windfarm site are shown on the Simplified Geological Observations Plan in Appendix B.

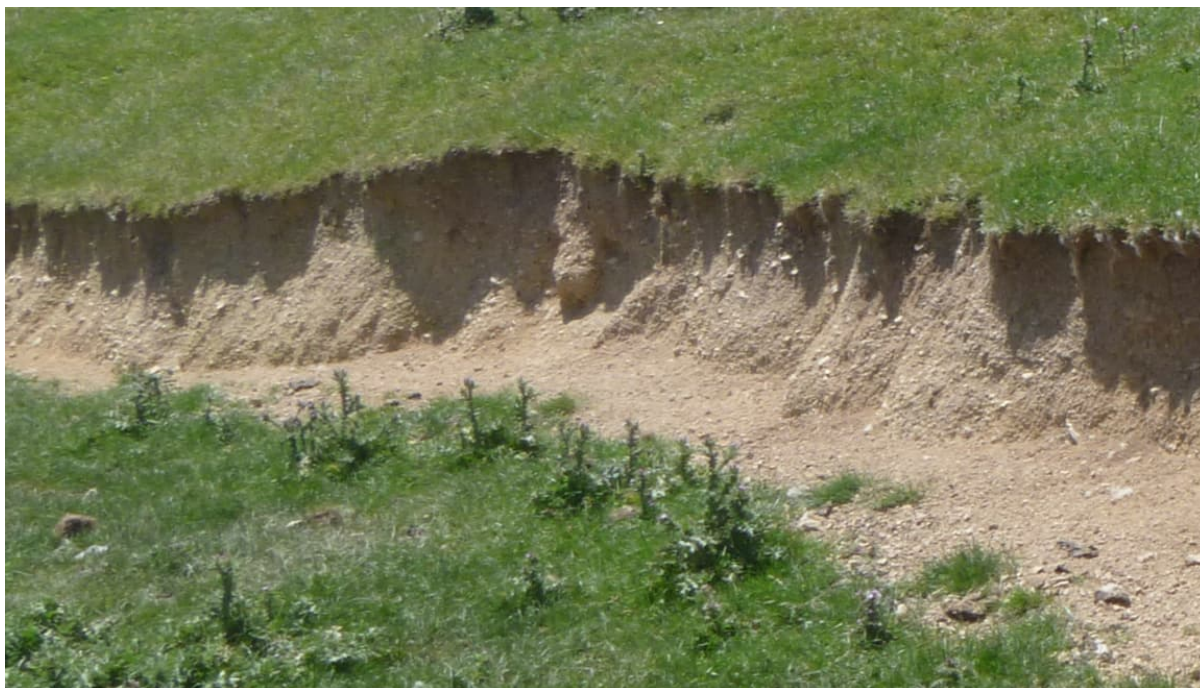
Photograph 4.1: Gravel and silt dominated colluvium soils mantling the slopes

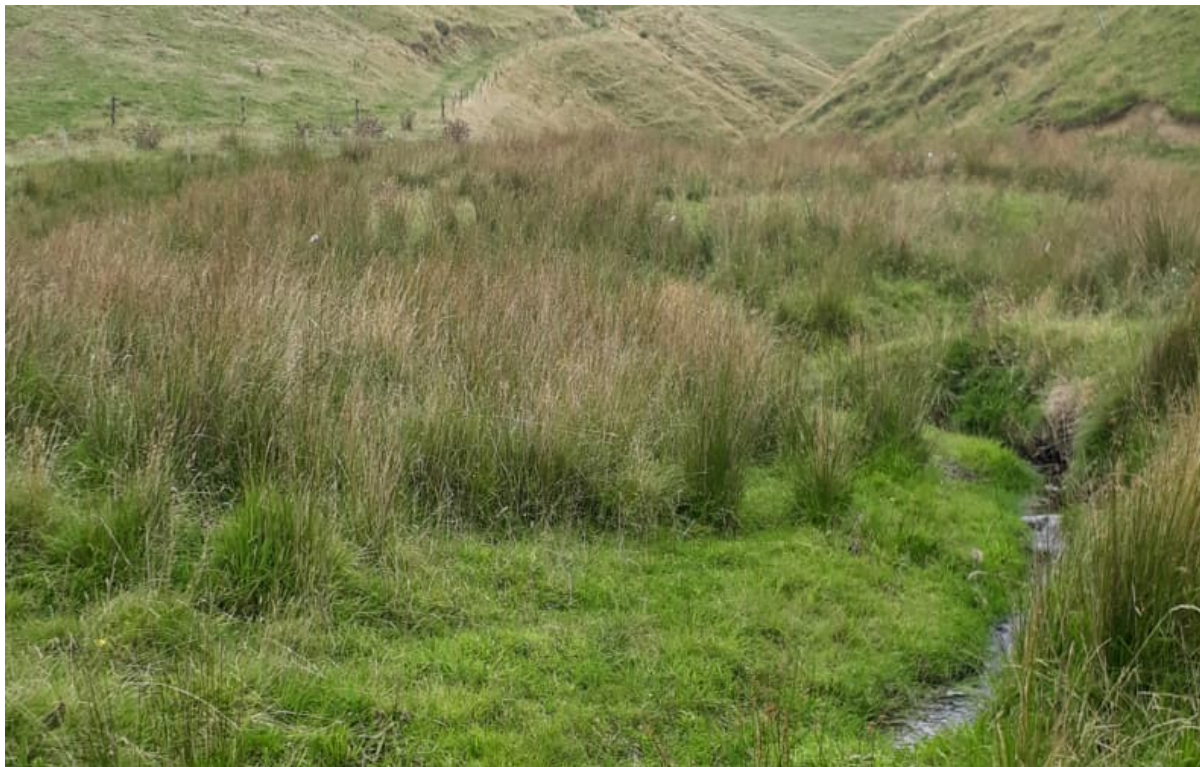
Photograph 4.2: Holocene alluvium on valley floor and covered with vegetation

Holocene alluvial deposits were observed during the site walkovers in gullies. They are relatively thin deposits (typically less than 2m thick) and comprise grey and brown silts and silty sands.

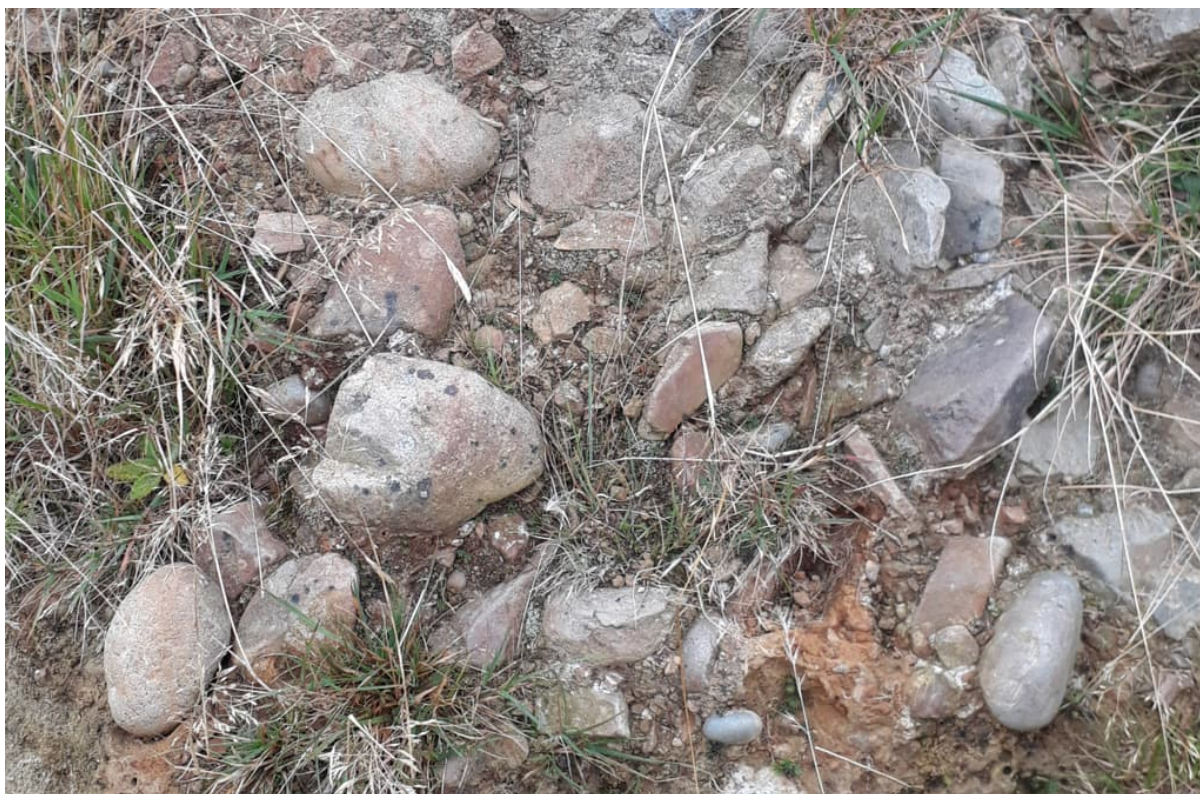
Photograph 4.3: Pleistocene alluvium on the lower terrace at the laydown area.

Pleistocene age alluvial deposits were observed in exposures on the river terrace and in Test Pit TP16. The material is described as a Sandy SILT with some gravel.

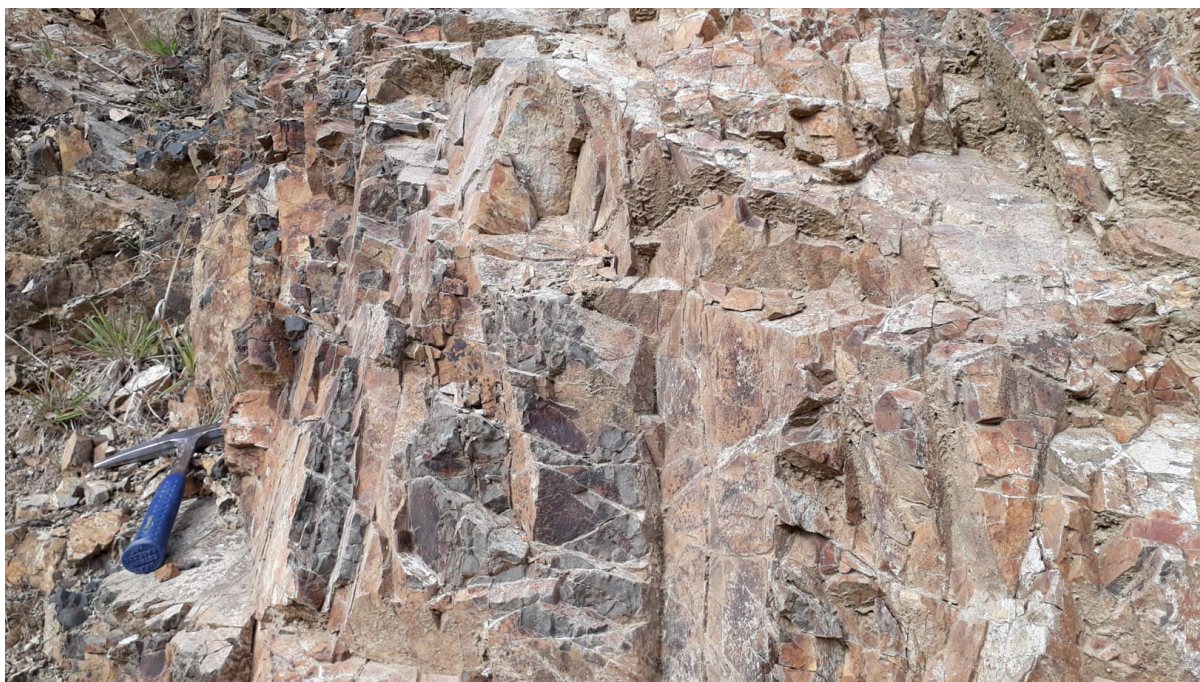
Photograph 4.4: Jointed moderately weathered greywacke rock typical of the windfarm site

The greywacke typically has closely and very closely spaced fractures. Locally there are areas where a high frequency of shearing is encountered. As the rocks have been subject to extensive burial, deformation and uplift in their past, they are slightly metamorphosed (i.e. they have been changed by heat and pressure when they were buried). As such, in many places, silica within these rocks has been remobilised during burial and these fluids have solidified in fractures to form veins of quartz.

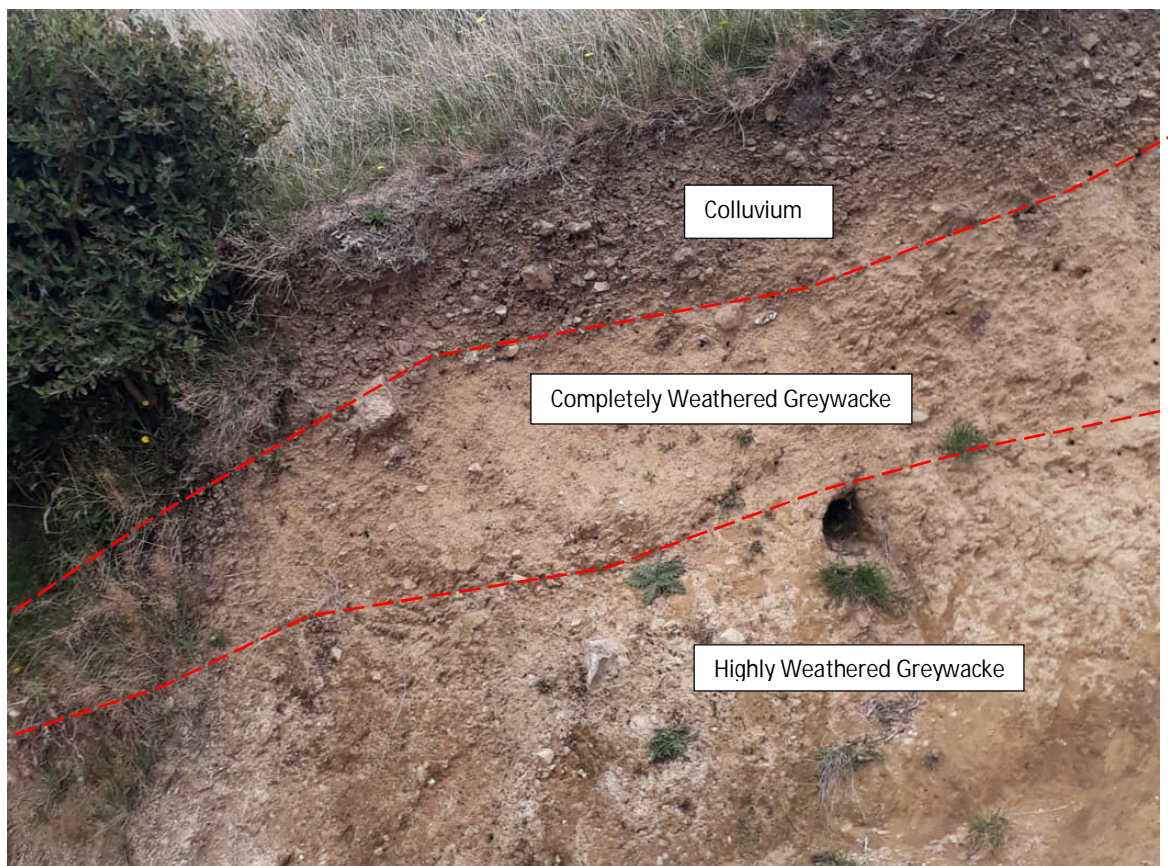
Photograph 4.5: Example of highly and completely weathered greywacke on the windfarm site

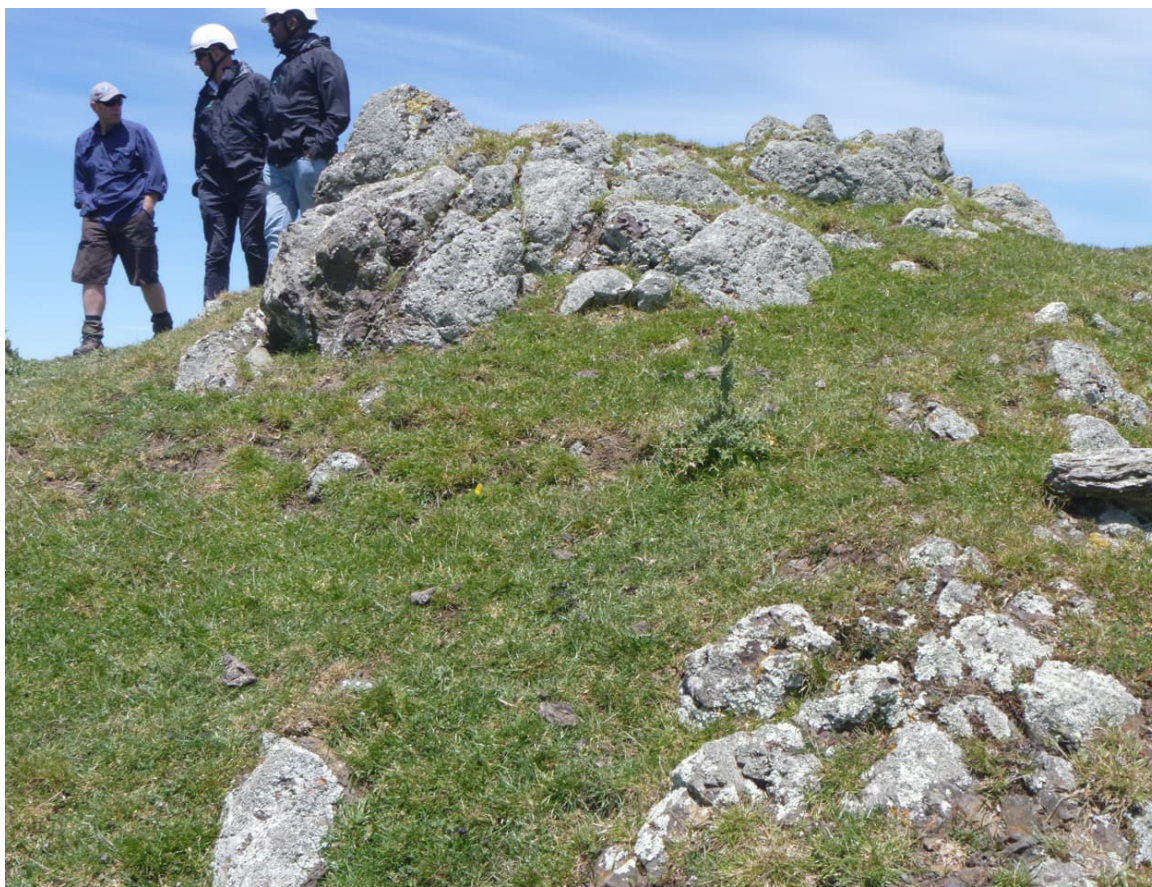
Photograph 4.6: Example of strong chert outcrops around the windfarm site

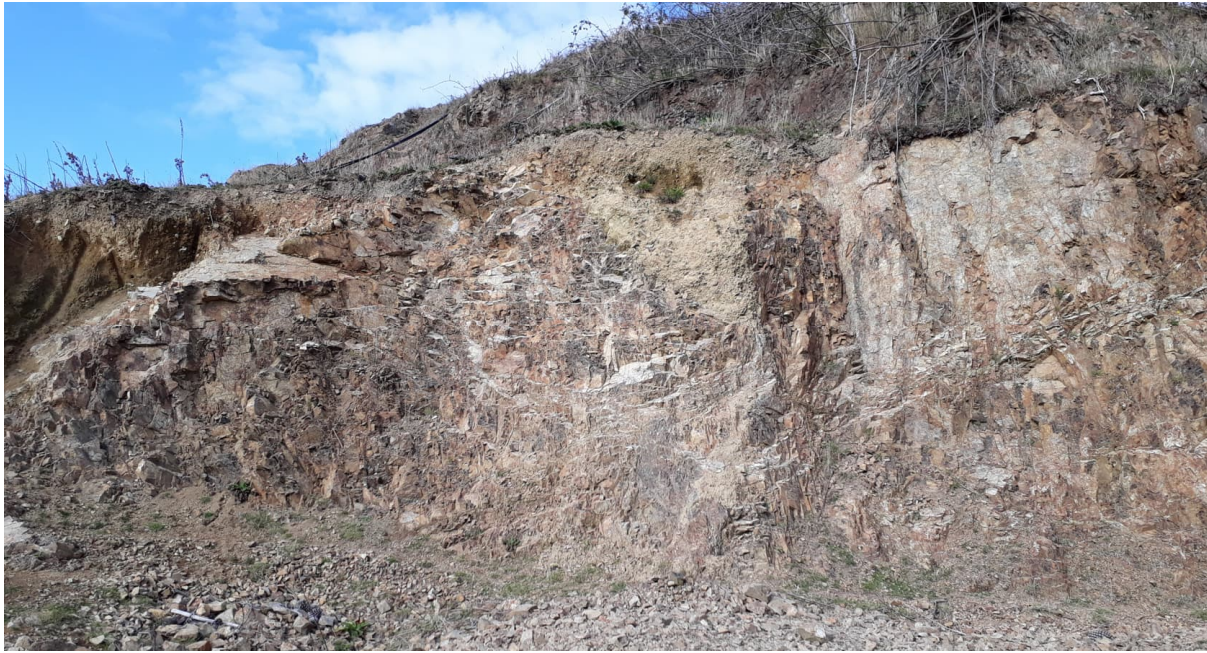
Photograph 4.7: Borrow area in Greywacke Rock off Coach Road (South)

There are two small quarries and a small borrow area off Faulkner Road and Coach Road (South) that expose greywacke rock. Although the quarries were not accessible, the Greywacke rock was observed from a distance to be characteristic of the Greywacke rock observed around the windfarm site.

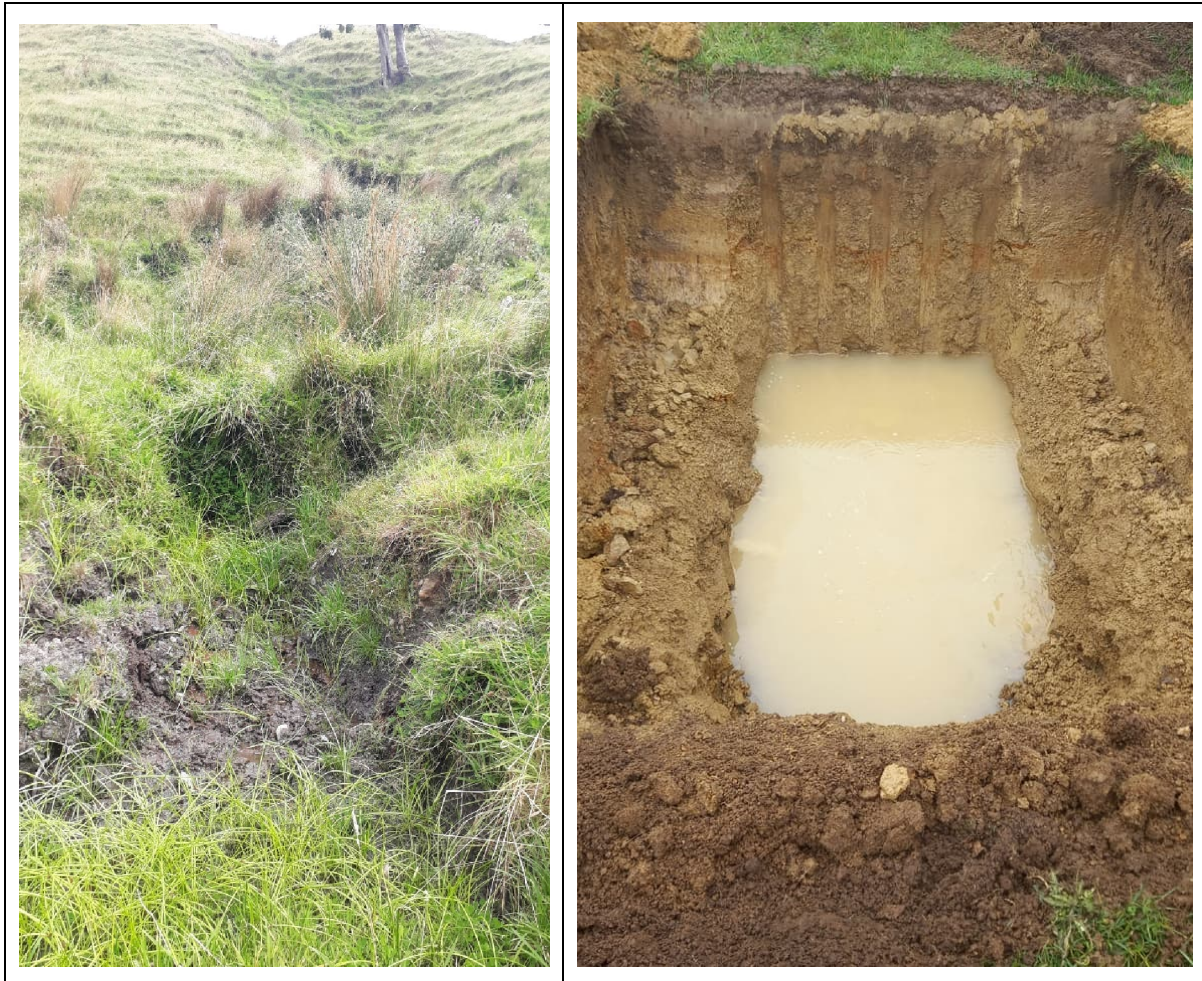
Photograph 4.8a&b: (a) Groundwater seeps from gullies resulting in shallow landslides and (b) in test pits along the soil / rock interface

During the test pit investigations, all except two test pits recorded groundwater seepages. Groundwater seepage in the test pits ranged from slow seepage to rapid inflow through the colluvium or rock defects.

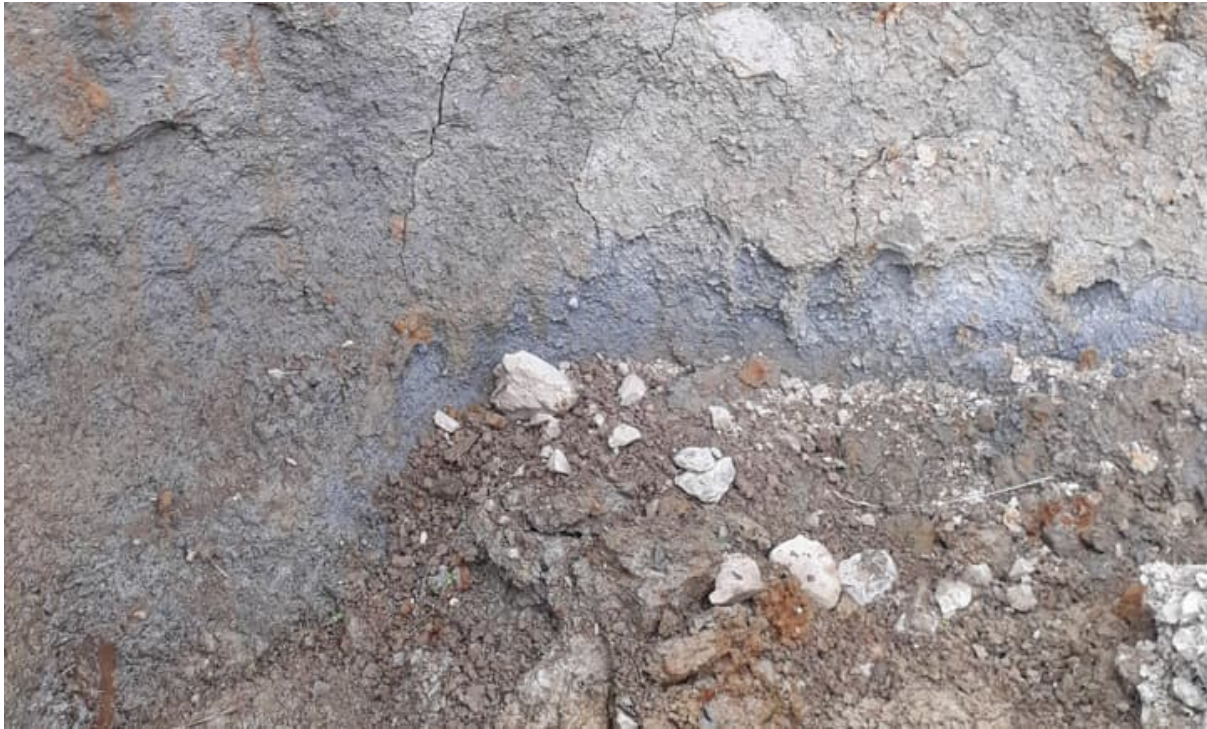
Photograph 4.10: Blue grey gravely clay on valley floor where road R02 crosses stream

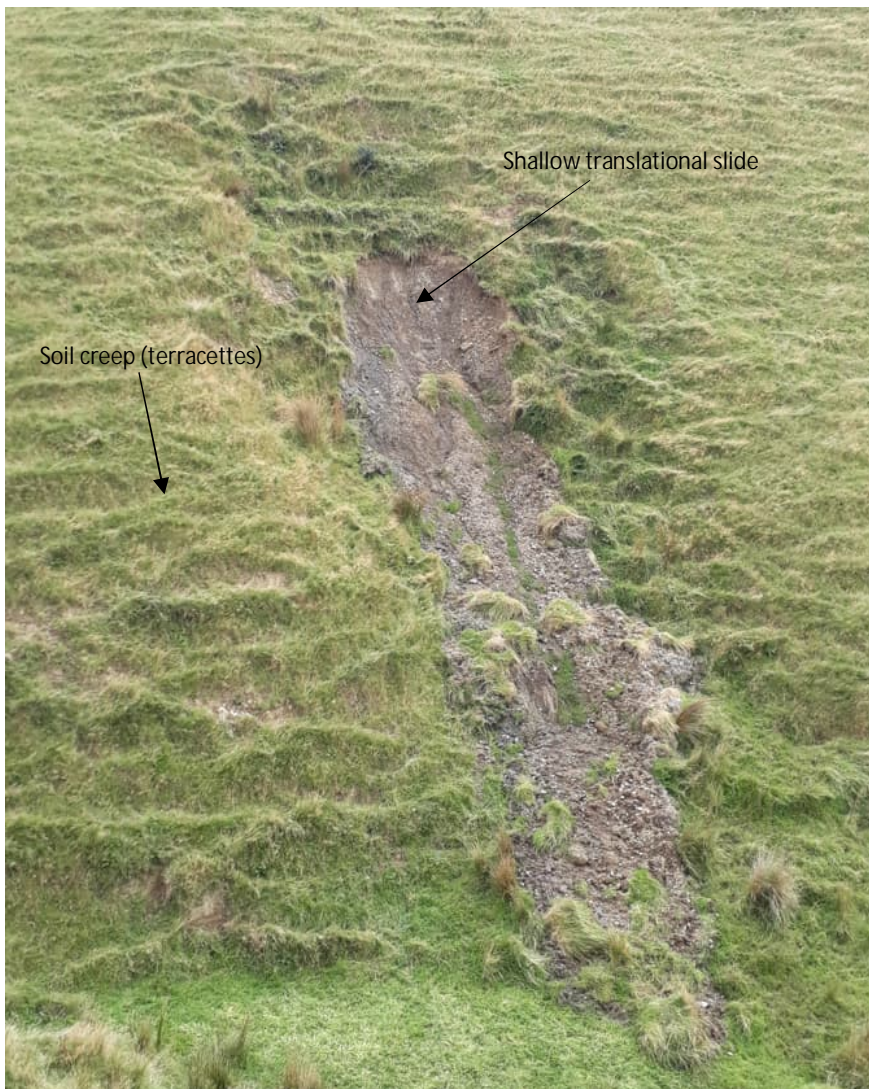
Photograph 4.11: Example translational landslide and shallow creep forming terraces (refer Geological Observations Plan in Appendix B for approximate location)

Some shallow translational slides and resulting debris earthflows were observed onsite.

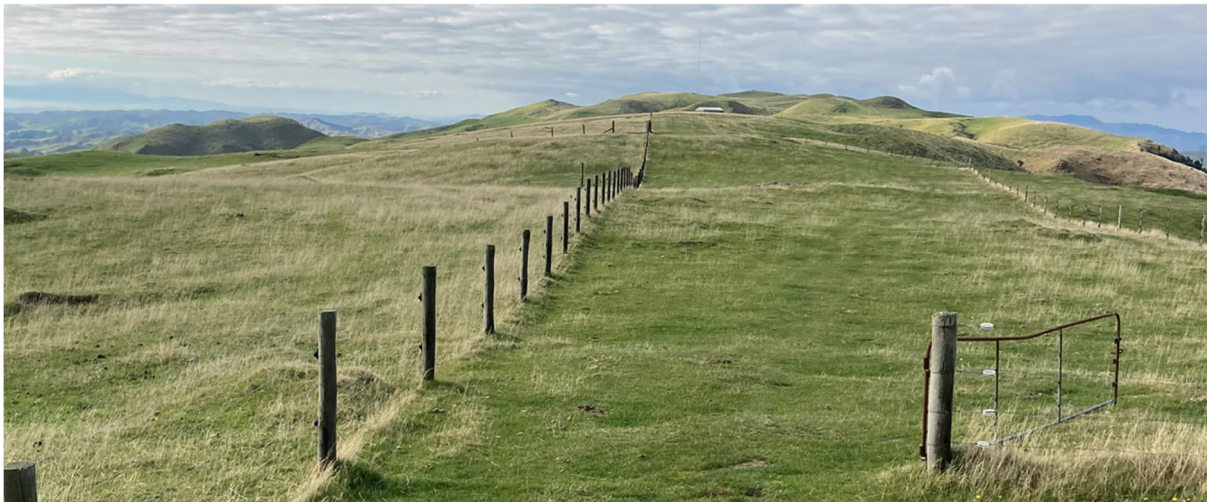
The site topography is governed by the underlying geology described in the sections above. The wind farm site is generally underlain by the older, stronger volcanoclastic greywacke, sandstones and mudstones. These strong greywacke rocks are more resilient to erosion and weathering and have formed the steep and high hill slopes across the area. These stronger rocks erode and weather at different rates depending upon the rock types (sandstones are typically more resilient than the siltstones and mudstones) and also the rock can erode and weather a lot quicker if they are more heavily sheared and fractured. These local variations result in the changes in topography (i.e. ridges and gullies) within the main windfarm site.

Photograph 7.1: Photo looking south west along the main ridge of the site

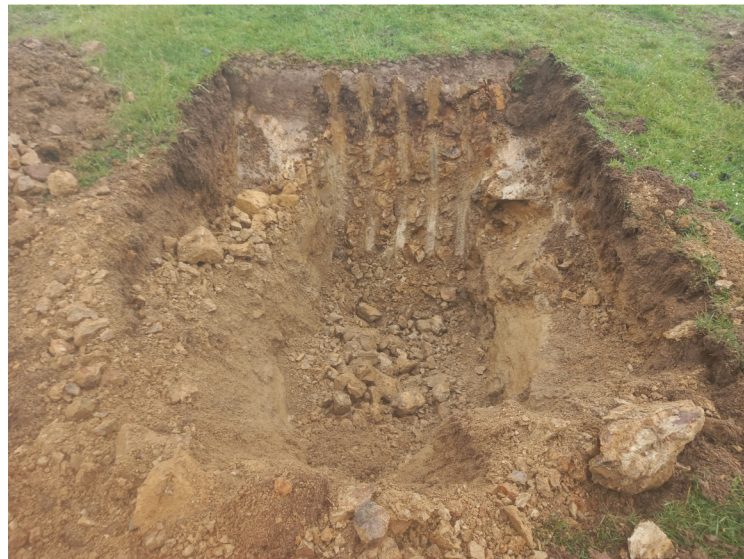
SKETCH / PHOTO:

EXCAVATION TESTS			ENGINEERING DESCRIPTION				GEOLOGICAL					
PENETRATION	SUPPORT	WATER	SAMPLES	RL (m)	DEPTH (m)	SOIL NAME, PLASTICITY OR PARTICLE SIZE CHARACTERISTICS, COLOUR, SECONDARY AND MINOR COMPONENTS	MOISTURE CONDITION	WEATHERING	STRENGTH/DENSITY CLASSIFICATION	ESTIMATED SHEAR STRENGTH (kPa)	DEFECTS, STRUCTURE, COMMENTS	UNIT
1 2 3										10 25 50 100 200		
	None			466	0.5	<p>0.00m: SILT, some organics and some gravel, minor sand; dark brown. Very soft, wet, non-plastic to low plasticity. Gravel, fine to medium, angular, moderately weathered, greywacke; sand, fine to coarse; organics, rootlets.</p> <p>0.30m: Moderately to highly weathered, orange brown, SANDSTONE. Weak to moderately strong, fine to medium grained. Defects are orthogonal, spacing close to very close (approx. 20mm to 200mm).</p>	W	VS				Topsoil
		DRY 14/12/2021		465	1.5	1.4m: Criteria achieved						Greywacke

COMMENTS: 1) Coordinates are determined from hand-held GPS. 2) Elevation determined from LiDAR 1m DEM of Wellington (2013-2014), sourced from LINZ. 3) Hole dry, no observable flow of water.

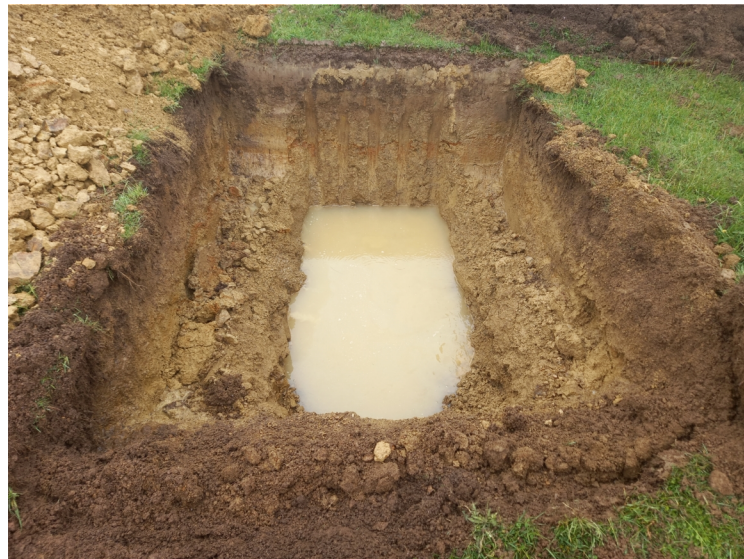
SKETCH / PHOTO:

1.20m: Moderately to highly weathered, orange brown, SANDSTONE. Weak to moderately strong, fine to medium grained. Defects are orthogonal, spacing close to very close (approx. 20mm to 200mm).	MW-HW					Greywacke
				458	1.50 - 1.55		1.5m: Criteria achieved

COMMENTS: 1) Coordinates are determined from hand-held GPS. 2) Elevation determined from LiDAR 1m DEM of Wellington (2013-2014), sourced from LINZ. 3) Rapid inflow of water below the groundwater level. 4) Water stood at groundwater level. 5) Sample is a general bulk sample from across the colluvium layer.

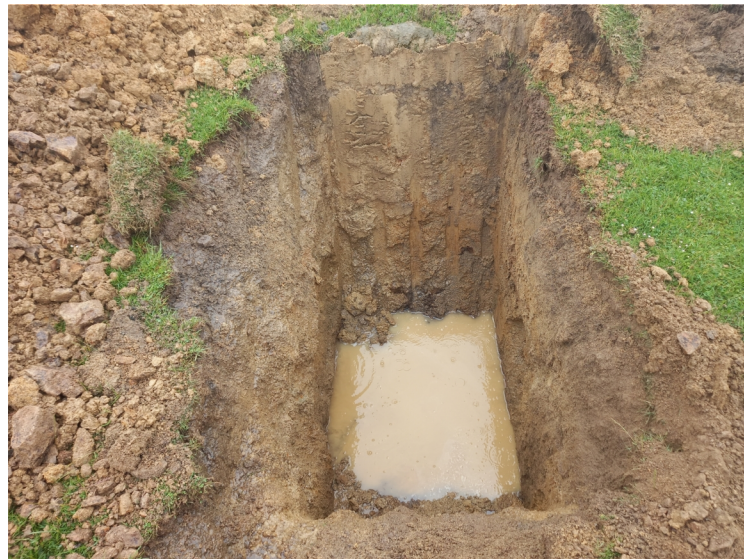
SKETCH / PHOTO:

1.10m: Moderately to highly weathered, orange brown, SANDSTONE. Weak to moderately strong, fine to medium grained. Defects are orthogonal, spacing close to very close (approx. 20mm to 200mm).	MW-HW					Greywacke
				457	1.5m		1.5m: Criteria achieved

COMMENTS: 1) Coordinates are determined from hand-held GPS. 2) Elevation determined from LiDAR 1m DEM of Wellington (2013-2014), sourced from LINZ. 3) Inflow of water estimated to be at approximately 1.2 m, however much of the water filling the hole seemed to be due to overland flow. 4) Sample is a general disturbed sample from across the colluvium layer.

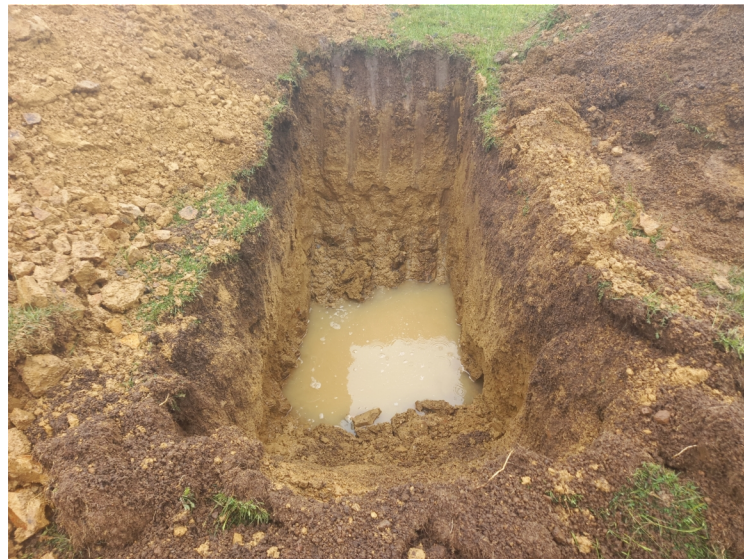
SKETCH / PHOTO:

S			Colluvium
										MW-HW			Greywacke
				465	1.5		1.5m: Criteria achieved

COMMENTS: 1) Coordinates are determined from hand-held GPS. 2) Elevation determined from LiDAR 1m DEM of Wellington (2013-2014), coursed from LINZ. 3) Inflow of water below 1.1 m. 4) Samples are general disturbed samples from across the colluvium layer.

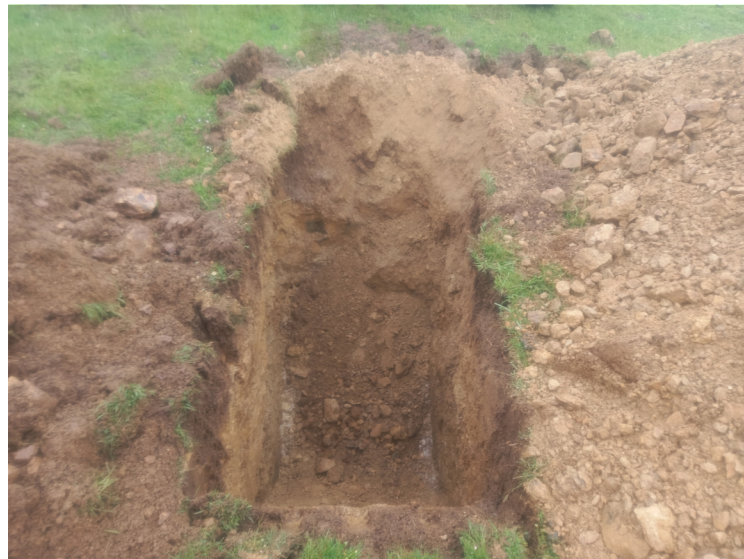
SKETCH / PHOTO:

<p>0.00m: SILT, some organics and some gravel, minor sand; dark brown. Very soft, wet, non-plastic to low plasticity. Gravel, fine to medium, angular, moderately weathered, greywacke; sand, fine to coarse; organics, rootlets.</p> <p>0.30m: Moderately to highly weathered, SANDSTONE. Weak to moderately strong. Defects are orthogonal, spacing close to very close (approx. 20mm to 200mm).</p>	W	VS	10 25 50 100 200			Topsoil
				467	1.5		1.5m: Criteria achieved						Greywacke

COMMENTS: 1) Coordinates are determined from hand-held GPS. 2) Elevation determined from LiDAR 1m DEM of Wellington (2013-2014), sourced from LINZ. 3) Slow inflow of groundwater below 1 m. 4) Sample is a general bulk sample from across the upper layer of the rock head.
