Mt Munro Wind Farm

Civil Engineering Report

Prepared for
Meridian Energy Limited

Prepared by
Tonkin & Taylor Ltd

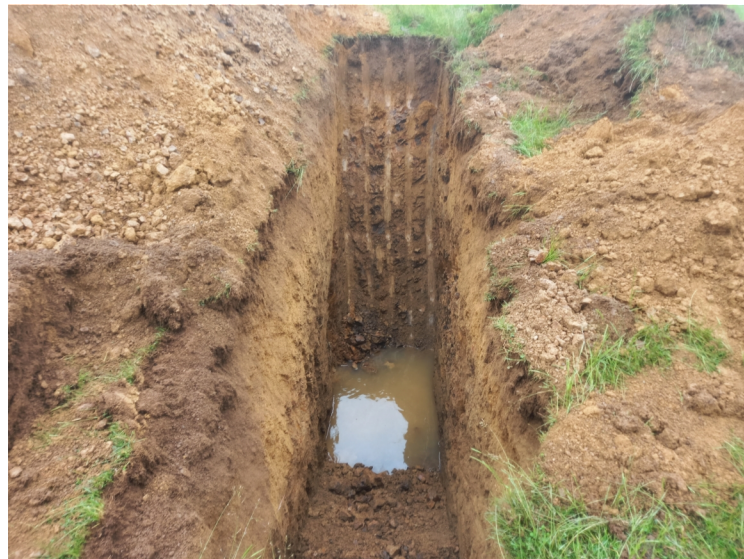
SKETCH / PHOTO:

COMMENTS: 1) Coordinates are determined from hand-held GPS. 2) Elevation determined from LiDAR 1m DEM of Wellington (2013-2014), sourced from LINZ. 3) Slow inflow of groundwater below 2.3 m. 4) Sample is a general bulk sample from across the upper layer of the rock head.

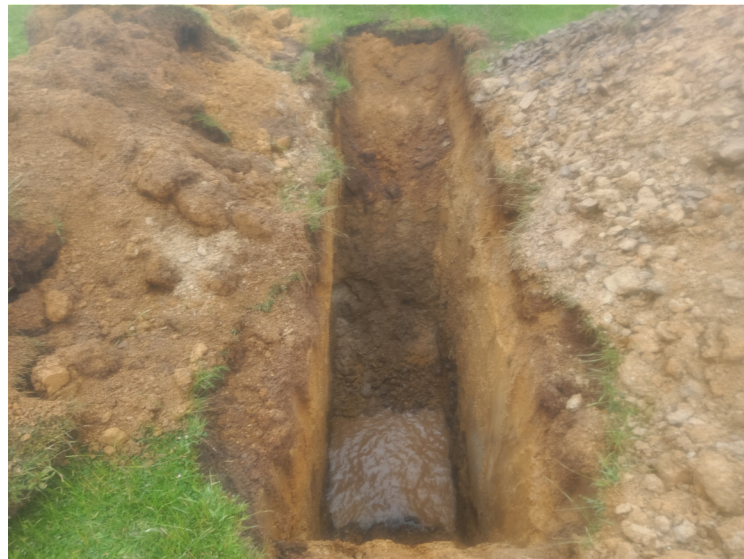
SKETCH / PHOTO:

1.50m: Moderately weathered, grey with brown staining, SANDSTONE. Weak to moderately strong, fine to medium grained. Defects are orthogonal, very closely to closely spaced (approx. 20mm to 200mm).	MW-HW		30-40		Greywacke
				454	3.00m		3m: Criteria achieved

COMMENTS: 1) Coordinates are determined from hand-held GPS. 2) Elevation determined from LiDAR 1m DEM of Wellington (2013-2014), sourced from LINZ. 3) Rapid inflow of water on all sides of pit below 0.4 m. 4) Samples are two disturbed samples from across the colluvial layer and a general bulk sample from across the upper layer of the rock head.

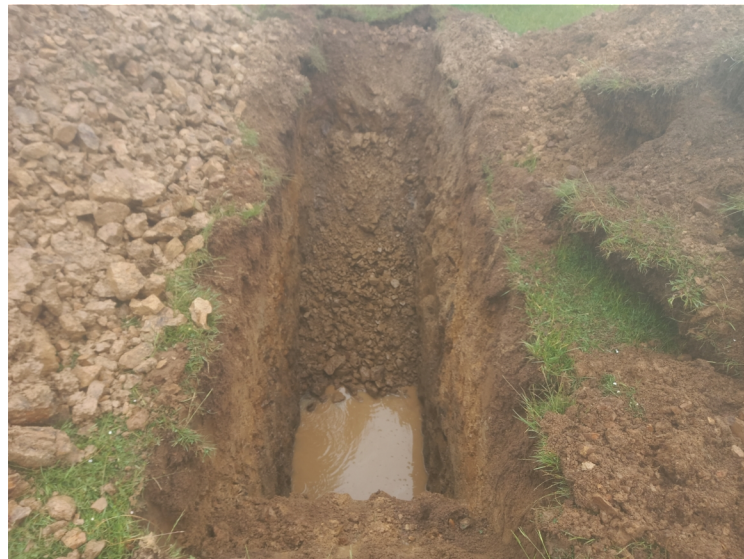
SKETCH / PHOTO:

COMMENTS: 1) Coordinates are determined from hand-held GPS. 2) Elevation determined from LiDAR 1m DEM of Wellington (2013-2014), sourced from LINZ. 3) Inflow of groundwater below 0.7 m.

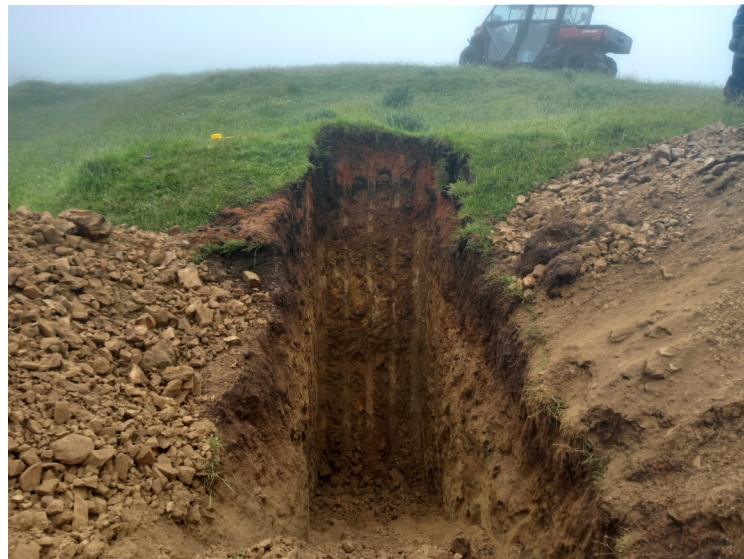
SKETCH / PHOTO:

472	0.50m			MW-HW					Bedrock
				471	2.4m		2.4m: Criteria achieved						
				470	3.0m								
				470	3.5m

COMMENTS: 1) Coordinates are determined from hand-held GPS. 2) Elevation determined from LiDAR 1m DEM of Wellington (2013-2014), sourced from LINZ. 3) Hole located on a high point, no groundwater inflow identified.

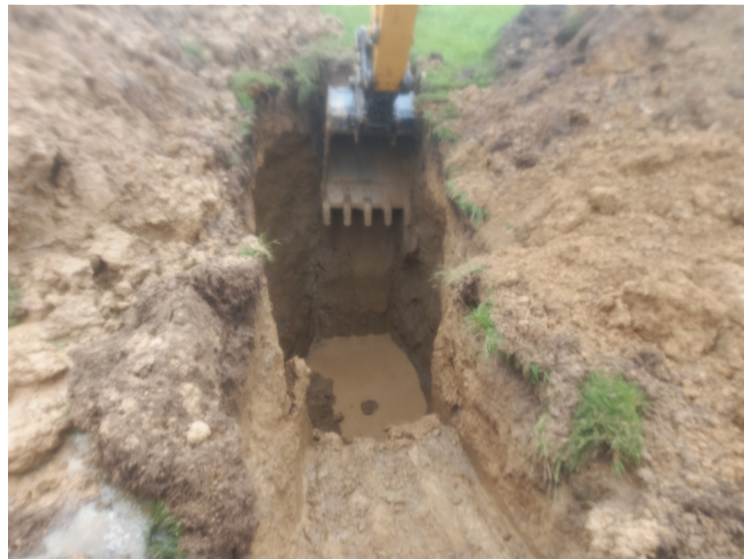
SKETCH / PHOTO:

463	3.50m		<p>3.40m: Moderately weathered, grey, SANDSTONE. Weak to moderately strong. Defects are orthogonal, spaced closely to moderately widely (approx. 100mm to 250mm). Excavator refusing on rock head.</p>	MW					Greywacke
				462	4.00m		3.5m: Target depth. Side collapse.

COMMENTS: 1) Coordinates are determined from hand-held GPS. 2) Elevation determined from LiDAR 1m DEM of Wellington (2013-2014), sourced from LINZ. 3) Rapid inflow of water on all sides of hole. 4) Water pooling at ground-level in the vicinity of the hole, with overland flow identified. 5) Significant collapse of pit walls. 6) Sample is a general bulk sample from across the colluvial layer.

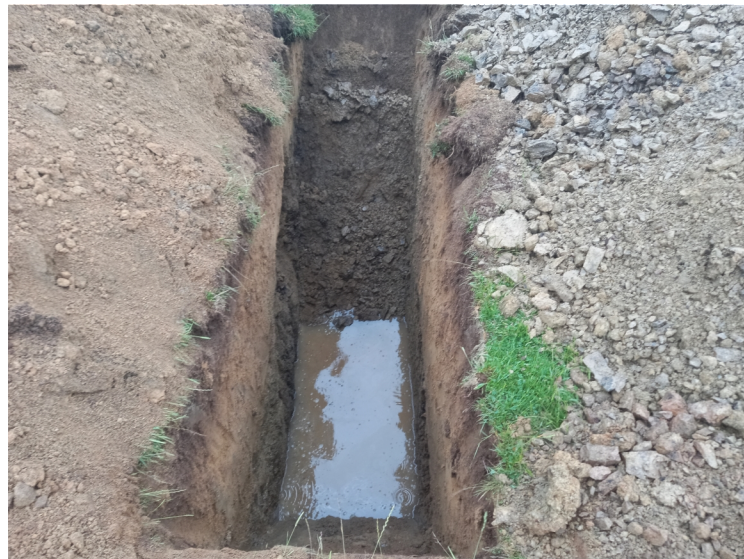
SKETCH / PHOTO:

COMMENTS: 1) Coordinates are determined from hand-held GPS. 2) Elevation determined from LiDAR 1m DEM of Wellington (2013-2014), sourced from LINZ. 3) Rapid inflow of groundwater below 1.6 m. 4) Samples are general bulk samples, one from across the colluvial layer and the other from across the upper layer of the rock head.

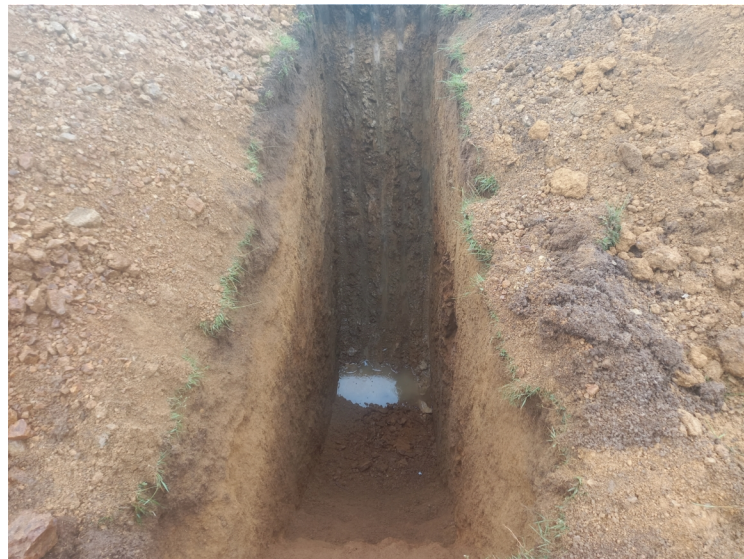
SKETCH / PHOTO:

COMMENTS: 1) Coordinates are determined from hand-held GPS. 2) Elevation determined from LiDAR 1m DEM of Wellington (2013-2014), sourced from LINZ. 3) Slow inflow of groundwater below 1.6 m.

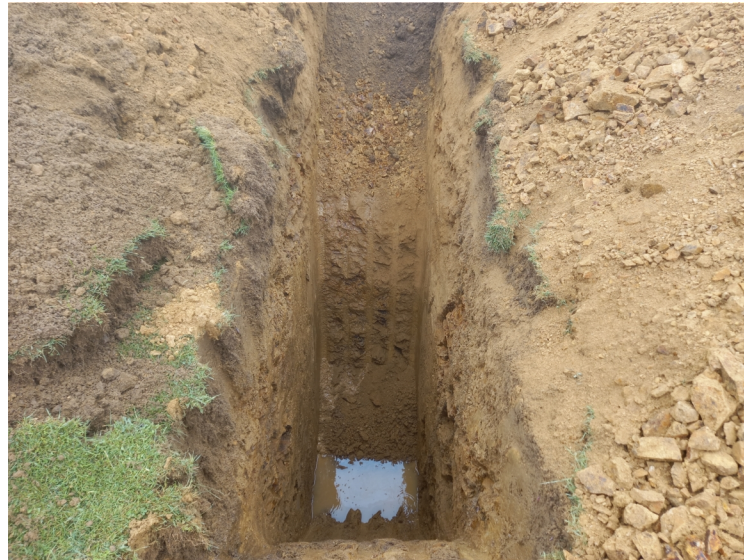
SKETCH / PHOTO:

COMMENTS: 1) Coordinates are determined from hand-held GPS. 2) Elevation determined from LiDAR 1m DEM of Wellington (2013-2014), sourced from LINZ. 3) Slow inflow of groundwater through rock defects below 0.4 m.

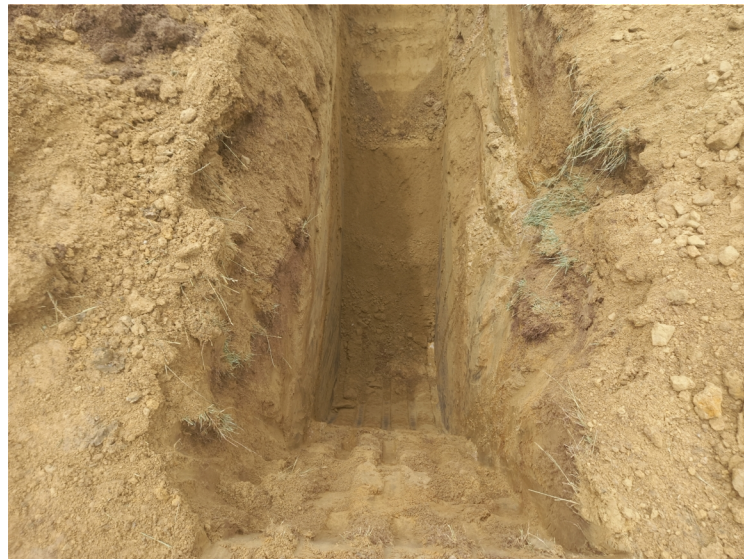
SKETCH / PHOTO:

COMMENTS: 1) Coordinates are determined from hand-held GPS. 2) Elevation determined from LiDAR 1m DEM of Wellington (2013-2014), sourced from LINZ. 3) Slow inflow of groundwater below 1.2 m.

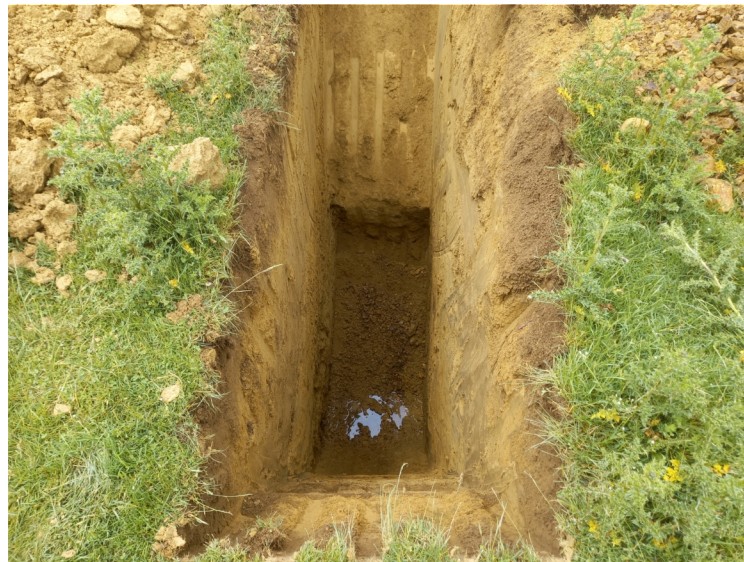
SKETCH / PHOTO:

COMMENTS: 1) Coordinates are determined from hand-held GPS. 2) Elevation determined from LiDAR 1m DEM of Wellington (2013-2014), sourced from LINZ. 3) Slow inflow of groundwater below 3.7 m. 4) Sample is a general bulk sample from across the residual soil layer.

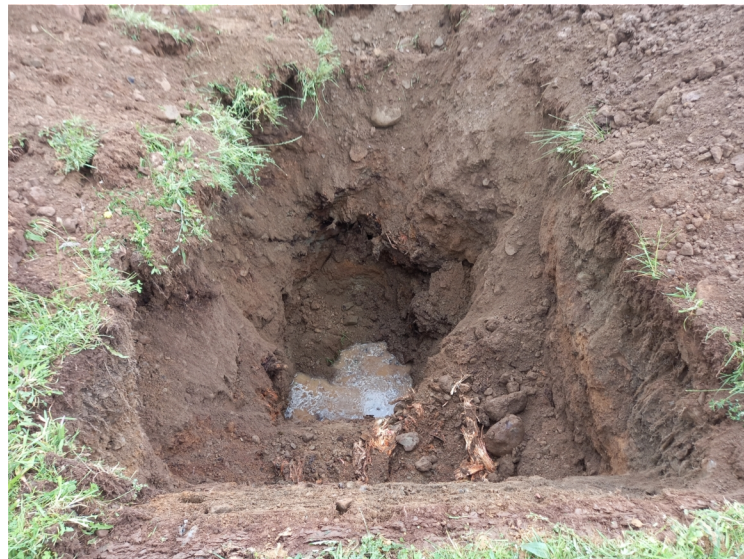
SKETCH / PHOTO:

3.00 - 3.50m: Saturated.			S			
						3.50		3.5m: Collapse

COMMENTS: 1) Coordinates are determined from hand-held GPS. 2) Elevation determined from estimation of contours. 3) Rapid inflow of groundwater below 3.0 m. 4) Groundwater stood at the groundwater level of 3.0 m. 5) Significant collapse of pit walls.
