**Mt Munro Wind Farm:
Long-tailed Bat Impact Assessment**

Prepared for
Meridian Energy Limited

Prepared by
Tonkin & Taylor Ltd

Date
May 2023

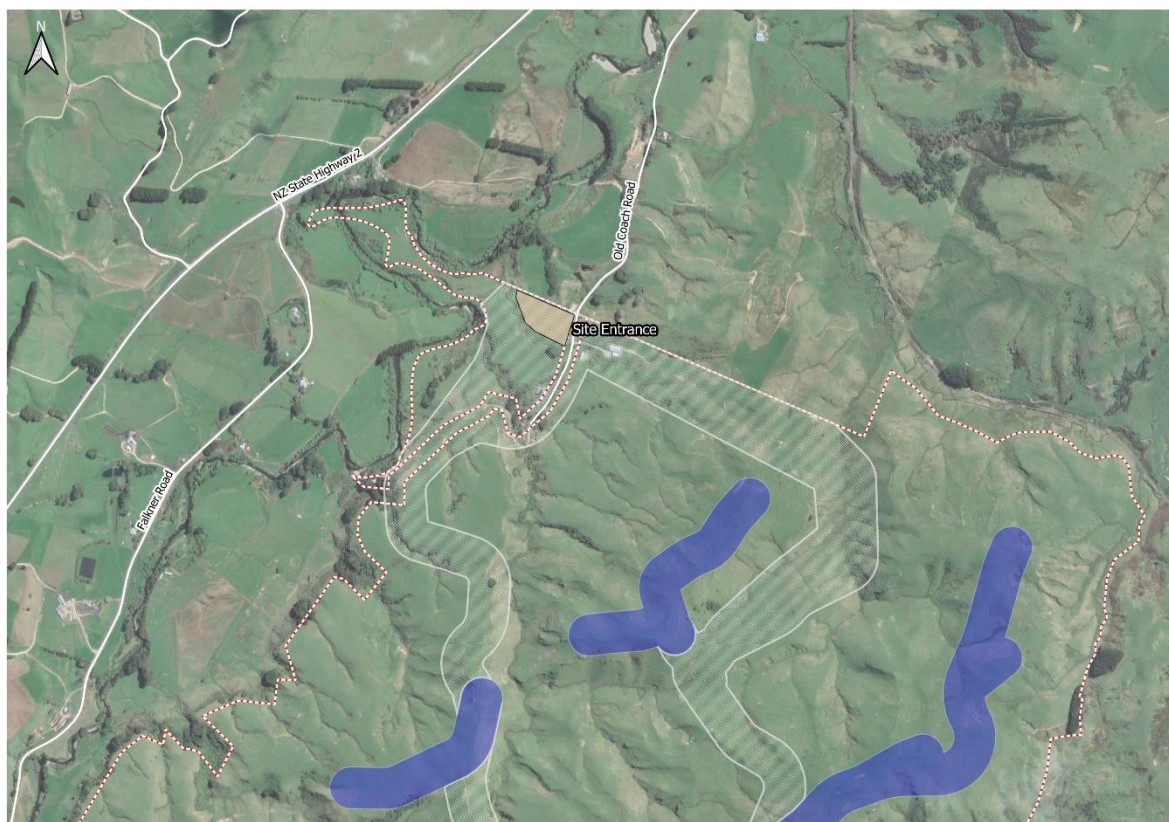
Figure 2.2: Location of the Site Entrance area in the north-western corner of the Site shown in light brown. The Turbine Envelope Zone is in blue, Turbine Exclusion Zone in grey thatching, and the Site boundary is the red and white dashed line (Figure provided by Meridian Energy)

After commissioning, the Site entrance area could be used for Operations, and could house the Services/O&M building, and/or continue to function as a storage area for spares and large components required for repairs etc.

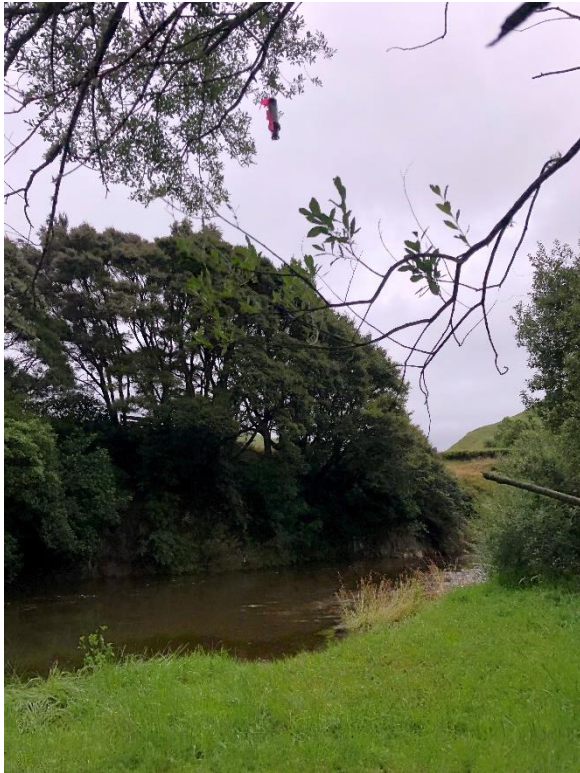
Photograph 3.1: Acoustic recorder (ABM) deployed in a willow tree at survey location Off-site 2

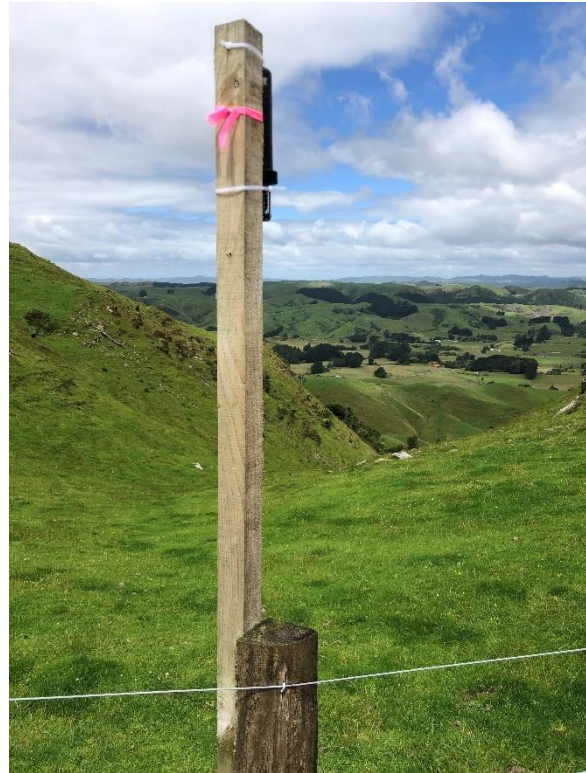
Photograph 3.2: ABM deployed along the main ridge at survey location Saddle 3

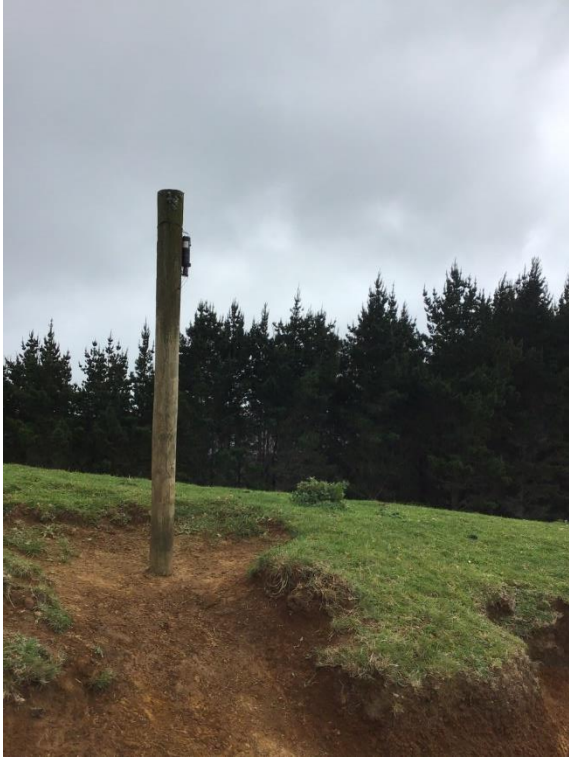
Photograph Appendix C.3: Acoustic recorder deployed on a fencepost adjacent to a turbine at Te Uku wind farm.

ABMs at turbine locations were attached to the fence posts at an approximate height of 2 m (Photograph Appendix C.3). The open treatment ABMs were attached to waratahs (Photograph Appendix C.4). The vegetation control ABMs were hung from branches at an approximate height of between 2-4 m (Photograph Appendix C.5).

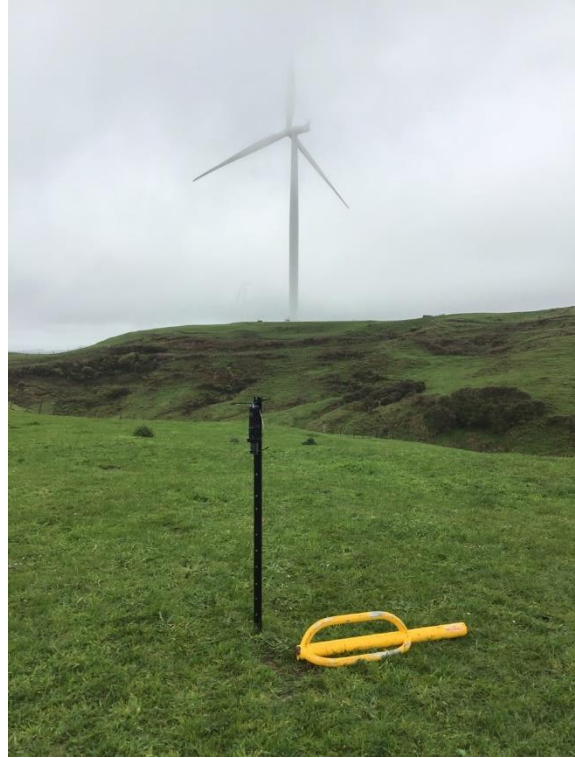
Photograph Appendix C.4: An 'open treatment' acoustic recorder deployed in open pasture a minimum 200 m away from any turbine on Te Uku wind farm.

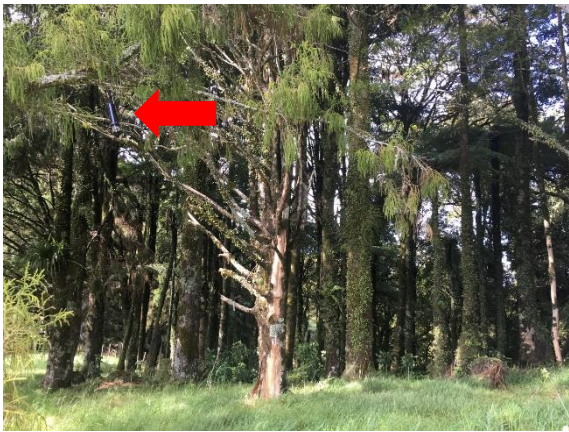
Photograph Appendix C.5: Acoustic recorder hanging from a tree branch (to the left of the red arrow) at Control Site 1 at Te Uku wind farm.

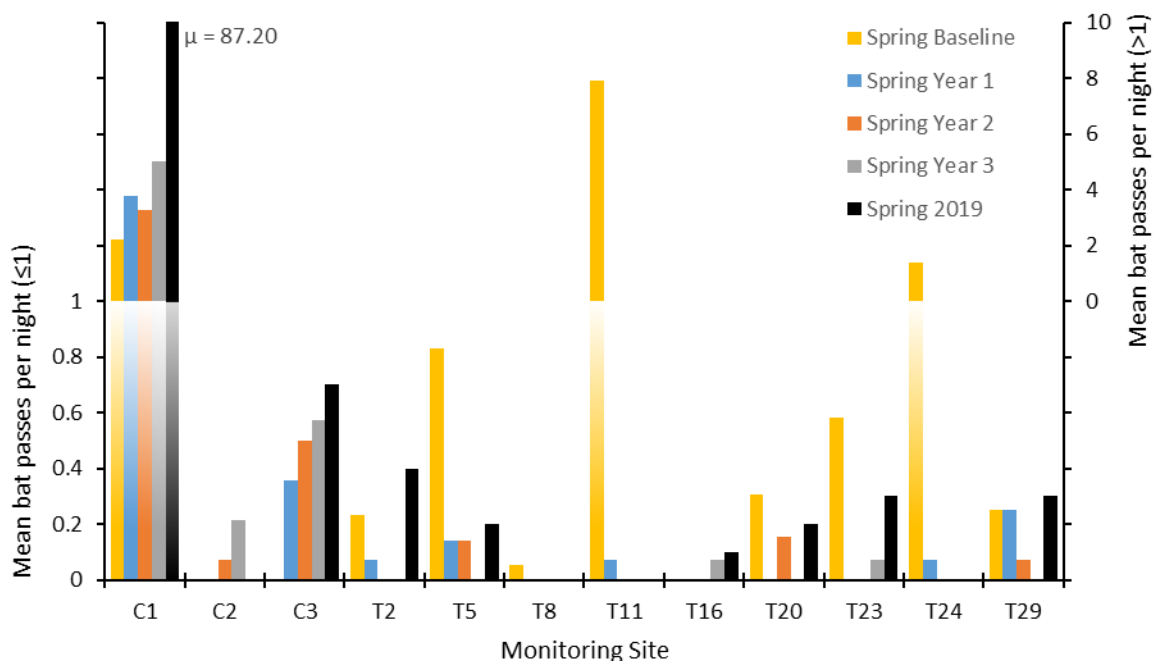
Figure Appendix C.6: Mean number of bat passes per night at monitored turbines and 'control sites' at Te Uku wind farm across five survey periods, including a pre-construction baseline survey.

As with the previous bat survey findings at Te Uku, the levels of bat activity were highly variable between survey locations. Control 1 recorded the most consistent bat activity during the spring post-construction surveys. This location appears to still be a key area for bats using the Te Uku site, averaging 87.2 passes per night in the most recent survey. This level of activity is an order of magnitude higher than activity levels previously recorded at this location (refer to Figure Appendix C.6: Mean number of bat passes per night at monitored turbines and 'control sites' at Te Uku wind farm across five survey periods, including a pre-construction baseline survey).

Figure Appendix C.6). The general pattern emerging for the other survey locations is that the activity levels recorded in 2019 are lower than the 2009 spring baseline activity levels but higher than the year 1 - 3 post-construction levels.

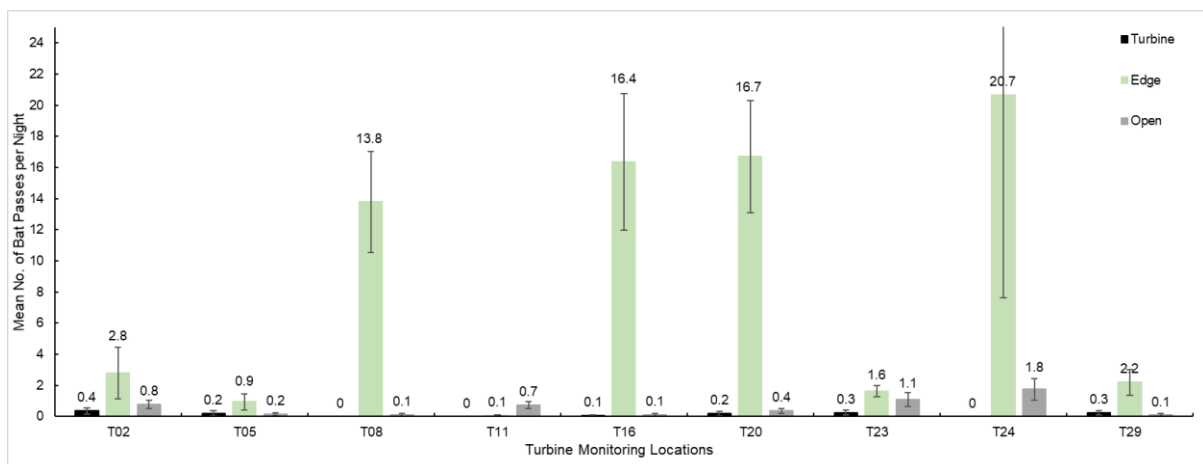
Figure Appendix C.7: Bat activity results from Spring 2019 acoustic bat monitoring undertaken at the operational Te Uku wind farm. Mean number of bat passes per night recorded at turbine survey locations and corresponding 'edge' and 'open' locations.

Figure Appendix C.7 displays the average passes per night at all of the turbine, 'edge' and 'open' locations. The graph clearly demonstrates that more bat activity was recorded at edge sites compared to the corresponding turbine and open locations. This is expected given the what is known of long-tailed bat ecology. There also appears to be a trend of open sites recording slightly more activity than the corresponding turbine location.

This trend was analysed using a two-way ANOVA⁴⁸ with both raw and transformed data. The relationship was also analysed using a permutation ANOVA which does not have the assumption of normal data. All three analyses found a significant difference in bat activity between open sites ($\bar{x} = 0.59$ passes per night) and turbine sites ($\bar{x} = 0.15$ passes per night), $p < 0.001$ for each analysis. By comparison, the mean number of bat passes over the edge sites was 8.6 passes per night.
