Prepared for Meridian Energy Ltd

Mt Munro Wind Farm

Archaeological Assessment of Effects

November 2022

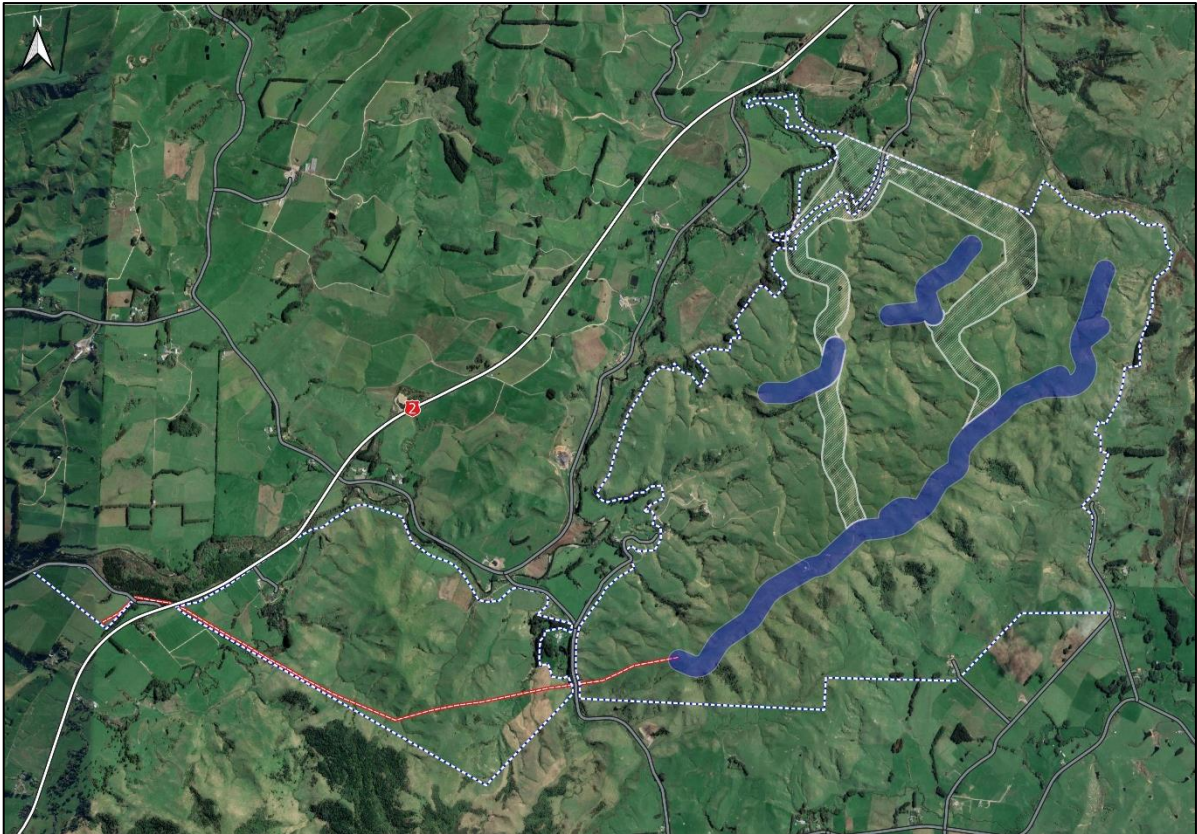
Figure 2: Project overview showcasing the Turbine Envelope Zone (blue shaded area), Turbine Exclusion Zone (white hashed area), and Transmission Corridor (red dashed line). All turbines and infrastructure will be located within these areas.

The proposed wind farm site comprises the following three zones (Figure 2):

1. A Turbine Envelope Zone on which all turbines and any infrastructure will be located.
2. A Turbine Exclusion Zone where infrastructure will be located, but no turbines.
3. A transmission corridor and substation to connect the wind farm to the national

The proposed works will involve excavations for the construction and a range of buildings, roads, transmission networks, and the turbines themselves. Works are limited to the areas within the Turbine Envelope Zone (shaded blue on Figure 2), and the Turbine Exclusion Zone (white hashed areas in Figure 2 and Figure 3), as well works associated with the building the transmission line (red dashed line in Figure 2), and substation.

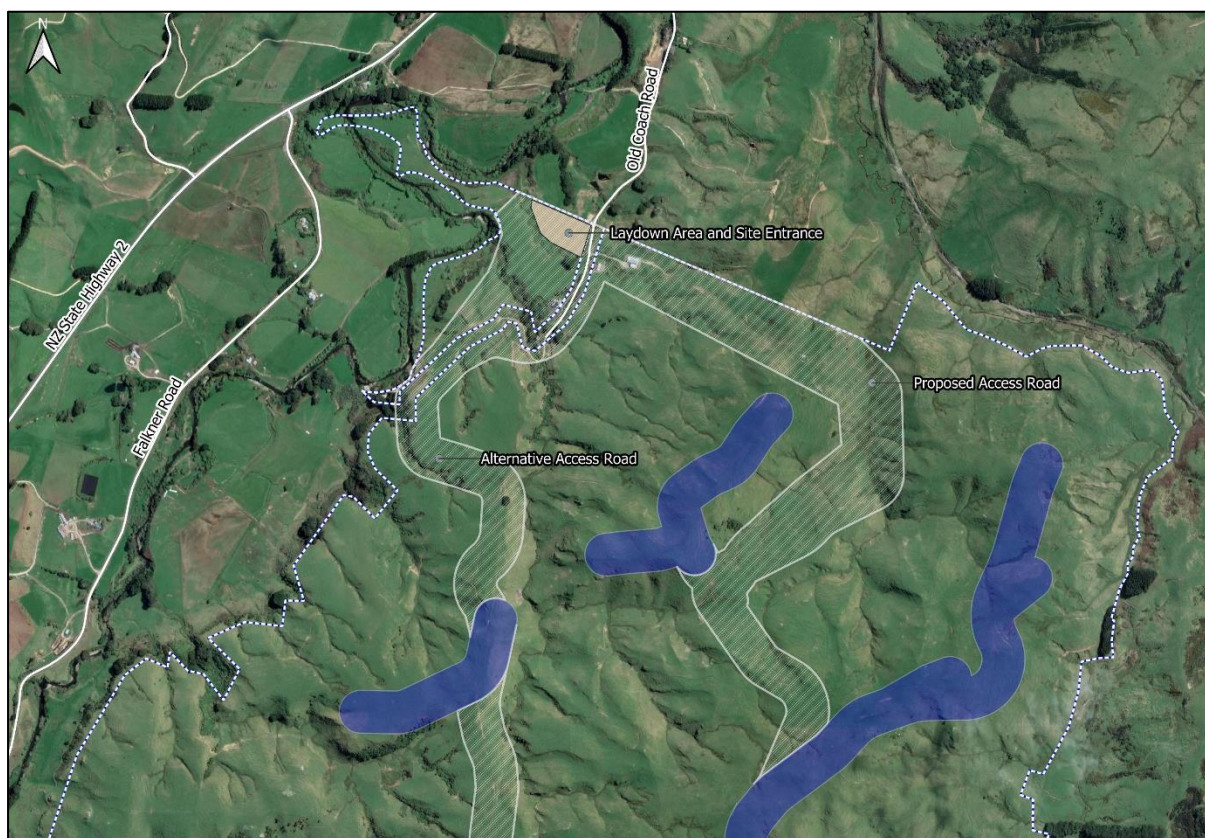
Figure 3: Site entrance and access road detail.

The "access roads" that run from the bottom of the hill to the wind farm ridges within the Turbine Exclusion Zone will be between 6 m and 8 m in width (Figure 3). The combined length of these roads

The site entrance will be located at the end of Old Coach Road (Figure 3).

The site entrance area (Figure 3) will house a temporary construction village including site offices, amenities, security, parking and laydown area (for turbine component deliveries).

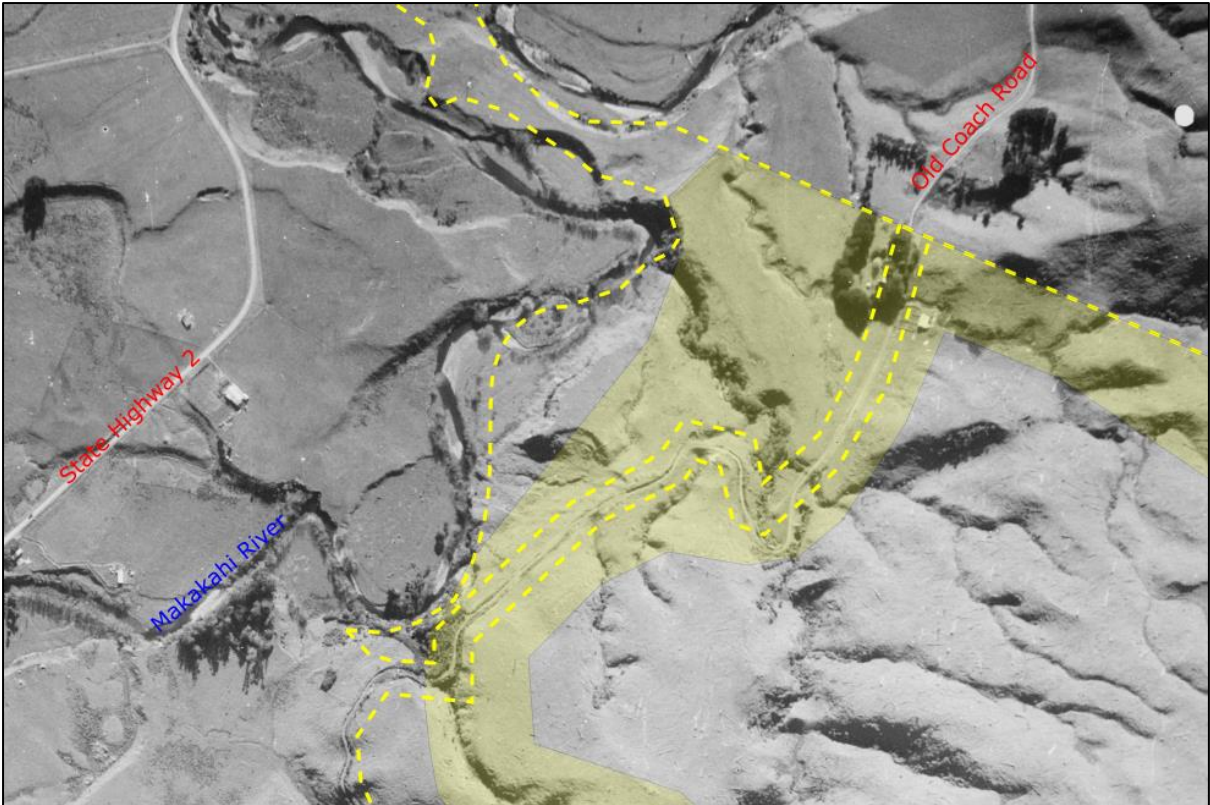
Figure 6: Aerial image from 1944, showing buildings on Old Coach Road within the proposed project access road areas (outlined in yellow). The project area is outlined in dotted yellow.

The earliest aerial images of the area were taken in the 1940s. These images largely show the proposed project area as cleared farmland (Figure 6). The Old Coach Road route can clearly be seen and may still have been in use as a farm road. There are no buildings or other features visible within the Turbine Envelope Zone or Turbine Exclusion Zones.

Two features of note can be observed. These include a house, surrounded by shelter trees, on the left side of Old Coach Road where the proposed site entrance will be located, and a building of unknown function on the opposite side of the road (Figure 6 and Figure 7). The house site is situated on a 39-acre block called Section 147, Block IX. The building on the opposite side of Old Coach Road were located on Section 133, Block IX. Currently farm buildings are situated on this same site, but the dwelling and trees on the opposite side of the road have been removed.

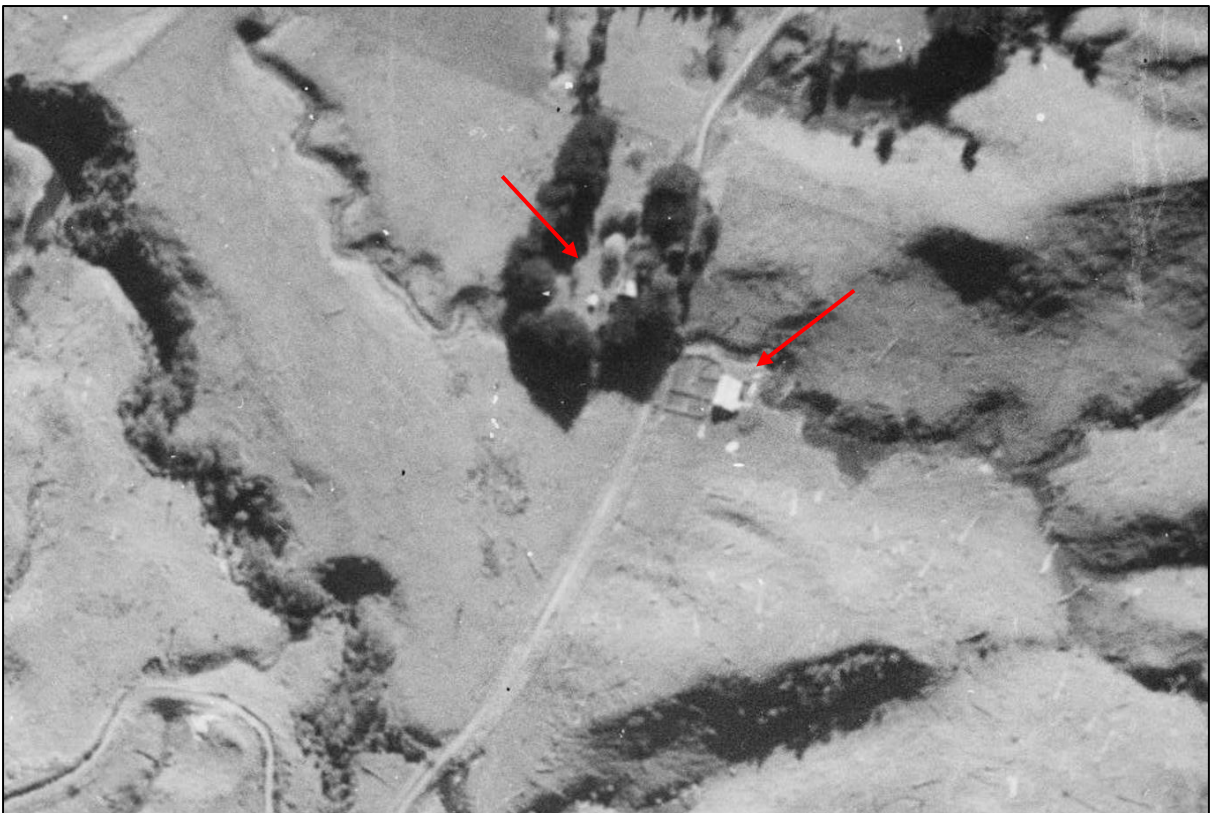
Figure 7: Enlarged portion of 1944 aerial image showing the buildings on either side of Old Coach Road (indicated by the red arrows).

Section 147 was purchased by John Oliver Wilkie Anderson in 1919. The dwelling visible on Section 147 the 1944 aerial image may have been constructed by Henry Stewart after he purchased the land in 1887, or it may have been built on by the Anderson’s after 1919.

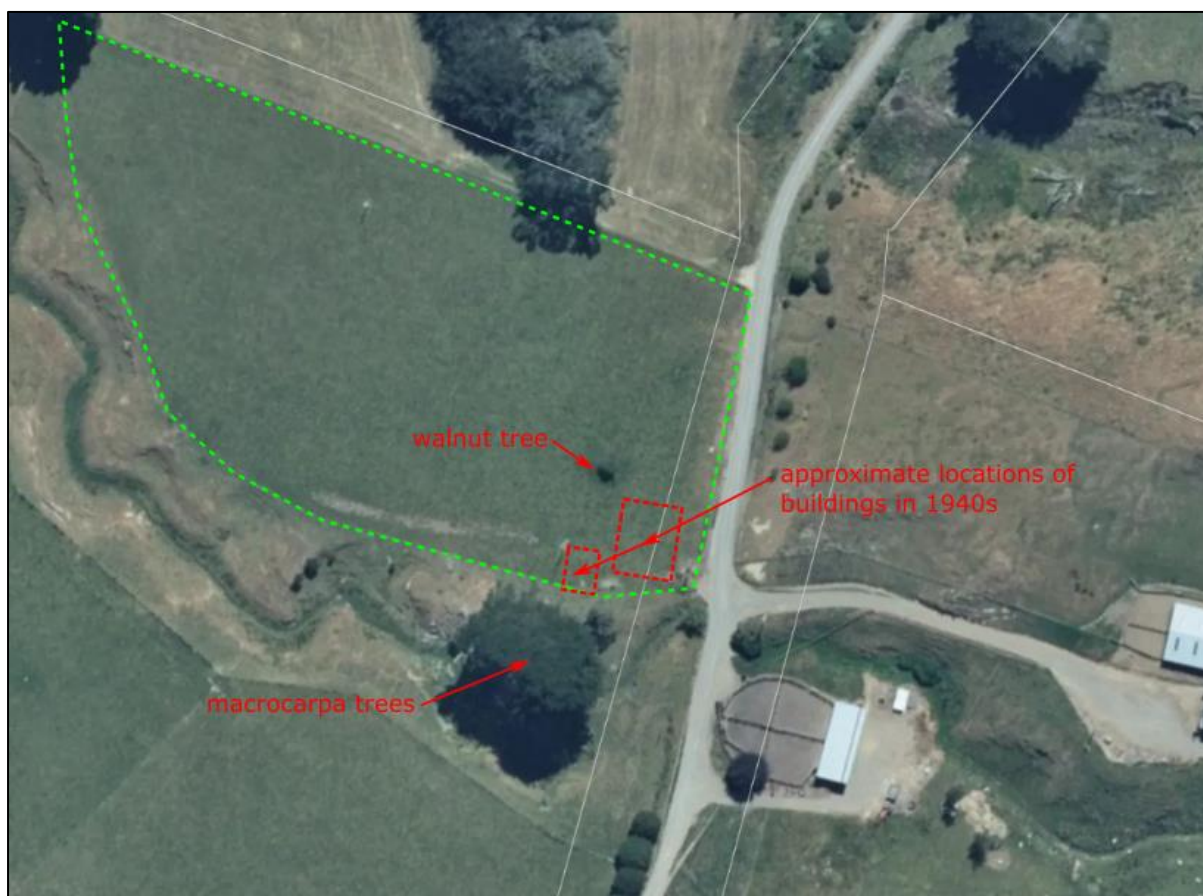
The site entrance paddock slopes gently towards the west, away from the road. The area is presently covered with cropped grass. There are two large macrocarpa trees on the edge of the stream to the south, and a walnut tree located in the middle of the site access paddock (Figure 8 and Figure 9).

No evidence of any building remains was observed in the site entrance paddock where the building footprints are thought to have been. The area is completely clear, with the exception of the remaining walnut tree. On the south side of the fence, between the macrocarpa tree and the road, some bricks were seen in the stream bank, however this is outside the area of proposed works (Figure 10). No artefacts were observed that could indicate when the buildings were built.

Figure 8: The site entrance paddock.

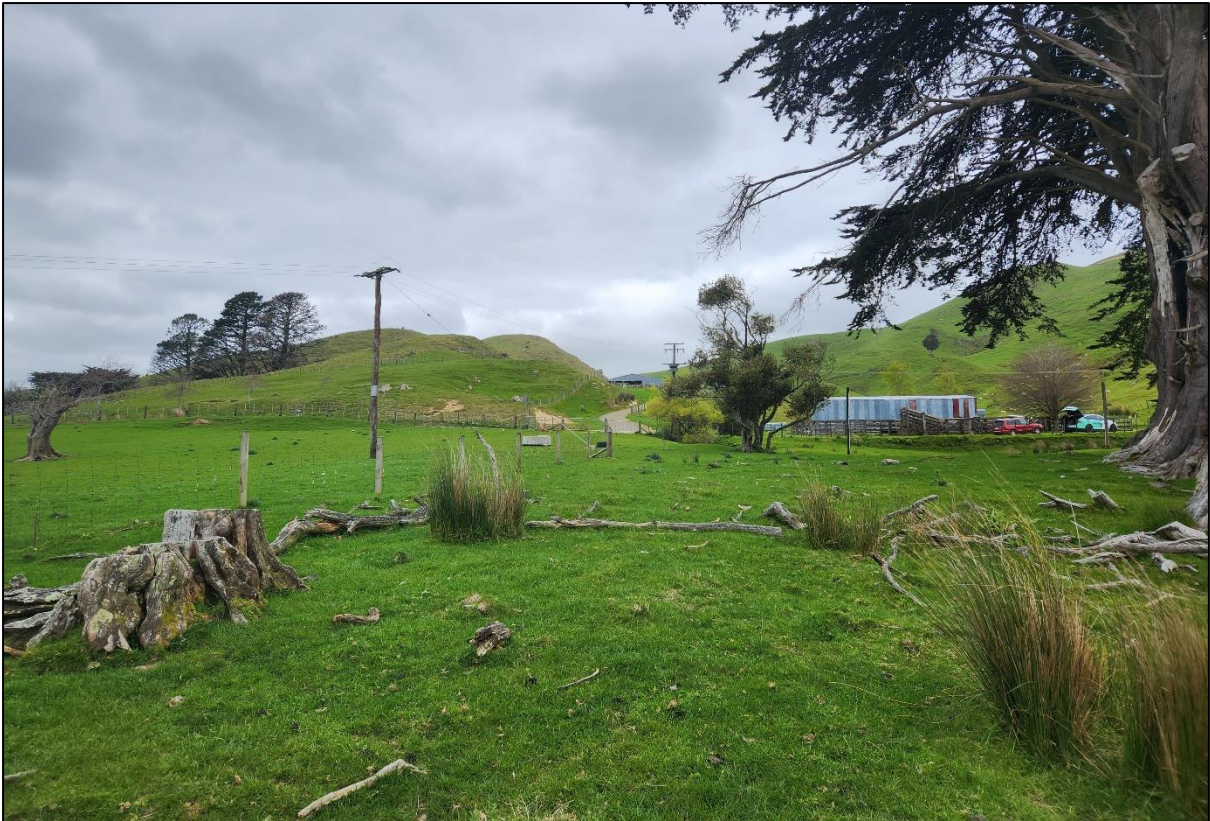
Figure 9: Looking east toward the building site and road from the paddock, the walnut tree is on the left, and the macrocarpas are on the right.

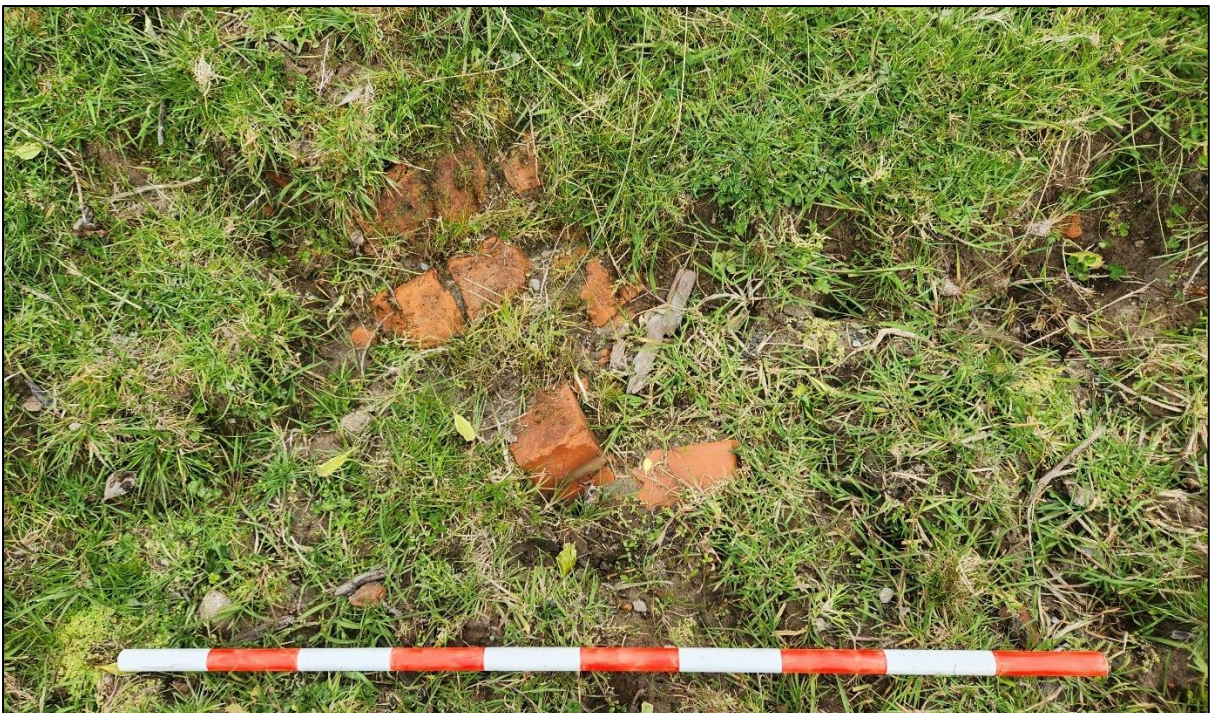
Figure 10: Brick observed in the bank of the stream between the macrocarpa trees and the road.

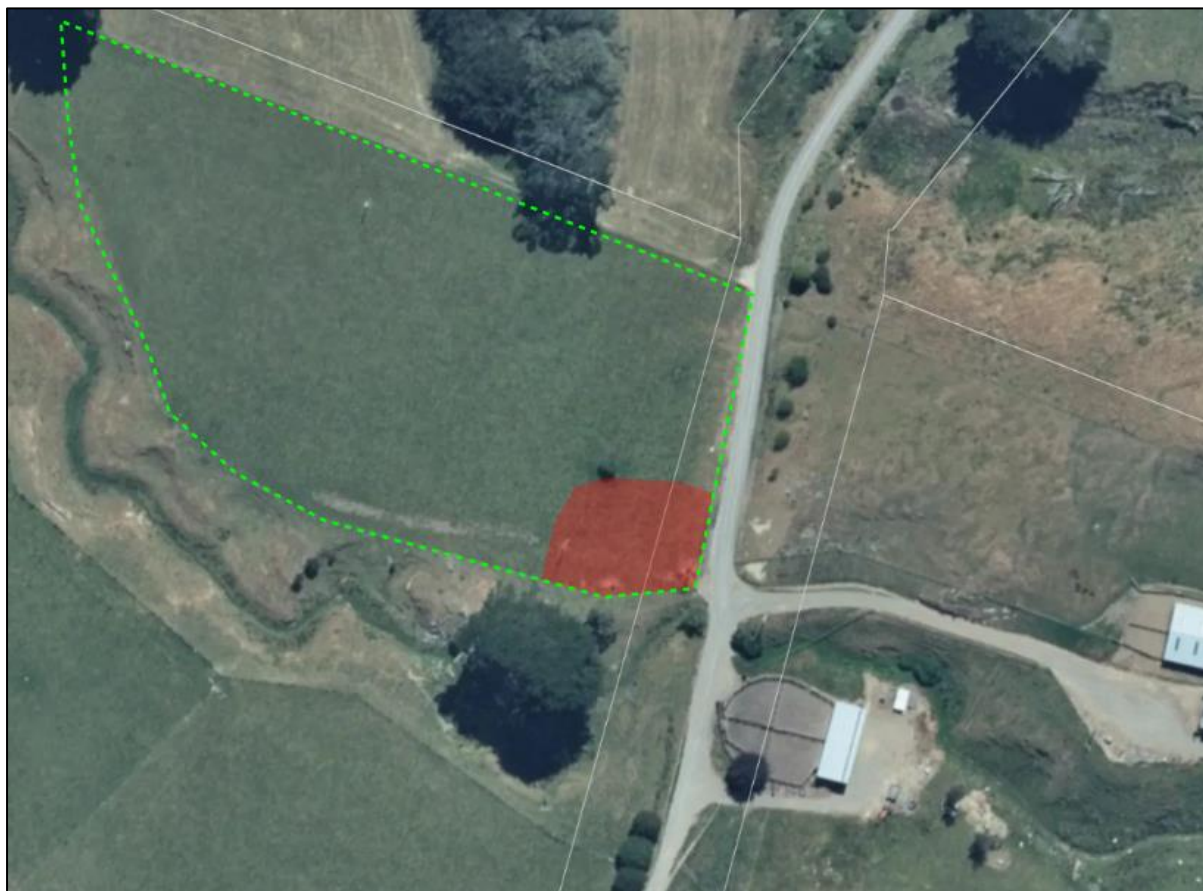
Figure 11: Recommended buffer area (shaded in red) where excavations should be avoided.

If it is possible to avoid excavations within the area of the original farmhouse, then this should be the adopted approach for managing the potential for impacting an archaeological site. The recommended exclusion area is shown in Figure 11 and comprises the southeast corner of the block out to the walnut tree.

If excavations cannot be avoided in this area there is a legal requirement under the *Heritage New Zealand Pouhere Taonga Act 2014* to seek an archaeological authority from HNZPT for any works that will modify, damage or destroy an archaeological site. As mitigation for information loss if an archaeological site is identified during the proposed works, it is recommended that archaeological

monitoring of groundworks within the area of the historic house is undertaken to identify and record any archaeological features if they are exposed.

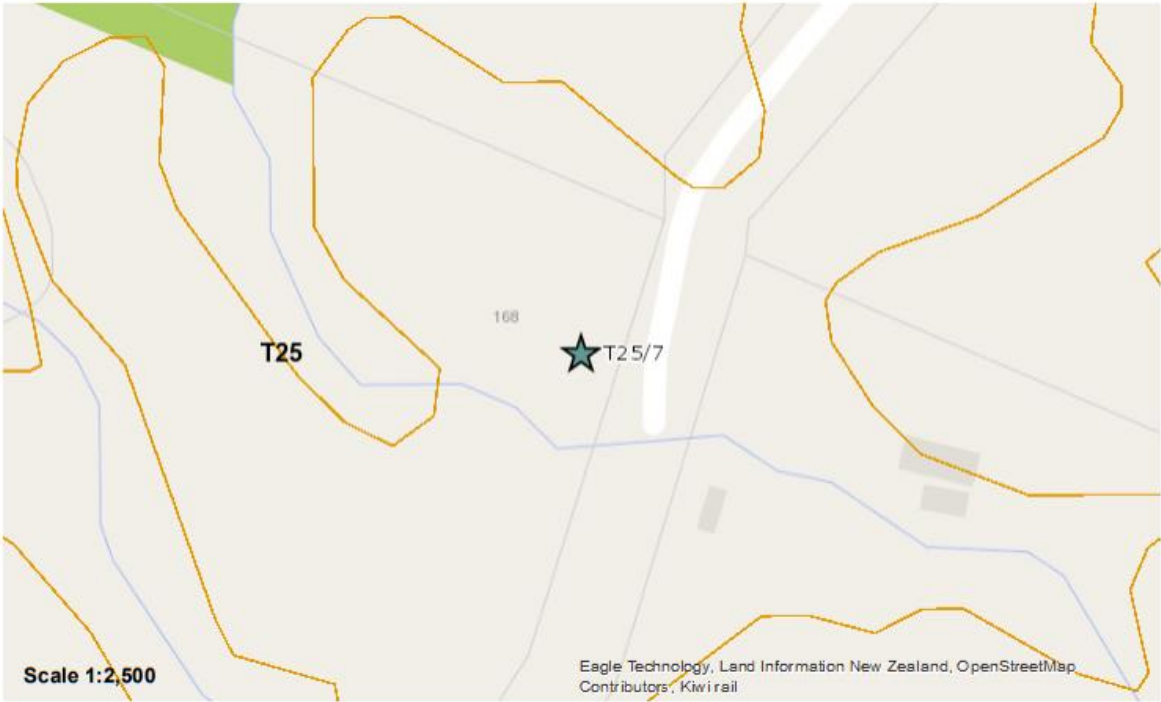
<p>Scale 1:2,500</p> <p>Eagle Technology, Land Information New Zealand, OpenStreetMap Contributors, Kiwi rail</p>	
<p>Finding aids to the location of the site 168 Old Coach Road, paddock north of the stream</p>	
<p>Brief description Site of 19th C farm house</p>	
<p>Recorded features Building - homestead</p>	
<p>Other sites associated with this site</p>
