Date: Wednesday, 11 March 2020
Time: 9.30am
Venue: Whanganui District Council
101 Guyton St, Whanganui

CATCHMENT OPERATIONS COMMITTEE

AGENDA

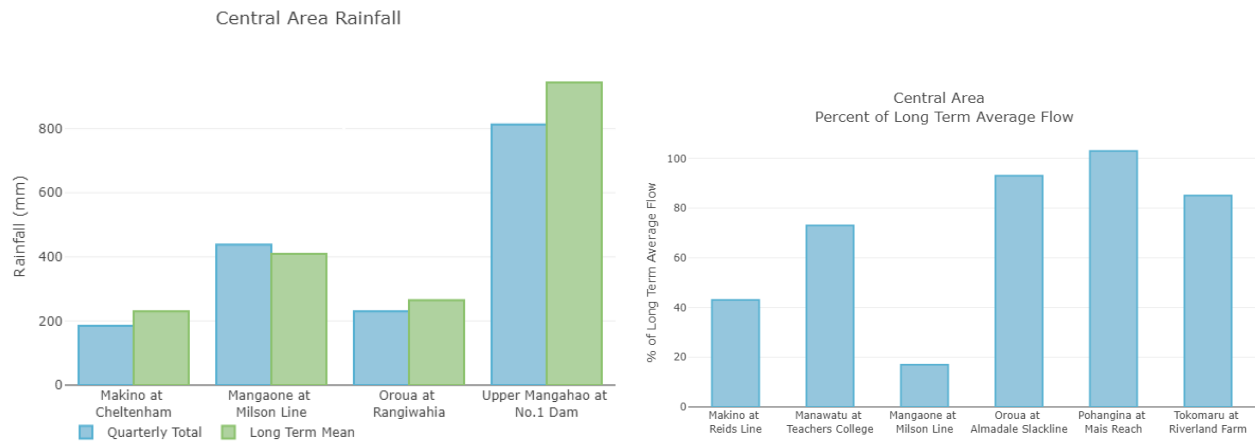
7.1. November Rainfall/Flow

- 7.4. This reporting period has seen very little rain through the system, and with strong winds has led to exceptional dry conditions. While this weather is good for earthworks, spraying is difficult.

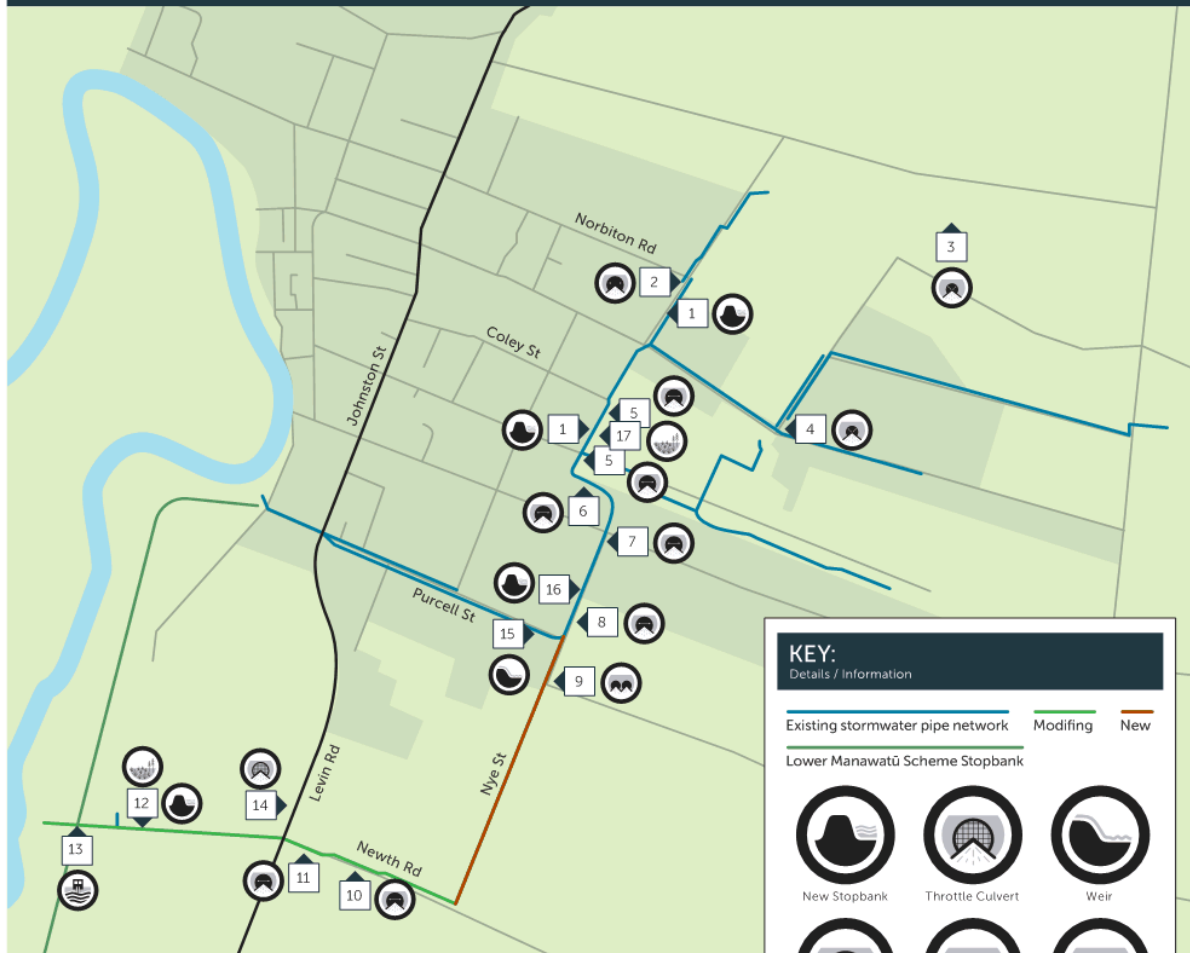
Foxton East Drainage System Issues and Options

| 1 Construct proper stopbank with sheet piled foundation to prevent piping failure; | 9 Twin culverts to divert flow to Duck Creek; |

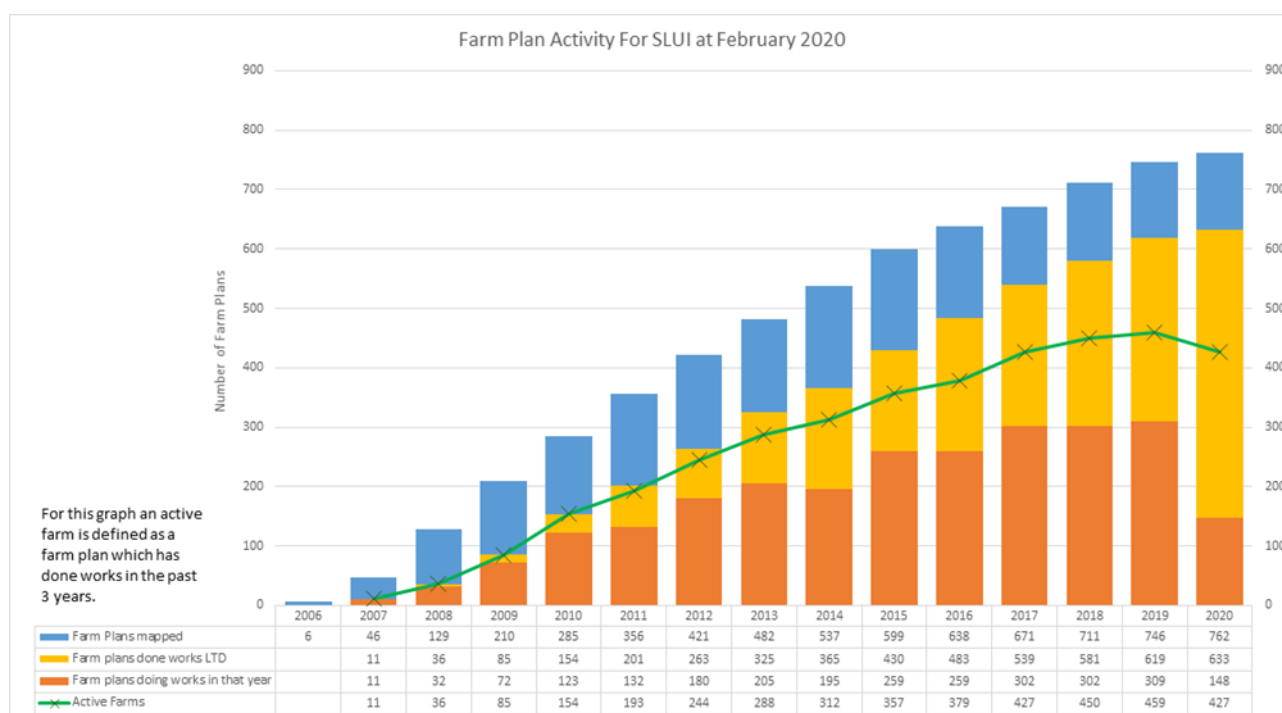
Graph 1: Farm Plan Activity at February 2020.

- 4.2.2 Graph 3 is a new way of looking at the farm plan activity as a whole, and in any particular year. It is a "stacked column graph" where the orange, yellow and blue components of the column add up to the total number of plans in SLUI at the end of any given year. For example, in 2018-19 there were 746 plans completed over the life of SLUI, 619 plans had completed some works (83% active), 309 plans completed some work in that year (41% of plans active in 2018-19). The green line tracks "active" farm plans, where active is taken to be "has completed works in the last three years". In this instance the number of plans at the end of 2018-19 with some works completed in the last three years was 459 (62%). It is noted that the lower number of farms completing works in this year in the graph reflects the year only being partially completed at this stage.

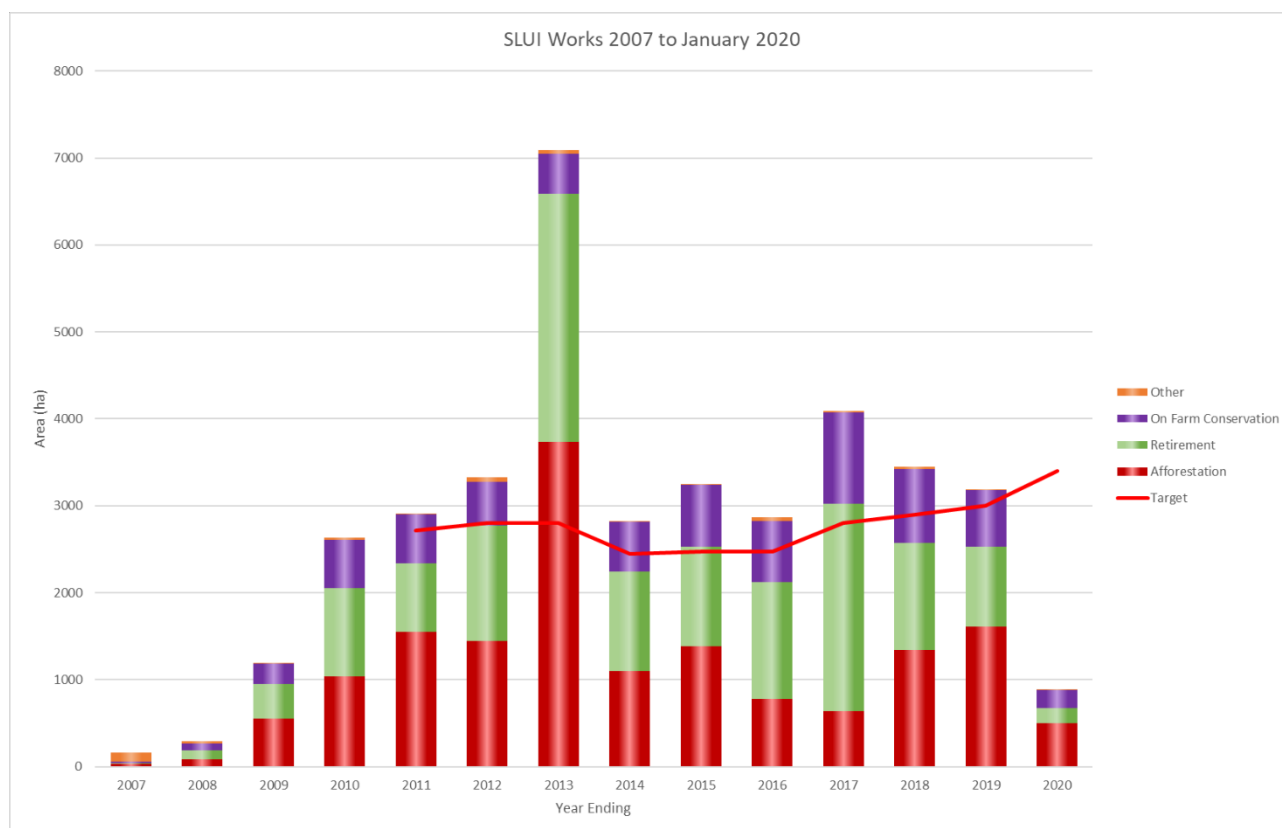
Graph2: SLUI works completed by work type during the life of the programme against annual contract targets (red line)

- 4.3.2 Each year since 2010 the contract target for hectares of works completed has been exceeded.
- 4.3.3 The amount of work completed was relatively stable from 2010 to 2016. However, 2013 was an exceptional year with 3,224 ha of afforestation. This was due to uptake of the Afforestation Grant Scheme and retirement projects in association with Ngā Whenua Rāhui.

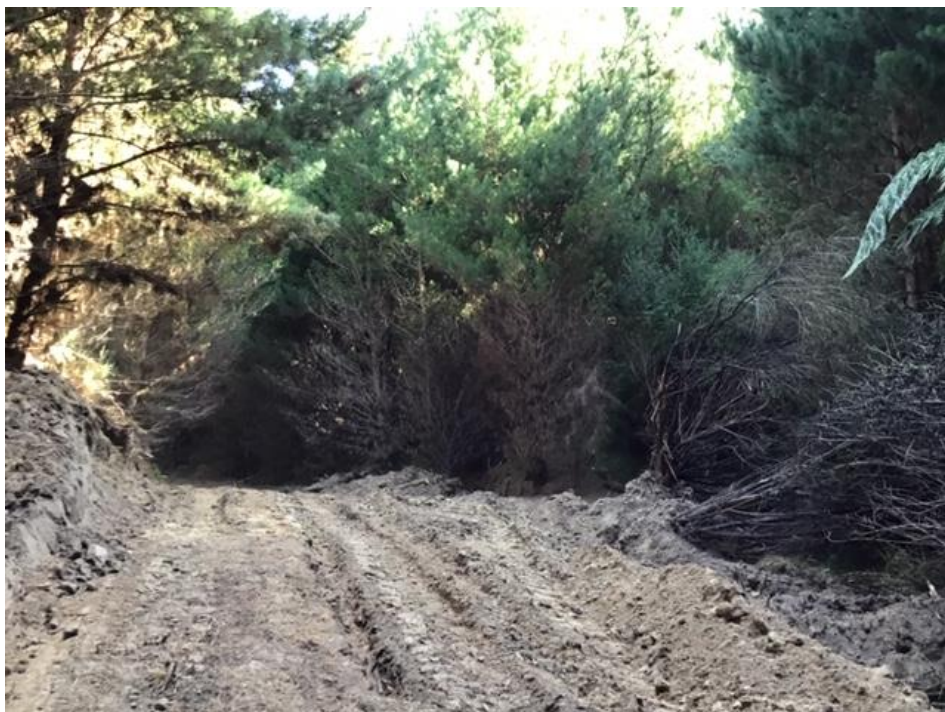
Photo 3: Firebreaks put in using D8 bulldozer. Photo courtesy of Josh Penn.

- 4.6.3 On Saturday 1 February John Jamieson was notified of a forest fire on Whanganui River Road near our Wickham joint venture forest. Rural fire services were on the scene and helicopters had been called in. Horizons staff (John Jamieson, Sara Mathieson and Josh Penn) were on the scene and assisted Rural Fire with information as the fire was fought over Saturday until Monday. The main effort to control the fire was on Sunday with up to seven heavy lift helicopters, ground crews and a large D8 bulldozer being used. The fire appeared to have started on the river side of the road, jumped the road and spread up the hill with assistance of a strong wind. The fire took hold in a neighbouring forestry block (Parakino) and entered the Wickham block. The bulldozer was used in the Wickham block to upgrade tracks and establish firebreaks. The fire was largely extinguished on Monday, but equipment was kept on site in case of flare ups. Staff couldn't access the block until later in the week to assess damage. Initial estimates suggest the efforts of Rural Fire to contain the fire spread were impressive as damage to the Wickham JV is less than 2 ha with about 0.5 ha of trees badly damaged. Some gateways and fences were damaged and tracks opened by the D8 for firebreaks need repair. This work is currently underway. The block was scheduled for waste thinning in February. This is scheduled to begin on Monday 17 February with tight controls in place, including using a smaller crew, having access to a helicopter for firefighting, early starts and finishes and a maintenance check at the end of each day.
