Date: Wednesday, 12 February 2020
Time: 9.30am
Venue: Tararua Room
Horizons Regional Council
11-15 Victoria Avenue, Palmerston North

ENVIRONMENT COMMITTEE

AGENDA

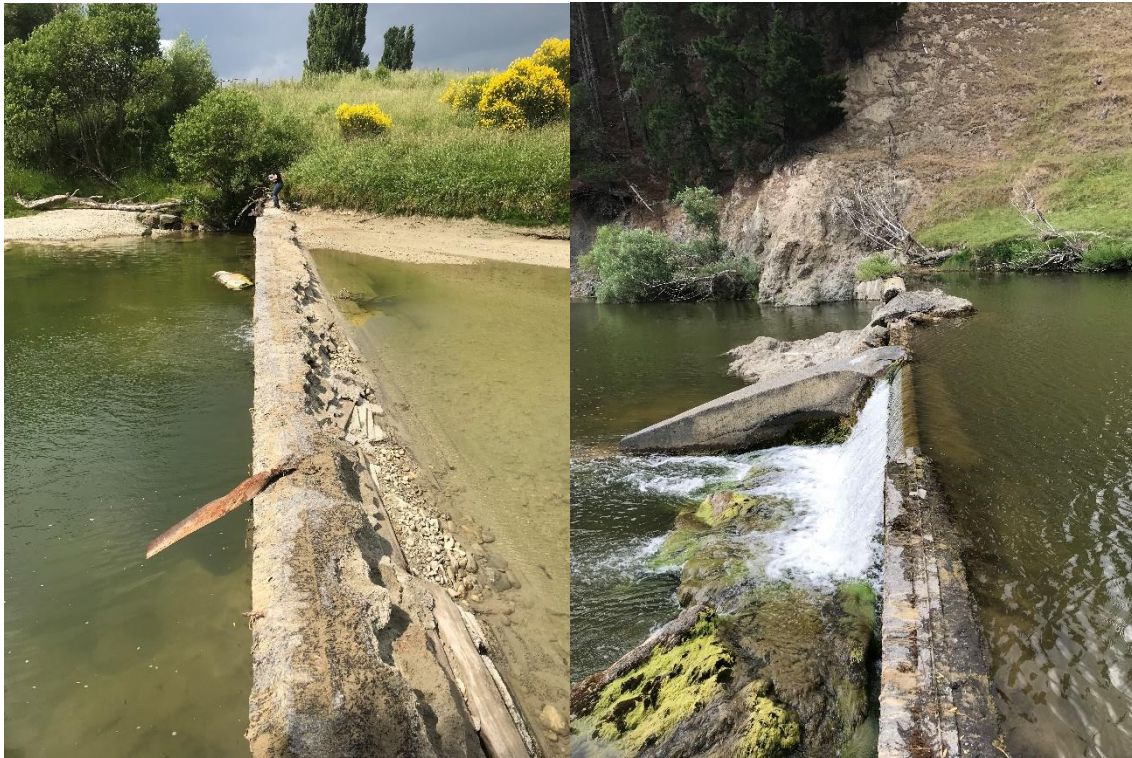
Figure 1: Akitio weirs – left, the rabbit weir (NB no water flows over the weir during low flows, only under it) and right, the salt water wedge weir.

3.3.6 It was identified that removing the two weirs on Akitio River would significantly benefit fish passage into the river. During the reporting period a site visit was undertaken to the two weirs with a geomorphologist from Tonkin and Taylor to look at potential effects if the weirs were to be removed. A report outlining some potential effects and recommended monitoring to further inform these effects prior to and after their potential removal is due in the new year. A salt water wedge investigation is being completed in January 2020 with NIWA to see if the wedge reaches the base of the lower weir. The lowest weir in the catchment was originally installed to prevent salt water migrating inland causing water to become unsuitable for stock. The base of the weir definitely experiences tidal fluctuations but it is unknown if the salt water pushes this far back inland. Depending on the answer from this work, it may alleviate some of the concerns that surrounding landowners have around their ability to continue to take stock water.

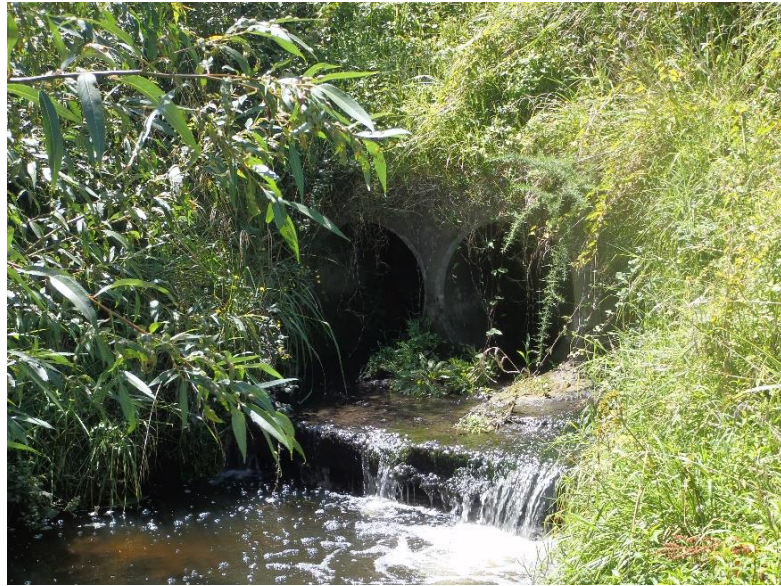
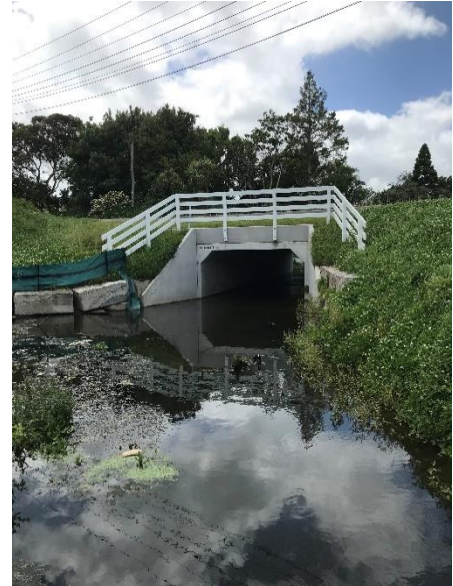
Figure 2: Awarua Stream fish passage restoration by culvert replacement. Photo on the left taken in 2013 and the right in December 2019 after replacement of the culvert and installation of a leaky weir downstream of the culvert.

3.3.8 During the reporting period Horizons and Whanganui District Council representatives met to discuss improving fish passage at a newly installed culvert on the Awarua Stream, which flows beneath Wikitoria Rd at Putiki, Whanganui. Both the existing and now new culvert are in the tidal zone of the Awarua Stream, and therefore there are high numbers of whitebait downstream of culvert, evidenced by the number of whitebaiters downstream of the culvert. The onsite meeting resulted in an agreement to install a “leaky weir” consisting of large rocks being placed approximately 20 metres downstream to allow the stream to back up, flooding the culvert. Horizons conducted pre- and post-weir installation monitoring with results indicating an improvement in the ability of migratory galaxiids (whitebait) to swim upstream through the culvert.

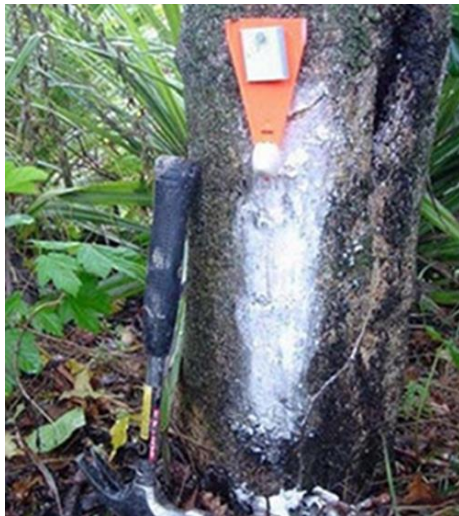
Photo 1: Wax-tag monitoring device as set in the field. The green square is luminous to attract possum attention at night.

4.1.2 The monitoring programme operators put out 25 lines of 10 wax-tags (Photo 1) per PCO and the number of bite marks gives an index of the possum abundance. The monitoring lines are randomly selected to remove bias and provide a robust estimate. The monitoring is predominately done by an independent contractor who is not involved in any of the control work. Some of the internal team monitor the possum control work completed by external contractors.

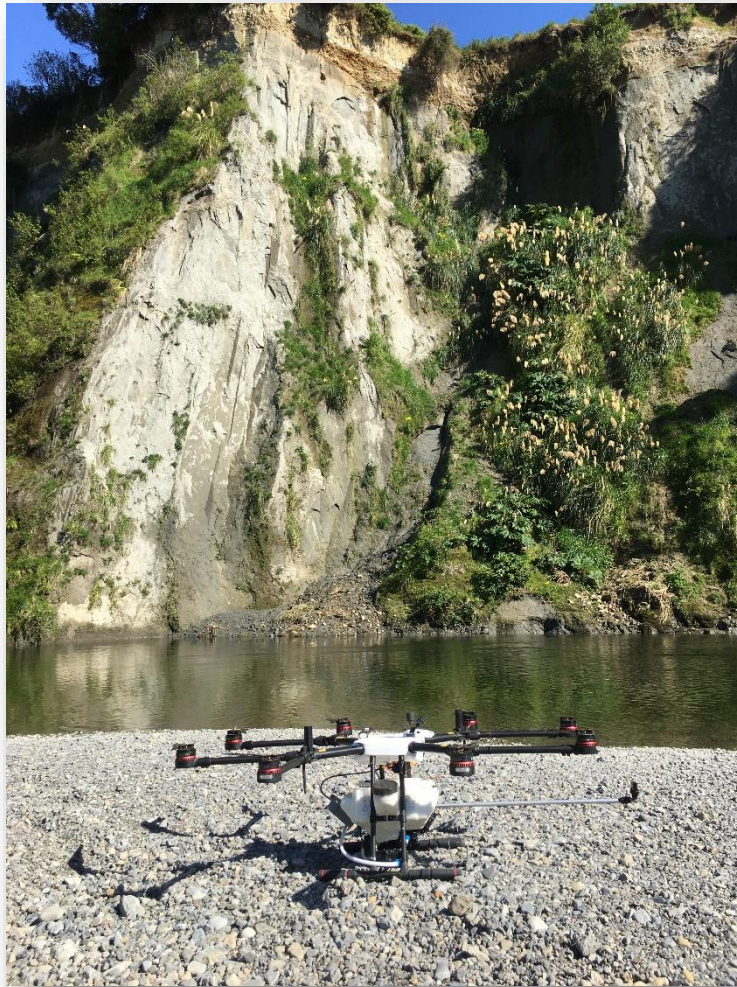
Photo 4 Drone about to spray gunnera on cliffs along the Mangahao River (J Keast).

- 4.2.5 Staff have been searching for methods to deliver the best control with minimal collateral damage for the places they are located for some time. Many sites are inaccessible to ground contractors except for abseilers and the option of aerial treatment can be costly and may lead to off-target damage. We have used a drone operator against Darwin's barberry at Tongariro National Park and this year a local operator was engaged to control Chilean rhubarb on river cliffs. The drone was able to fly across a river and treat individual plants with a modified drone spraying system which applied herbicide directly to the plants in a quick and efficient manner. We were able to avoid health and safety issues due to the cliffs and cover a lot of sites in a short time.

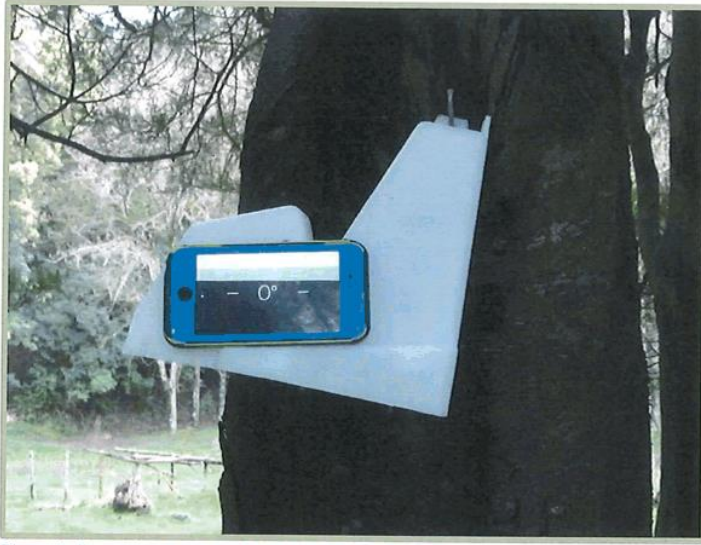
Photo 1: Base plate level on a side set (Photo J Hart)

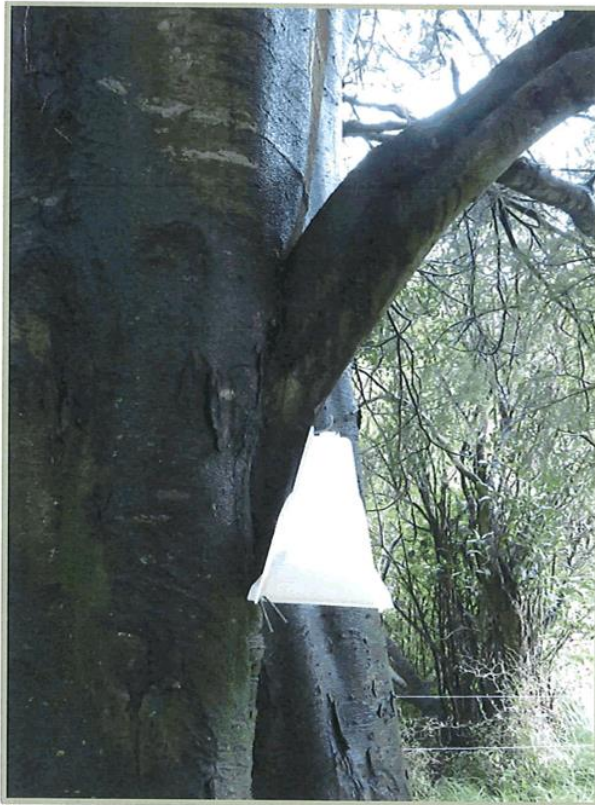
Photo 2: Base plate level from the front view (Photo J Hart)

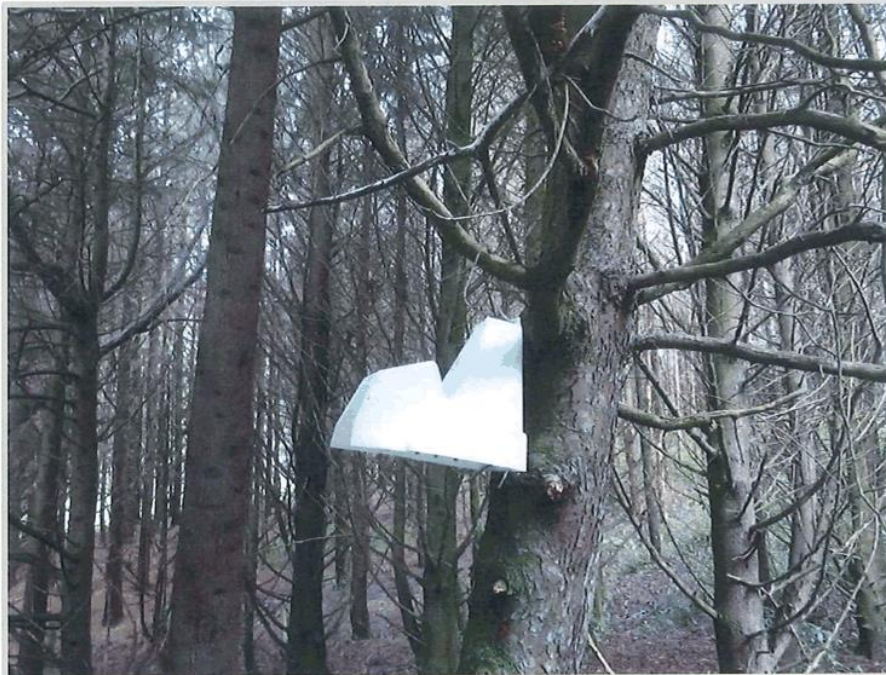
Photo 3: Back set, note the level base plate and 2 nails in base to prevent the station from moving (Photo J Hart)

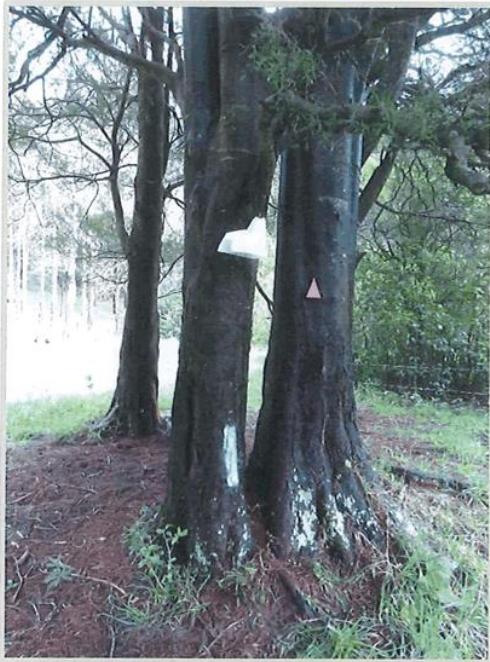
Photo 5: An example of a side set (Photo J Hart)

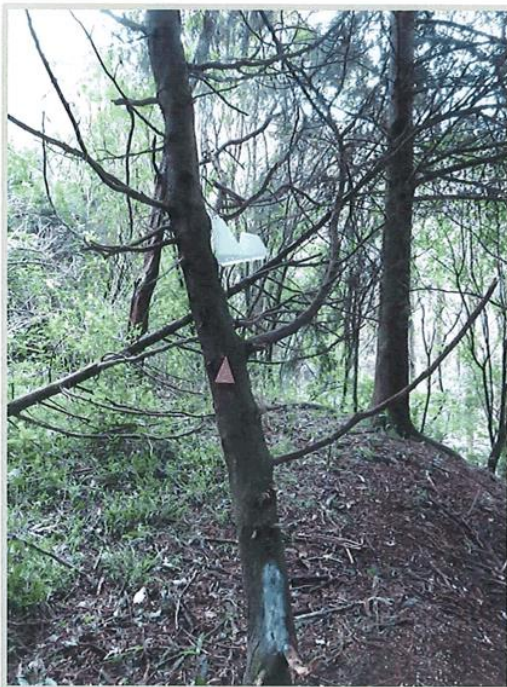
Photo 6: An example of a back set (Photo J Hart)

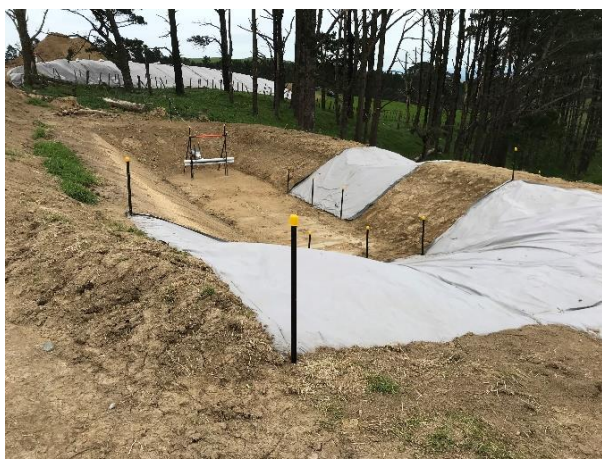
Figure 1. Decanting Earthbund

7.7. Figures 1-4 show some of the environmental controls installed on the Windfarm.

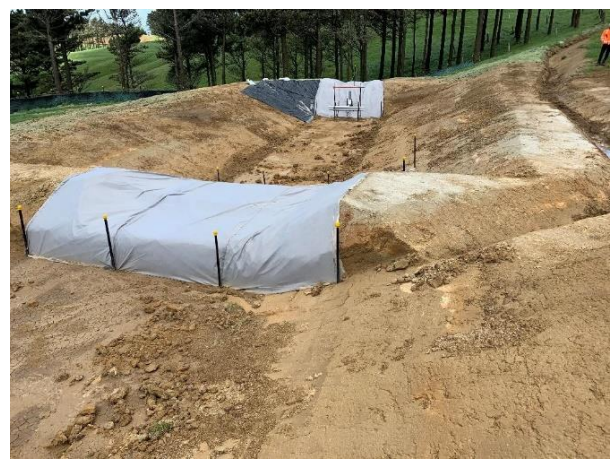
Figure 2. Sediment Retention Pond

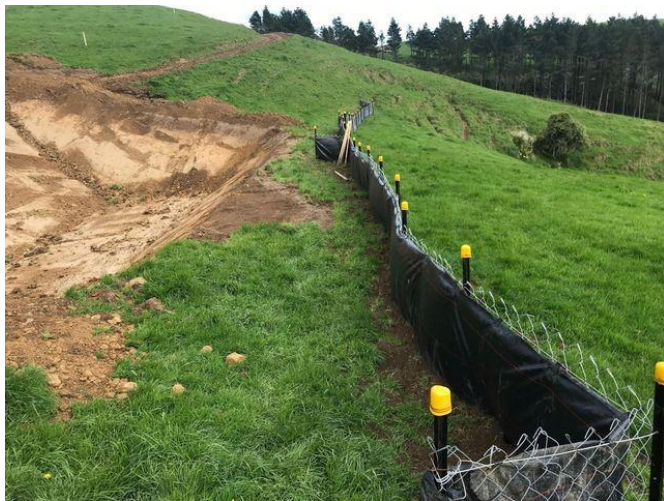
Figure 3. Super Silt Fence controlling sediment run-off while primary control is constructed

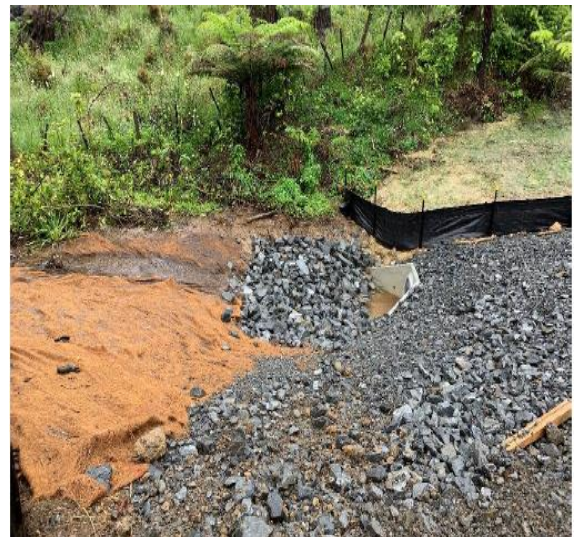
Figure 4. Culvert installation
