# Koputaroa No. 4 Pump Station Network Environmental Enhancement Potential

**May 2019**  
**Report No: 2019/EXT/1636**

## 2.4 Map of Current Drainage Network Key Features

## 2.5 Table of Photos Plus Description of Key Features

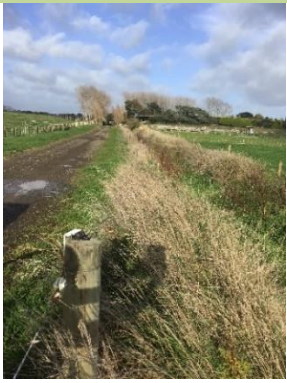
Feature Type	Photo	Description/ Profile
Paddock runoff -drainage channel

Side drain running along farm track <ul style="list-style-type: none"> <li>▪ fenced both sides- 2-wire</li> <li>▪ grassed up drain banks</li> <li>▪ low batter slopes</li> </ul>
Paddock runoff -drainage channel

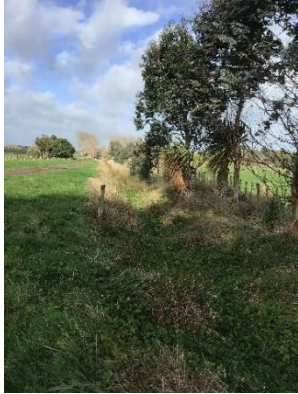
Side drain running along farm track <ul style="list-style-type: none"> <li>▪ fenced both sides- 2 –wire</li> <li>▪ grassed up drain banks with a few native cabbage trees and toi toi</li> <li>▪ low batter slopes</li> </ul>
Culvert

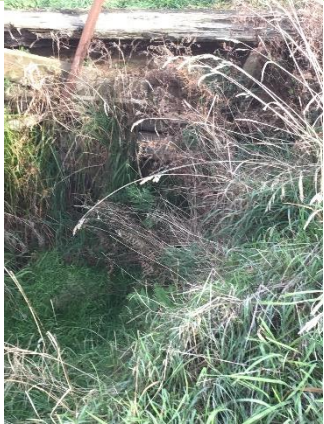
<ul style="list-style-type: none"> <li>▪ 500 mm plastic culvert</li> <li>▪ 30% water level</li> </ul>
Culvert

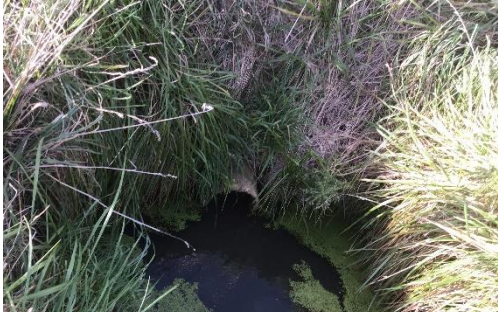
<ul style="list-style-type: none"> <li>▪ 300 mm concrete culvert end pipe dipping- could be perched in low water levels due to dropping of end pipe.</li> </ul>

- Some sections of drains are yet to be fenced which has led to stock damage of the drain. Fencing of the remaining sections of drain will exclude all stock from the waterways.
- There was one perched culvert identified, replacing this with a correctly design fish friendly culvert will extend the habitat available to native fish.

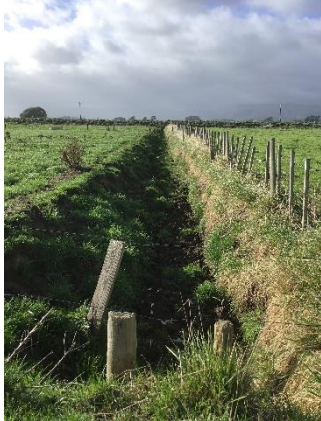
<p>Paddock runoff -drainage channel- runs into scheme drain</p>

<p>First 300 m section fenced both sides.</p> <p>Last 200 m section only fenced one side- can see where stock have trampled in and out.</p>
<p>Scheme drain A5-( 0-300 m section)</p>

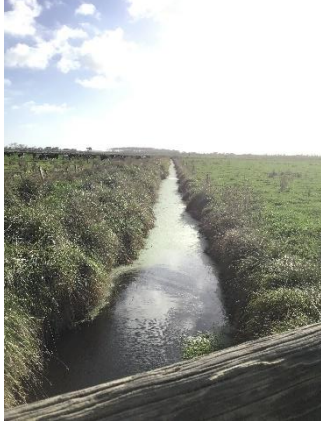
<p>Fenced both sides.</p> <p>Good grass cover on banks with small over hang.</p>
<p>Scheme drain A5-( 300-600 m section)</p>

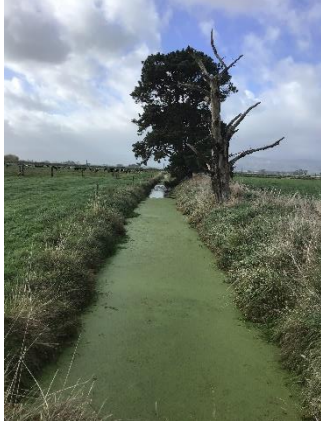
<p>Fenced both sides.</p> <p>Good grass cover on banks with small over hang and a few larger trees.</p>
<p>Culvert crossing on A5 drain</p>

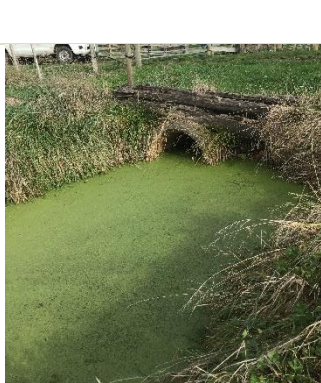
<ul style="list-style-type: none"> <li>▪ 900 mm culvert</li> <li>▪ 50% full of water</li> </ul>

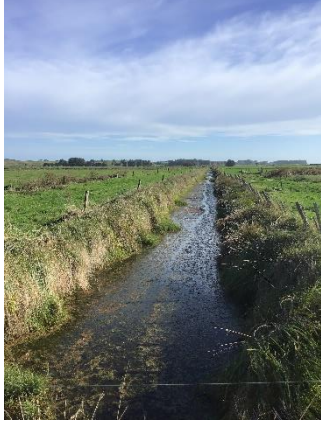
<p>Fenced both sides.</p> <p>Good grass cover on slopes.</p>
<p><b>Koputaroa No. 4 Pump Station</b></p>		
<p>Scheme Drain A1</p>

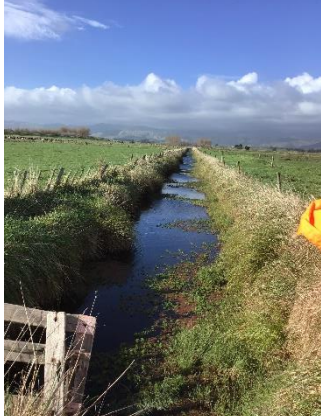
<p>Fenced both sides.</p> <p>Grassed banks.</p>

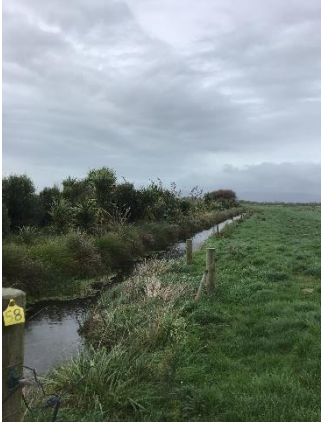
<p>A3 drain</p>

<p>300 m upstream from outlet into A1 a 150 m section has been planted up with native plants.</p> <p>The drain has been fenced off both sides.</p>
<p>A4 drain</p>

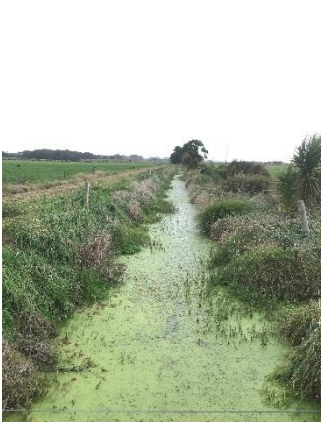
<p>A 400 m section of the right bank has also been planted up with natives plants and the drain fenced off.</p>
<p>Culvert across access track on A4</p>
