Landcare Research Site Investigation Report

AFFCO Manawatu – Soil Assessment of Proposed Irrigatable Land

May 2013

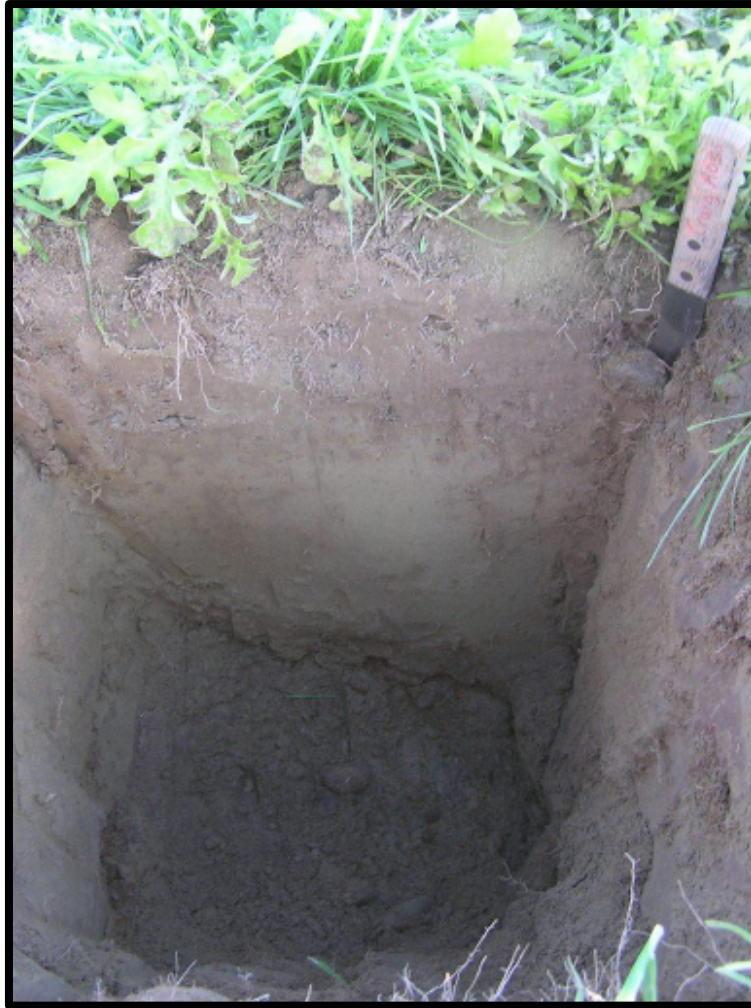
Figure 1 Manawatu gravelly loam fine sand over banded sands to 50 cm on gravels.

- 40% deep (50–120+ cm) sandy Manawatu soils (Photograph 1) with fine sandy loams or loam fine sands over banded sands or gravels
- 50% stony or boulder sandy Rangitikei shallow soils (Photograph 2) on former river channels and stony ridges, reflecting the river system that historically flowed through the area
- 10% man-made (Anthropic) stony soils with sandy topsoil matrices at the eastern end of the block. A small mounded stony area to the west of the large building and south of the small shed/ stock yards was a former de-odorizing or filtration pad.

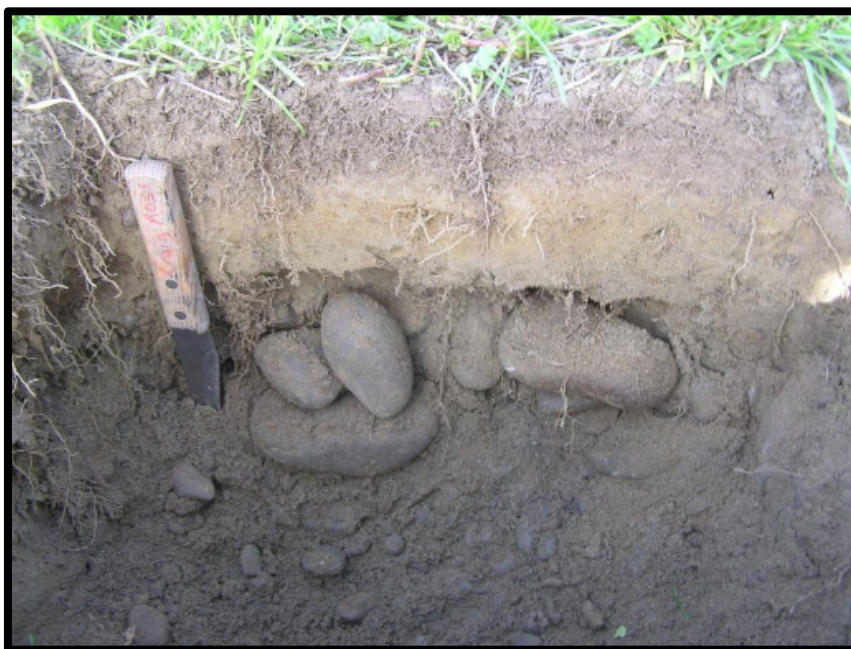
Figure 2 Shallow and stony man-made (Anthropic) soil similar to Rangitikei shallow soils.

The paddock to the north-west of the Effluent Ponds has an area on the west side of the shingle track that contains up to about 30 cm of composted paunch waste over loose sands on gravels. The rest of the paddock has shallow and stony man-made (Anthropic) soils – see Photograph 2. The former soils in this paddock appear to have been excavated, as there is a distinct bank of about 1-m height along the boundary fence line.

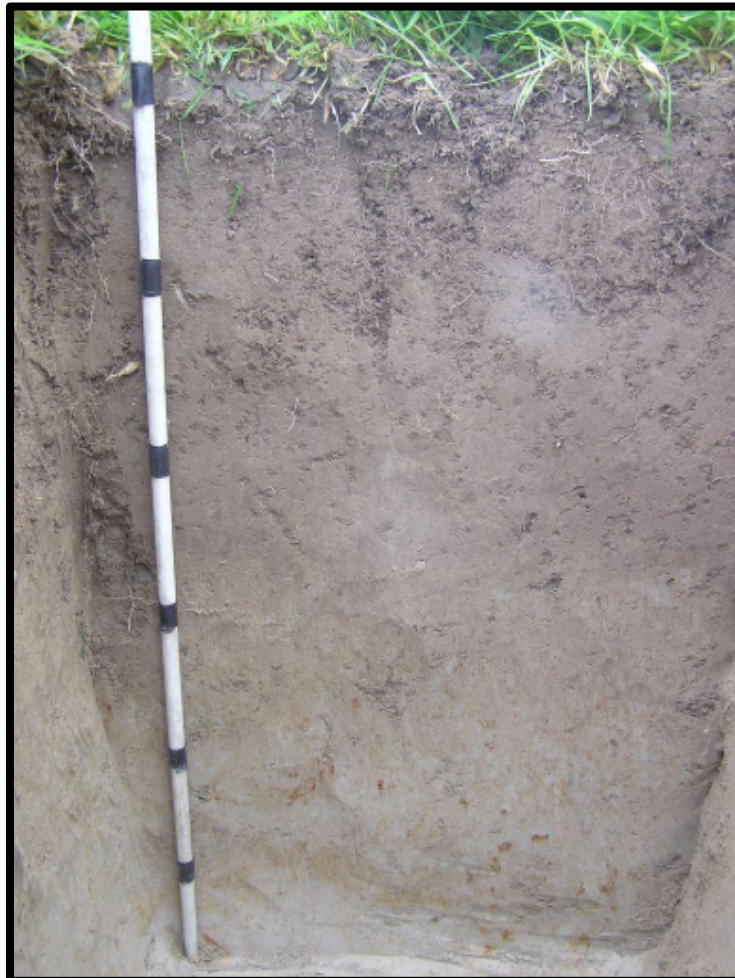
Figure 3 Kairanga silt loam soil, imperfectly drained.

The paddocks along Ratanui Street, to the south-west of Wallace Corporation Hides and Slinks buildings, have well and moderately well-drained deep sandy and silty Manawatu soils over the larger area of paddocks to south of the main AFFCO buildings area. The Manawatu soils grade into imperfectly drained Kairanga silty soils (Photograph 3) at the south-eastern end.
