**HOROWHENUA DISTRICT
COUNCIL**

**STATEMENT OF EVIDENCE OF PHILLIP SVERRE LANDMARK
(DESIGN/OPERATIONS) ON BEHALF OF THE CONSENT HOLDER**

2 September 2016

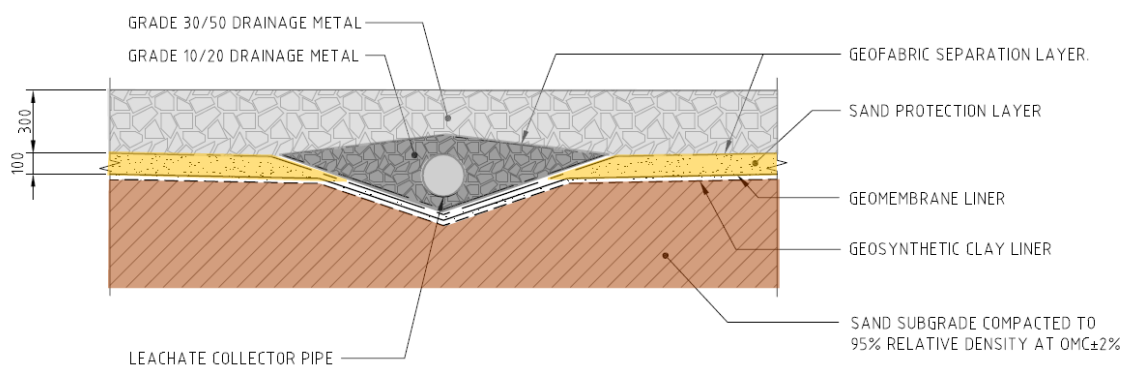
Figure 3: Diagrammatic section of the basal liner system at Levin Landfill

24. The liner system at the Landfill has two separate configurations, one for the flat base of the Landfill, and one for the lateral side slopes. **Figure 3** below shows the basal liner system.

25. It consists of the following layers which have different functions, as detailed in **Table 1** below. Layers are described from top to bottom.

Layer	Thickness	Function
Gravel drainage layer	300mm	Leachate drainage and liner protection
Geofabric	± 2mm	Separate gravel from sand underneath
Sand protection layer	100mm	Protect the geomembrane from mechanical damage
HDPE geomembrane	2mm	Primary leachate barrier
Geosynthetic clay liner	± 6mm	Secondary leachate barrier
Compacted sand subgrade	Varies	Foundation for landfill liner

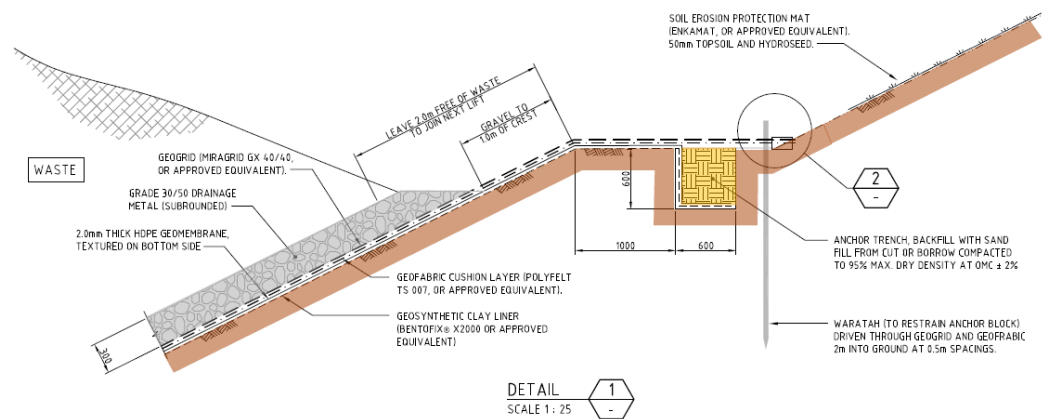
Figure 4: Diagrammatic section of the side slope liner system at Levin Landfill

26. The configuration of the side slope liner system is shown in **Figure 4** below. It needs to be different to the basal liner because a sand protection layer will stay on the side slopes and will be eroded by stormwater and wind. The configuration shown varies from that prescribed in the current consent conditions, as has been agreed with Horizons. It is proposed to amend the consent conditions to reflect this change.

27. **Table 2** below describes the different layers and their functions from the top down.

Layer	Thickness	Function
Sub-rounded gravel drainage layer	300mm	Leachate drainage and liner protection
Geogrid	2mm	Support the leachate drainage layer
Geofabric	± 6mm	Protect the geomembrane from mechanical damage
HDPE geomembrane	2mm	Primary leachate barrier
Geosynthetic clay liner	± 6mm	Secondary leachate barrier
Compacted sand subgrade	Varies	Foundation for landfill liner

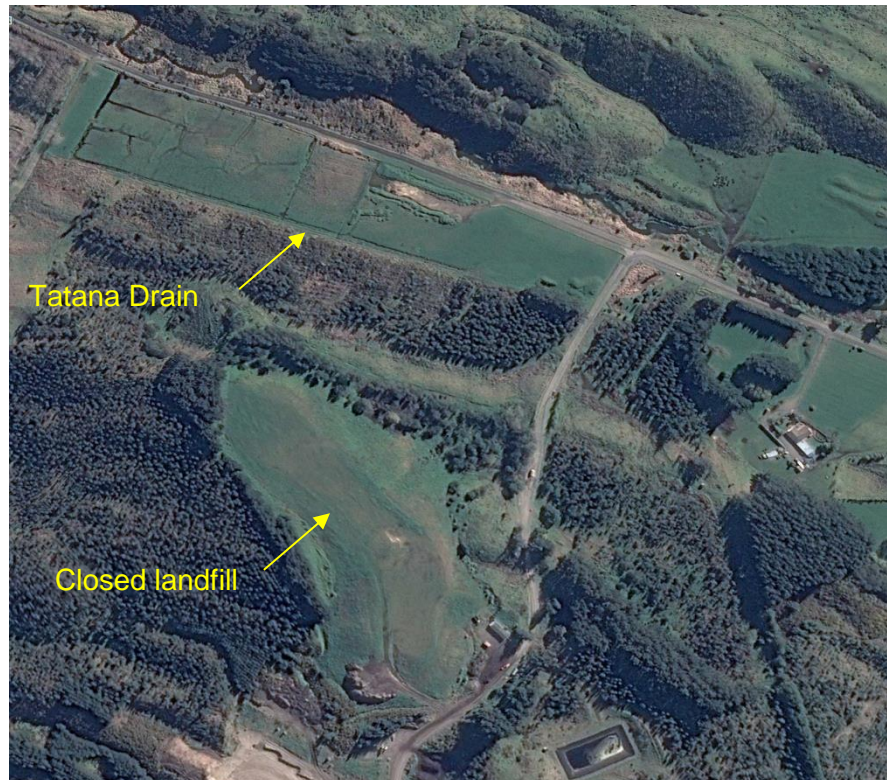
Figure 6: Aerial photograph (2013) showing Tatana property to the north of the Landfill site.

136. The “Tatana Drain” is situated on private land owned by the Tatana Family which lies immediately to the north of the Landfill site, as shown on **Figure 6** below. The property has been split into several paddocks and it is currently being used for the disposal of fill (described below), and on occasions cattle graze the property.

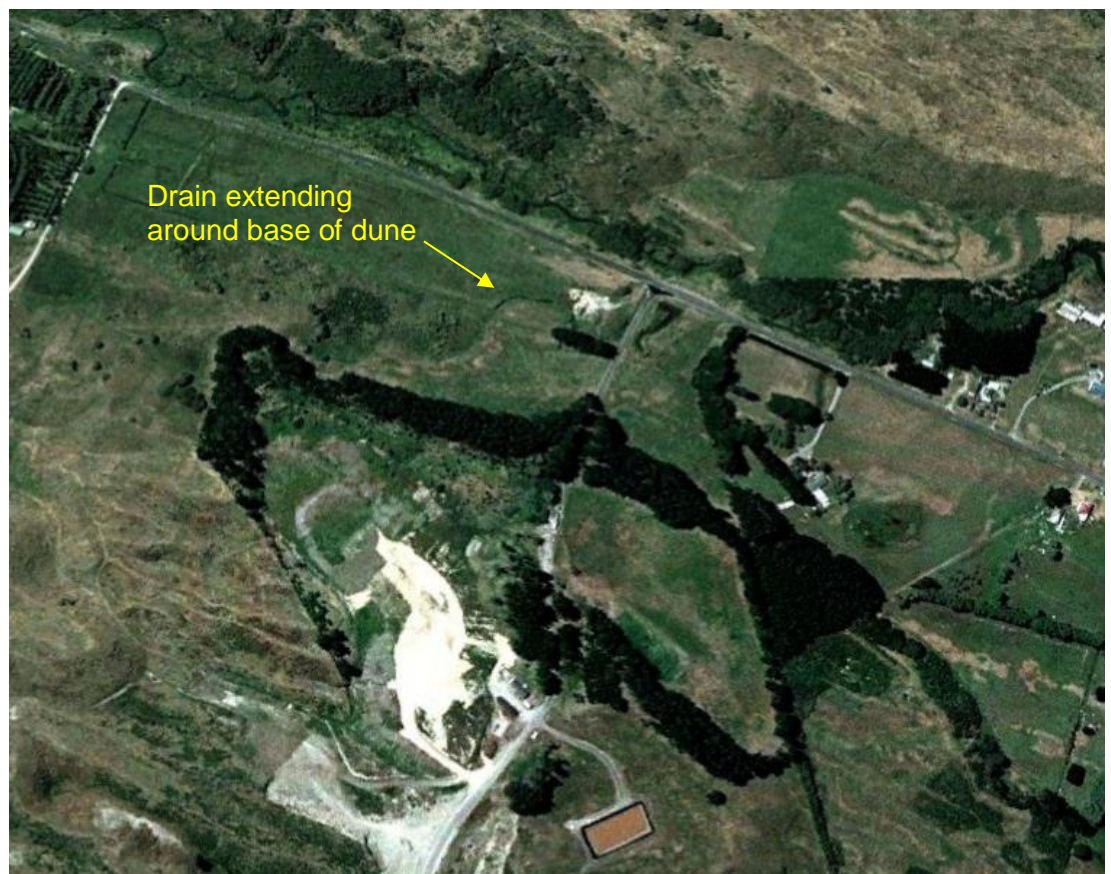
Figure 7: Aerial photograph (2005) showing filling operations commencing on the Tatana property.

141. The shallow groundwater is assumed to be the reason why Mr. Tatana has decided to raise the level of the property by progressively filling it with fill. **Figure 7** below shows an aerial photograph of the site in 2005 when filling had commenced at the eastern end of the property. As filling occurs, so the heaps of fill have been progressively flattened and the ground raised. **Figure 7** appears to show that the drain used to extend around the base of the dune which projects into Tatana property, as described previously. Presumably it has since been filled in as part of the operations to elevate the property above the groundwater table.
