Ricky Gowan
Imlay Compliance Manager
AFFCO NZ Ltd
PO Box 425
Wanganui

Results of Odour Extraction System December 2013 Inspection

This email summarises results from our inspection of the Rendering Plant air extraction system at the Imlay meat works on 12 December 2013.

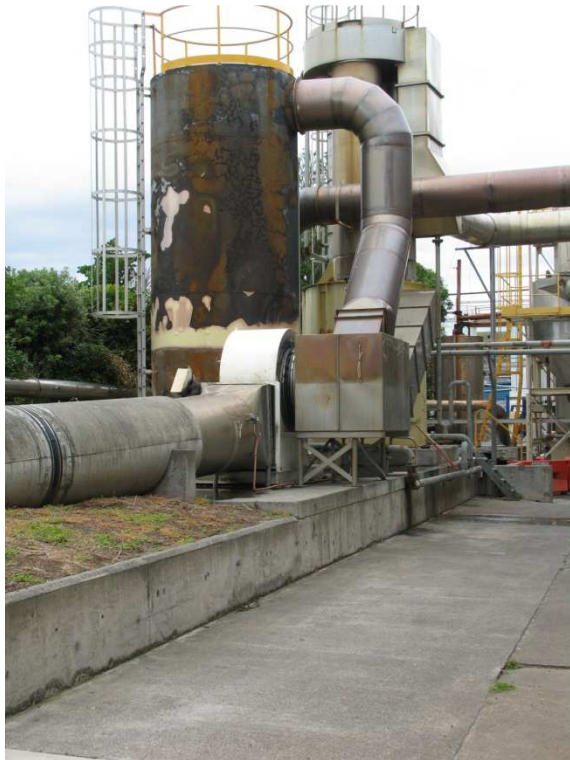
Fig 2: Humidifier/Scrubber Tower

Following the fire and clean up there was no packing left in the humidifier tower. As seen in Fig 5 in Appendix A only the steel packing support grating and one working spray nozzle remains. It appears that the spray manifold was built for three spray nozzles. From external observation it appears that the most intense heat generation in the fire came from the burning tower packing (see Fig 2). Without having seen any installation records, indications are that the packing had been polypropylene Type 2R Tellerettes, manufactured by Armatec Environmental in New Plymouth. For these to ignite and burn it is believed that there could not have been any water spray discharge onto the packing at the time of the fire upstream.

A thermocouple was able to be inserted through the narrow gap, after the manway hatch at the top of the tower had been closed. This indicated that the effect of the one working spray nozzle was reducing the temperature of the 32 tph airflow by 9.6°C on average, from 30.4°C to 20.8°C.

We were asked to provide details of the packing for replacement: The volume to be filled is 2.4m diameter up to a height around 2m i.e. a packing volume of 9 m³. Armatec currently have polypropylene Type 2R Tellerettes in stock at present and the cost would be \$24,480 plus freight. A fibreglass packing support grating would cost \$1690 plus freight if the existing grating has to be replaced. Armatec also have 4m³ of polypropylene pall rings as an alternative which would cost \$9792 but these would not be as effective as the Tellerettes. A further alternative would be to use a reduced height of Tellerettes say 1m, this would still give some improvement in gas-liquid contact at lower cost.

Give further consideration to the need for humidifier tower packing.

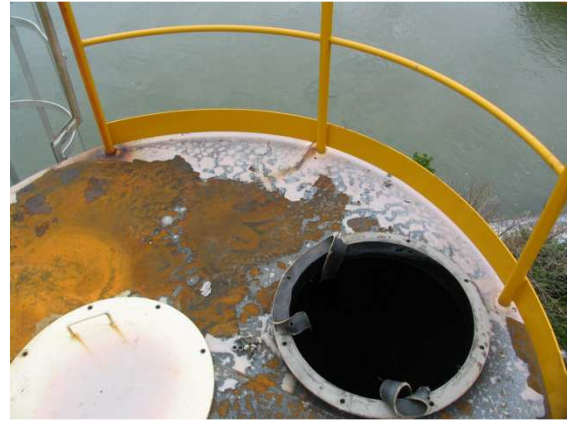
Fig 4: Open Manway

Table 2A shows the results of the uncovered biofilter flowrate and temperature measurements taken during the morning of 12 December 2013. During this testing it became apparent that airflow into the humidifier/scrubber was lower than expected yet the flow from the ID1 fan to the biofilter was higher than expected. Further investigation of the plant found an open manway hatch at the top of the humidifier tower. Apparently this had been opened by the Fire Service at the time of the fire and not subsequently closed. The hatch was closed and the results in Table 2B obtained.

In the first measurements made in the morning, the air flow to the uncovered biofilter was 45,300 – 47,100 m³/h or 53.9 to 56.1 tph (Table 2A). Measurements were taken at a removable plug eight metres downstream of the ID1 fan. The measured flow was 7% up on what it had been in May 2013. On the upstream side of the fan the flow from the wet process heat exchangers was about the same yet the air flow into the humidifier was only 57% of what it had been. Further investigation of the system then found that a manway on top of the humidifier tower was open (see Fig 4 photo in Appendix A) providing a passage for ingress of around 15,500 m³/h external ambient air. The manway was closed and subsequent measurement gave the results shown in Table 2B.

Manway hatch at the top of the humidifier spray tower needs a new gasket and bolting to eliminate inward air leakage

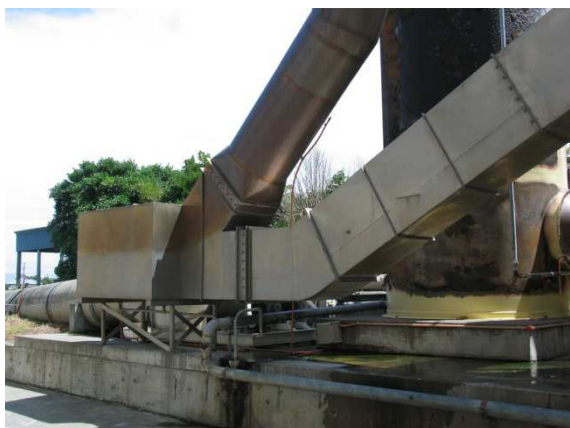
Fig 3: ID1 Fan Inlet Plenum

It was noted that the connection flanges on the balancing dampers in the ID1 fan upstream ducting had been slightly distorted in the fire and need additional bolting and gasket material if necessary to prevent air leakage into the duct.

Action: Ducting damper flanges need bolt adjustment and gasketing to eliminate inward air leakage.
