**Analysis of landsliding caused by the 15-17 February 2004  
rainstorm in the Wanganui-Manawatu hill country,  
southern North Island, New Zealand**

**G.T. Hancox and K. Wright**

**Institute of Geological & Nuclear Sciences science report 2005/11**

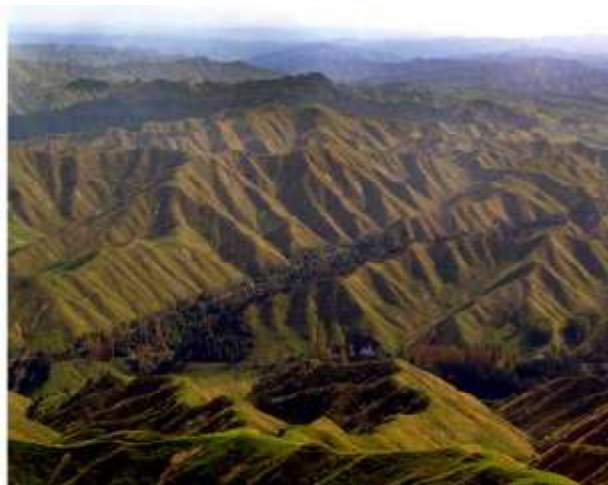
**Figure 6.** Typical Tertiary hill country of north-east Wanganui region (*photo G. Hancox 2004*).

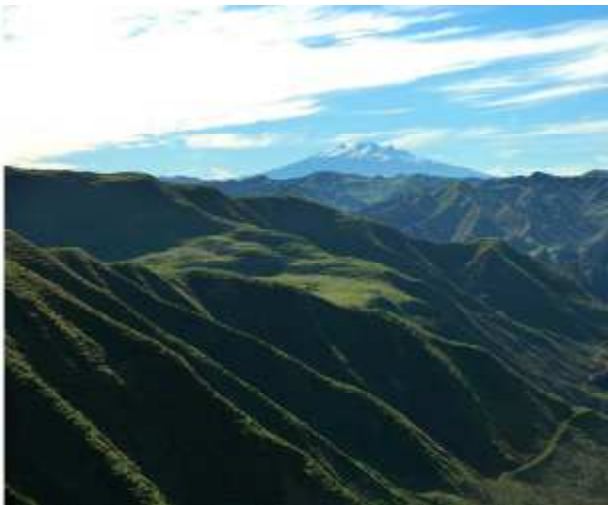
**Figure 7.** Photo showing typical hill country and preserved high level marine terrace in the Mangawhero valley – with Mt Ruapehu in the background. (*photo M. Crozier 2004*)

The north-eastern Wanganui hill country, which includes the Mangawhero, Whangaehu and Turakina study areas, comprises very steep (25-40°), rectilinear slopes formed in weak, Tertiary-age sandstone and mudstone which dip gently (between 2° and 8°) to the southwest. Ridges are narrow, sharp, and fluted where sandstone caps the dominant mudstone (Neall 1982). Dendritic drainage patterns produce highly dissected topography in the soft Tertiary sediments (Figure 6) typical of (geomorphically) young terrain. River channels are deeply incised, with little or no flood-plain development in the narrow valleys. In the highest hills of erosion-resistant rocks, some sub-mature marine terraces remain (Figure 7) but the majority of ridges are sharp and narrow.

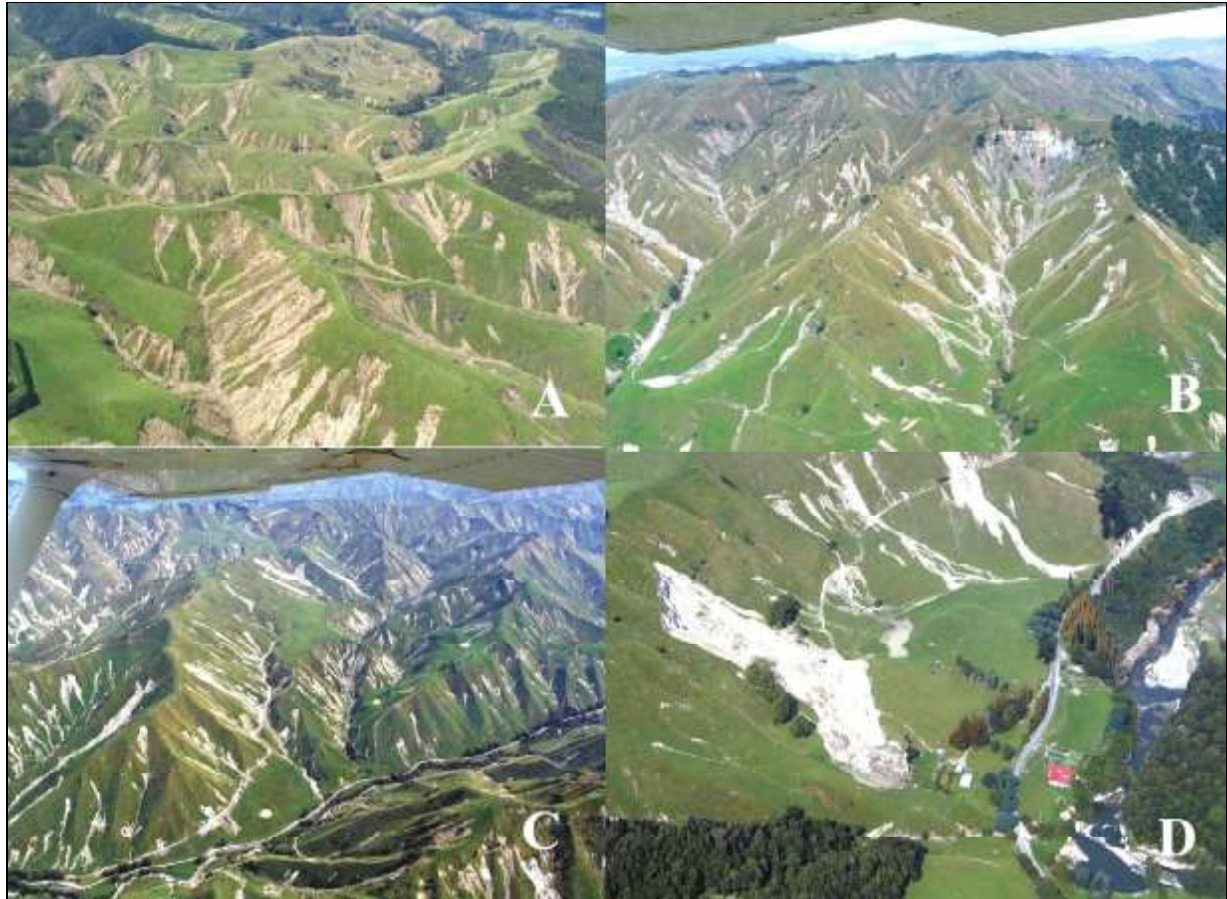
**Figure 10.** Typical landsliding caused by the February 2004 storm in different study areas.  
A – Shallow slipping in the weak sandstone (Us) unit in the Pohangina hill country.  
B – Shallow slipping on upper ridges of relatively strong (compact) sandstone (Sm) cap and soil flows in the underlying mudstone (Mm) slopes in the Whangaehu hill country.  
C – Both shallow and deeper seated slipping and flows in Mudstone (Mm) in Mangawhero hill country.  
D – Deep-seated rotational slide in mudstone in the Mangawhero River valley (*photos G. Hancox 2004*).

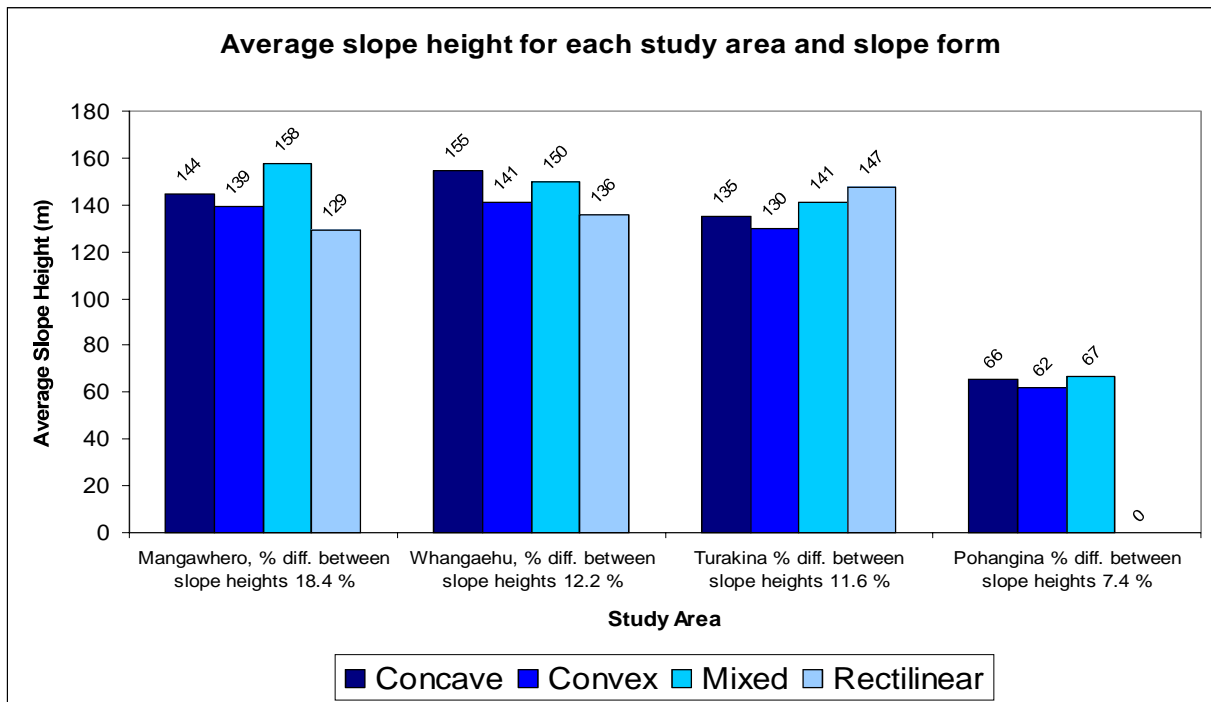
**Figure 12.** Classed by study area, the average heights are shown for slopes of different types present in each study area.

The Pohangina terrain is less than half the average slope height of the others whereas slope heights in the three Wanganui study areas are within 10 % of one another. A comparison of slope height in relation to slope form was also made; this is shown in Figures 12 and 13.

It can be seen that there is no apparent trend across study areas in terms of the highest slopes being related to particular slope forms. Pohangina shows little variation in slope height between slope forms (Figure 12), implying the terrain is far more regular in form.

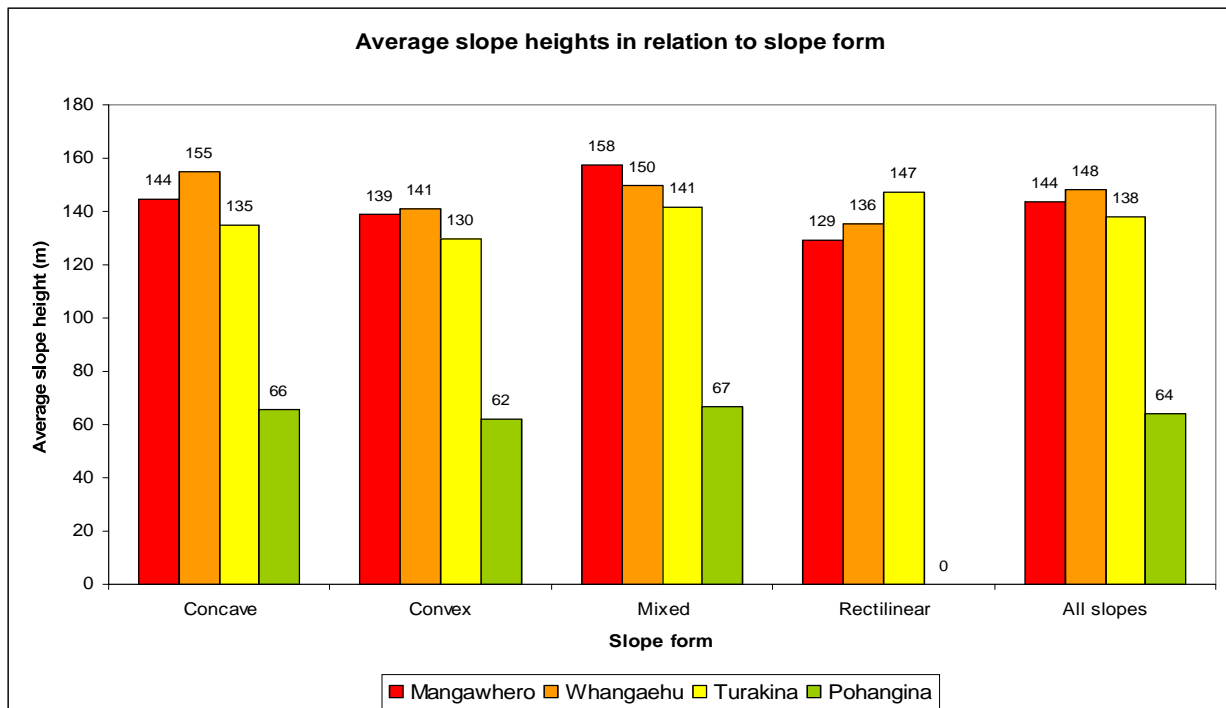
**Figure 13.** Average heights, classed by slope form in relation to the four study areas.

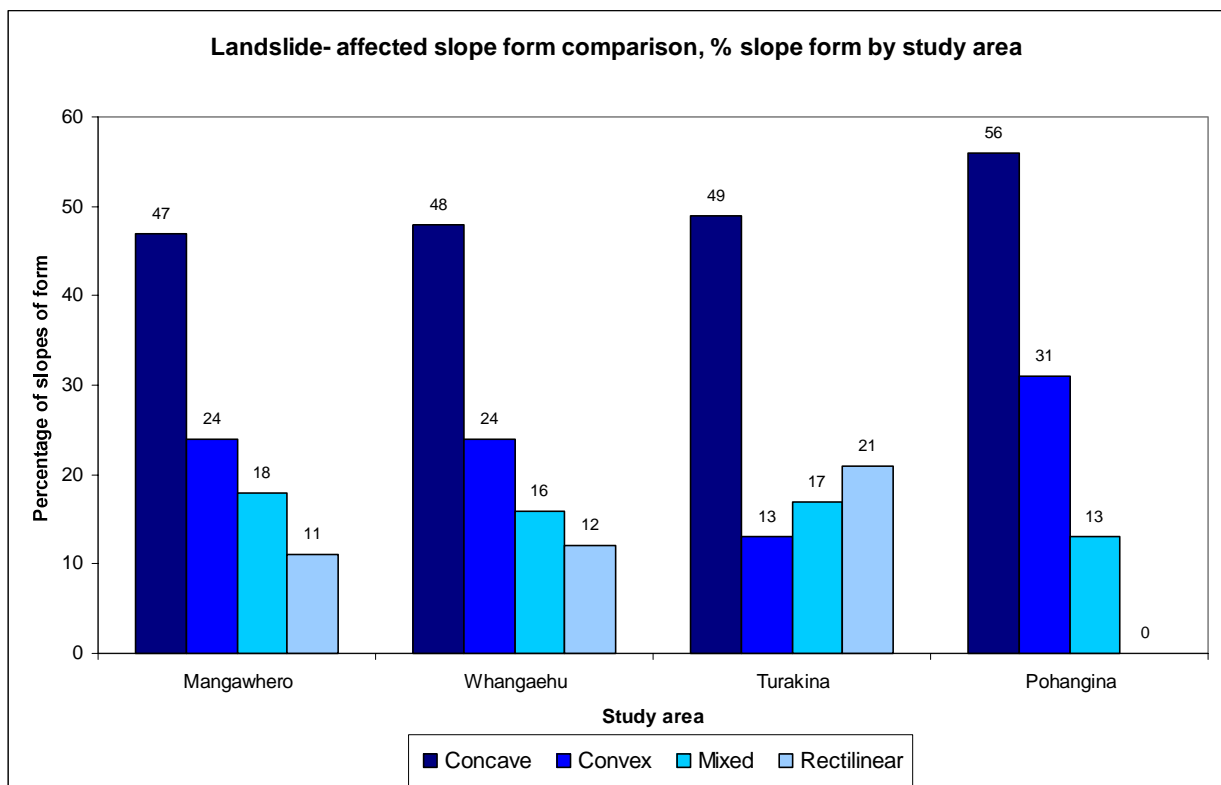
**Figure 14.** Percentage of slopes of each form by study area.

Slopes that had been affected by landsliding within the four study areas are separated into four classes: concave, convex, rectilinear, and mixed. Figures 14 and 15 show the data classed primarily by study area (Figure 14) and for comparison primarily by slope form (Figure 15). The slope-form data are summarised in Appendix 3.

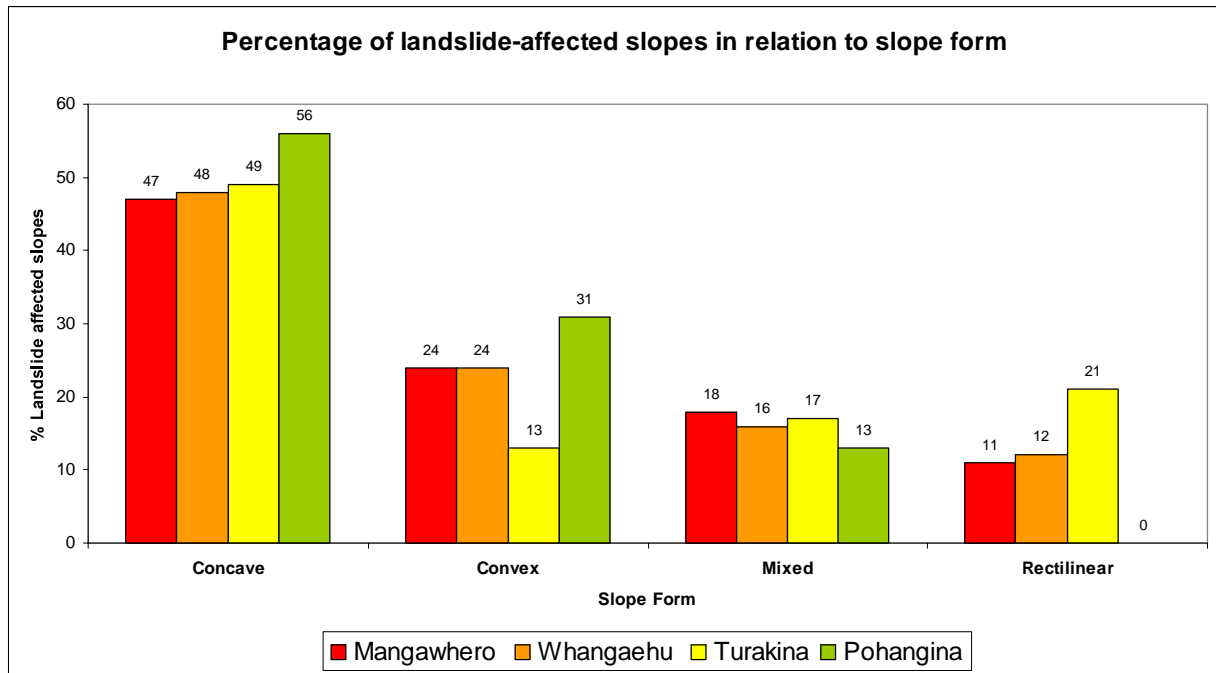
**Figure 15.** The percentage of landslide affected in each slope form class, the data are the same as in Figure 14 however, data are now grouped by slope form class. Clearly the majority of landslides in all study areas occurred on concave slopes..

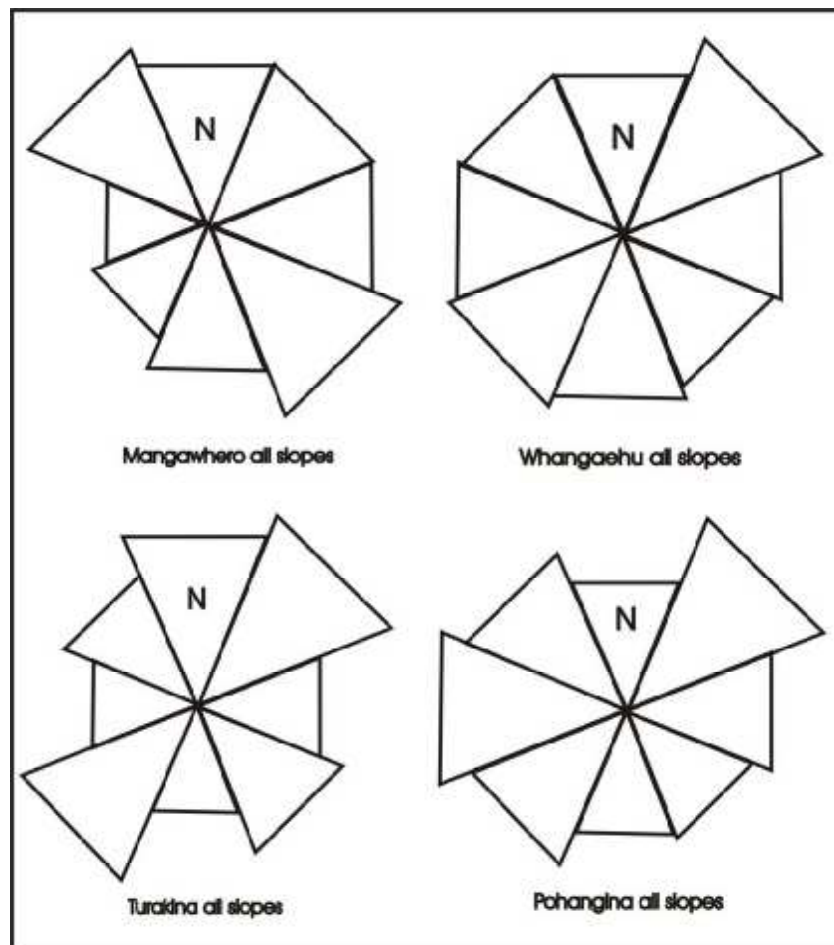
**Figure 17.** Aspect roses for all slopes within the four study areas. These show some variation between the 8 aspect classes (from average of 12.5% for each) but within areas the variations are not great.

From Figure 17 and Figure 18 it can be seen that landsliding aspect ratios do not correlate with aspect ratios for all slopes. It is also apparent that generally wetter south-facing (SW, S, SE) slopes appear least affected for all study areas. Antecedent rainfall conditions prior to the event suggest slopes were not close to saturation (pers. comm., John Medicott 2004); for these areas January and February are the driest months of the year with maximum evapotranspiration. The storm approached from a southerly direction for most of its duration; this would perhaps be expected to provide greater saturation, and hence greater landsliding on south-facing slopes. However, the ratio of landslide affected slopes as percentages of all slopes suggest that there is another control on preferential location of landsliding in the affected areas.

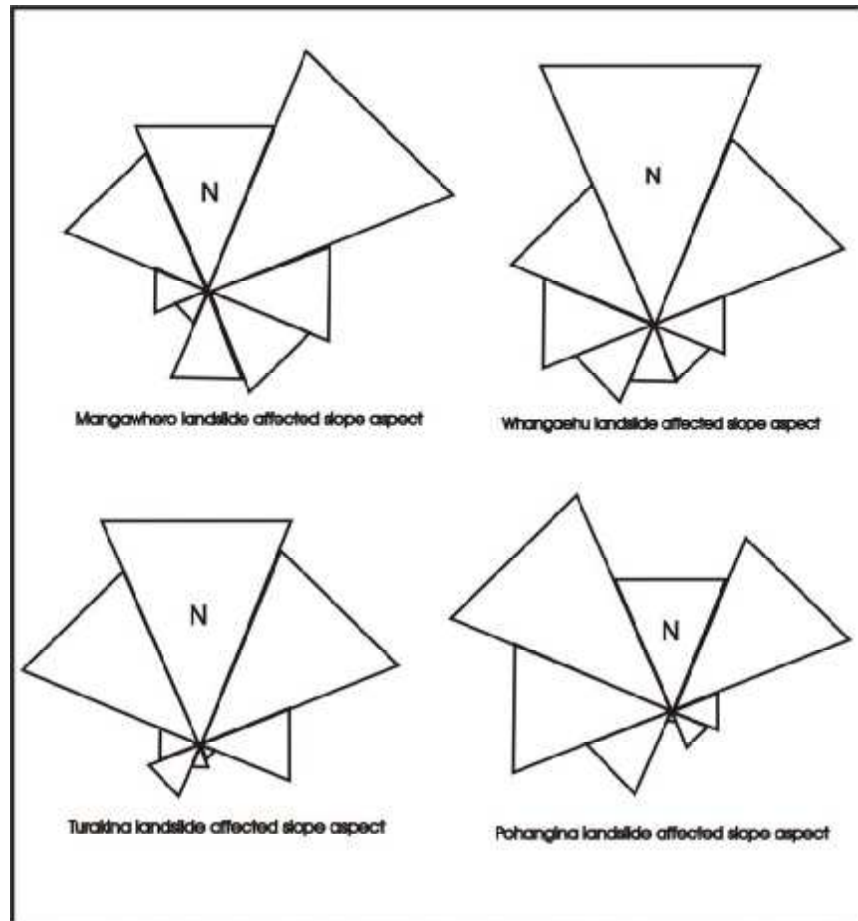
**Figure 18.** Aspect roses showing slopes affected by landsliding in the four study areas. Theoretically for an “ideal” landslide event landsliding preference would match all slope aspect classes for a given area, but all areas generally show landsliding preference on north-facing slopes (NW, N, and NE).

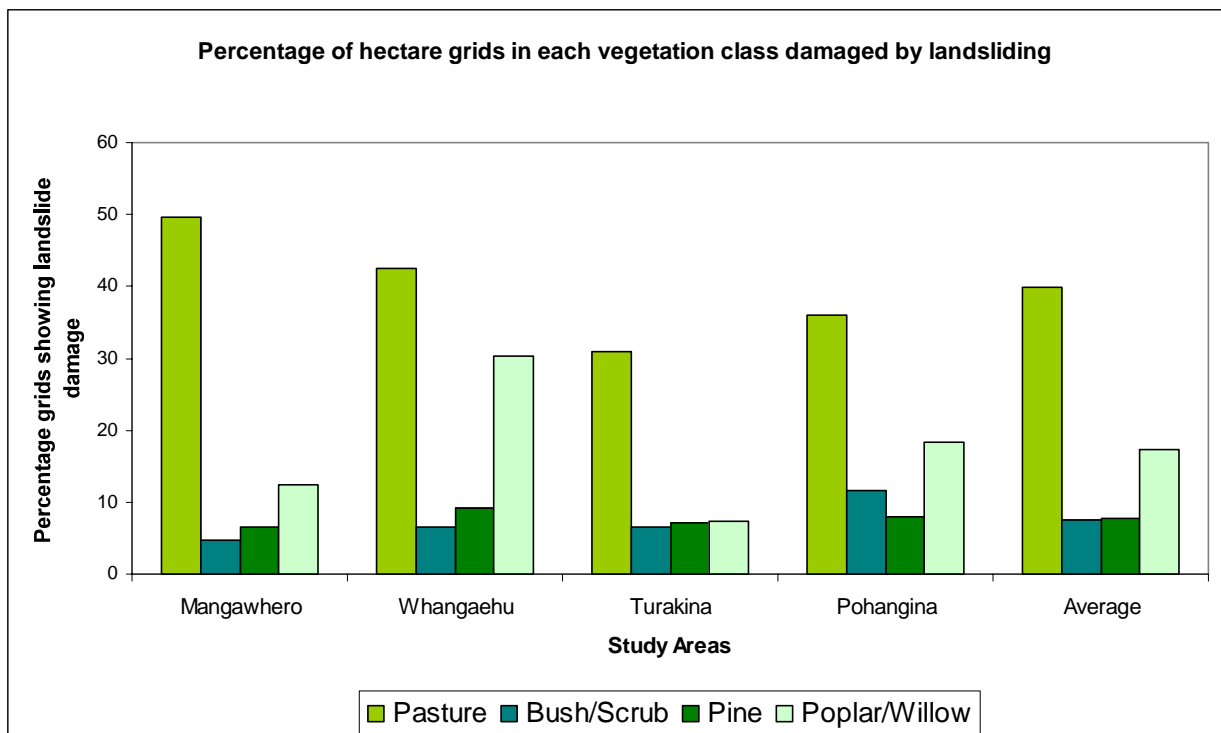
**Figure 20.** Proportion of vegetation class occupied by landslides for each of the four study areas.

Four classes of vegetation type were recognised: pasture, bush/scrub, pine, and poplar/willow. For each of the photographs, 1 km grid squares were overlaid on photos, referenced from the 1:50,000 NZMS 260 map. Each of these 1 km grid squares were then divided into 100 smaller grids, each one hectare in area. For each 1 km grid square the number of hectare grids of each vegetation class was counted, as well as the number of grids of each vegetation class that contained some landslide damage. These numbers were converted to percentages to reflect the density of landsliding in each vegetation class in the four study area (Figures 20 and 21).

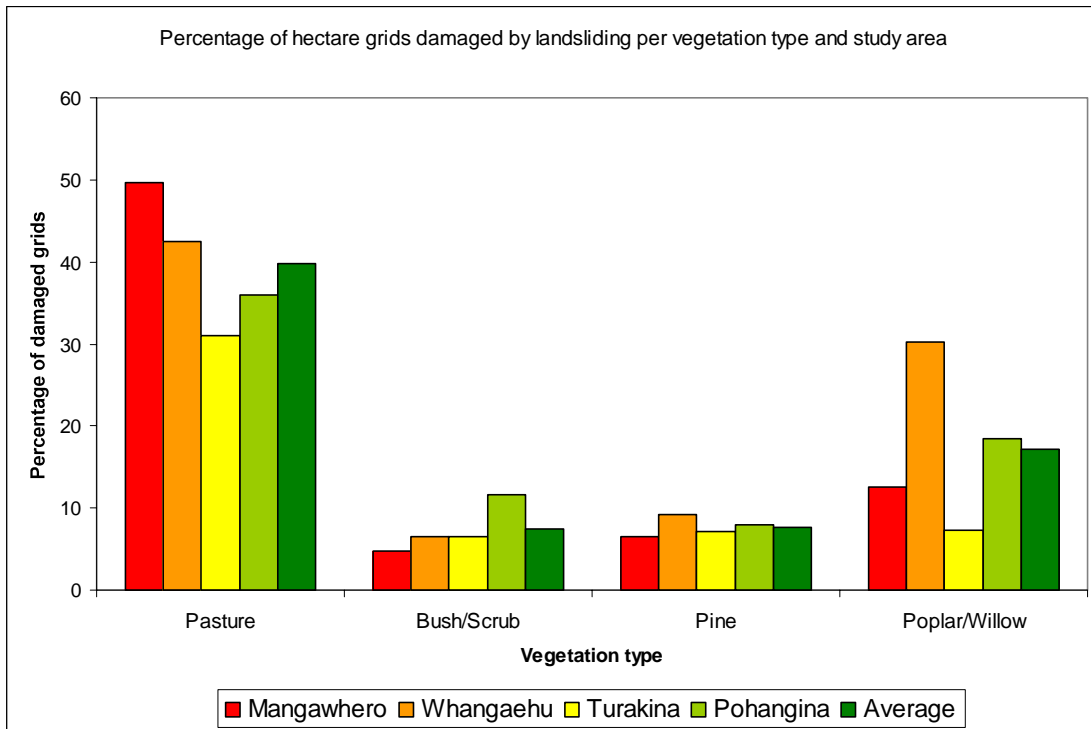
**Figure 21.** Percentages of grids occupied by landslides in study areas for each vegetation type.

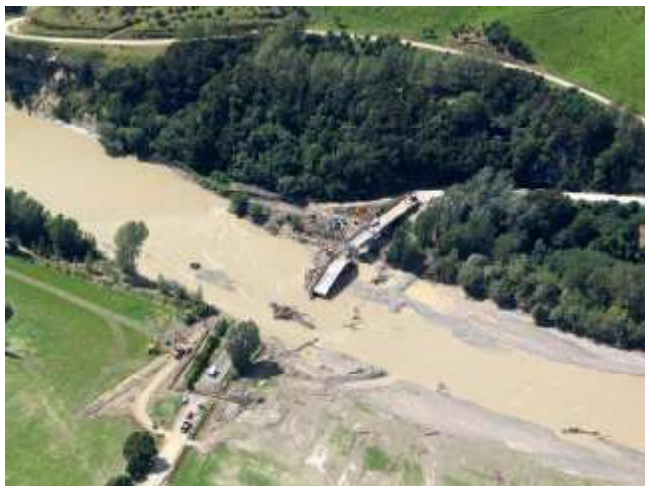
**Figure 22.** Loading of tree debris on bridge supports of the road bridge over the Pohangina River at Ashhurst contributed to its collapse during the flood. [GNS Photo: GH 1189].

A summary of vegetation and landslide data used for the analysis is presented in Appendix 5. Of the four main vegetation types, pasture (grassland) was clearly most affected by landslides in all four study areas. The percentage of landslide damage on pasture ranged from 31–49.6%, with an average of about 40%. Areas in native bush or scrub and pine forest had levels of landsliding averaging 7.5 % and 7.7 % respectively. However, in the Pohangina study area the percentage of landsliding in native bush and scrub was greater than other study areas, as there was considerable landsliding on river banks steepened by fluvial undercutting. Collapse of bush-covered riverbanks in the upper Pohangina valley probably was the source of the water-borne tree debris that contributed to the destruction of the road bridge at Ashhurst (Figure 22).

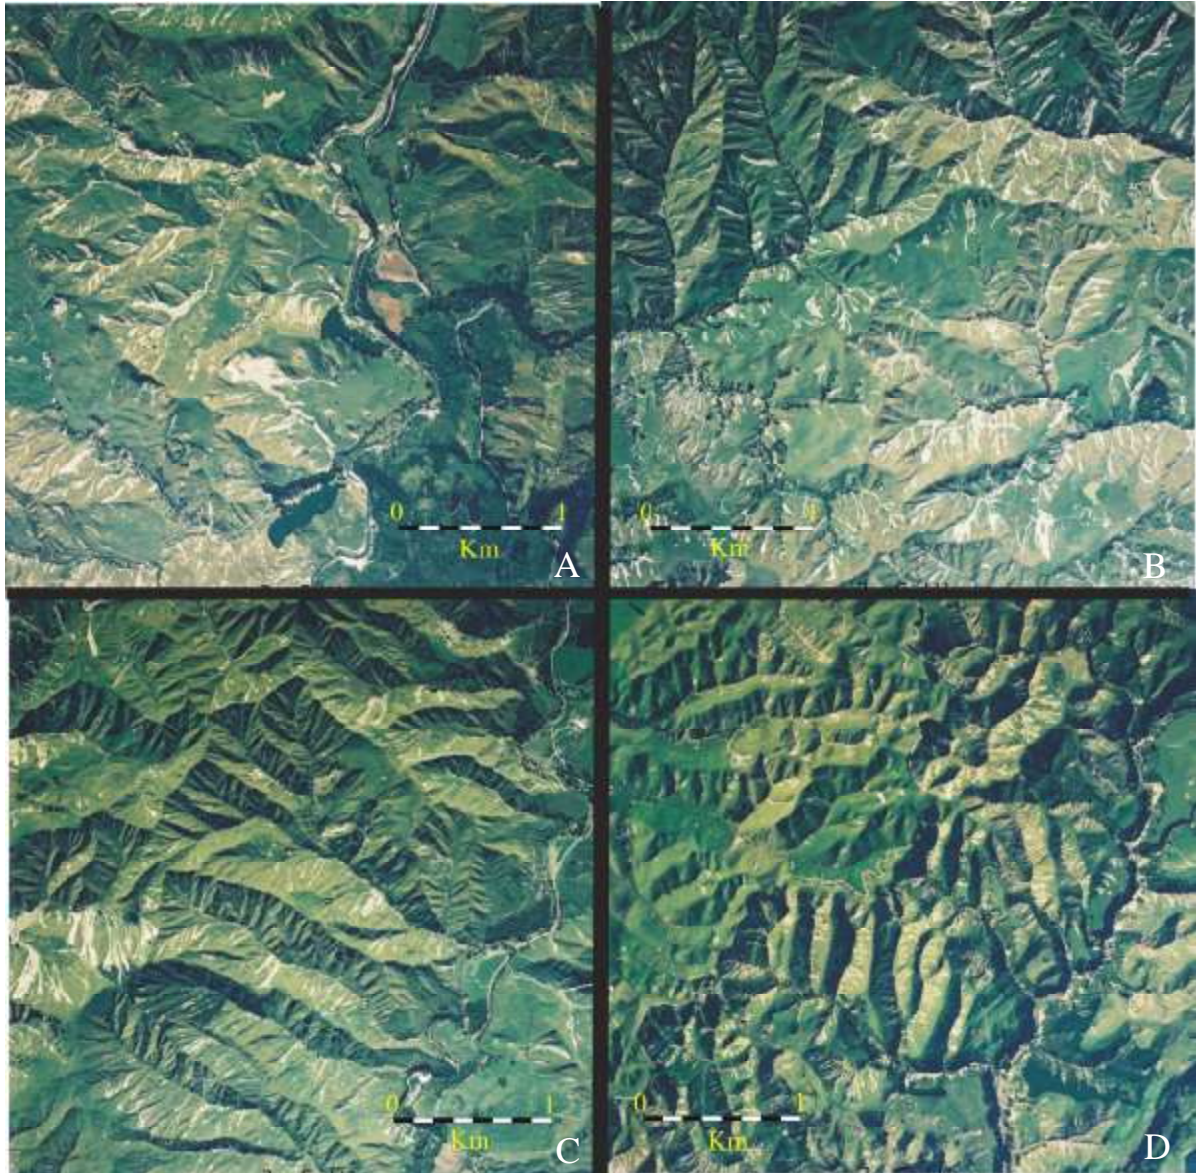
**Figure 23.** Four vertical aerial photos used for landslide counts in different study areas: A - Mangawhero, B - Whangaehu, C - Turakina, D – Pohangina (*original print scale 1:18 000*). These photos clearly show the differing landslide densities and styles of landsliding in the four areas. Note that the very large (~100 million m<sup>3</sup>) prehistoric Otoko Lakes landslide (bottom right, A) was unaffected by the rainstorm, as were many other very large prehistoric landslides in the region.

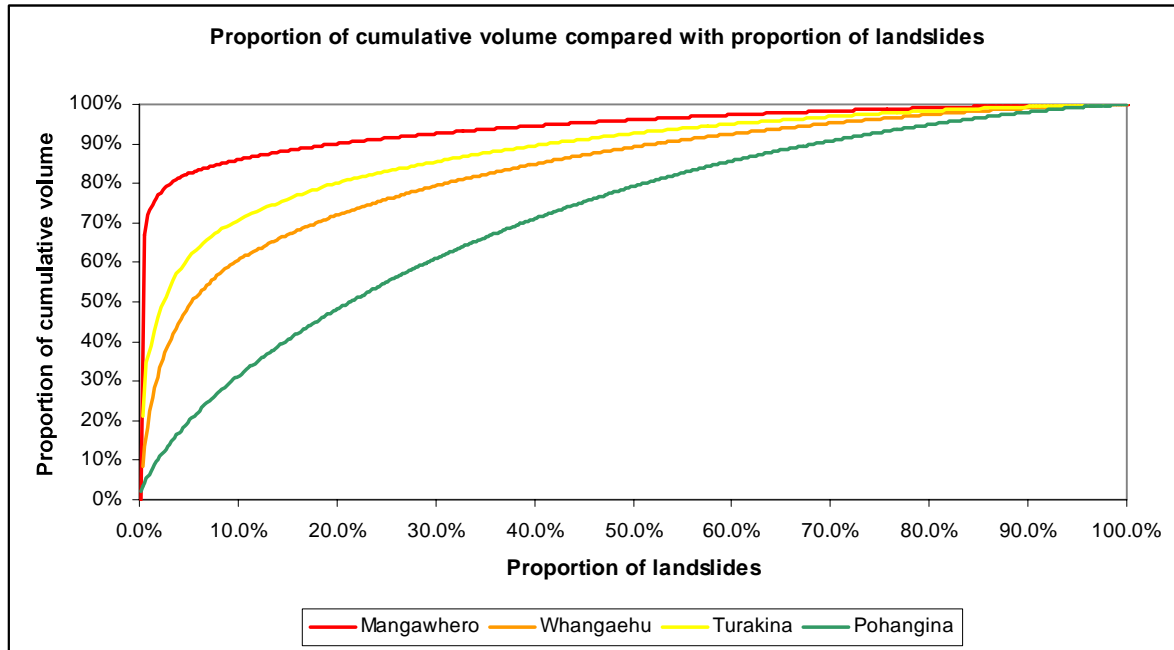
**Figure 24.** Proportional cumulative scar volume in relation to the proportion of landslides measured for each of the four study areas.

Landslide sizes were measured in representative areas of between 5.5 km<sup>2</sup> and 6.5 km<sup>2</sup> in each of the four study areas. This provided a dataset of at least 250 landslides for each study area, depending on landslide density. Approximate landslide sizes were determined by firstly measuring scar areas on highly magnified digital aerial photographs (using bar-scales with 10 m divisions to determine scar widths and lengths). Landslide scar volumes were then calculated using a default average depth of 0.5 m for most landslides; although for slides that appeared to be deep-seated a scar depth of 1.5 m was used. Landslide scar volumes were then calculated by multiplying measured areas by an inferred average depth (except where depths were known from field measurements, Wright 2005). A comparison of all data is shown in Figure 24. Proportional landslide cumulative volumes are shown compared with proportional number of landslides measured. Clear differences can be seen between the four study areas; for example the three Wanganui areas have curves that rise steeply indicating a high proportion of landslide erosion volume is produced by a low proportion of landslides (e.g. for Mangawhero approximately 5 % of landslides produce approximately 80 % of erosion for the landslides measured). The Pohangina data show a different relationship between cumulative scar volume and landslide number; the curve is gentler, showing a more even distribution of landslide sizes contributing to overall scar erosion volume.

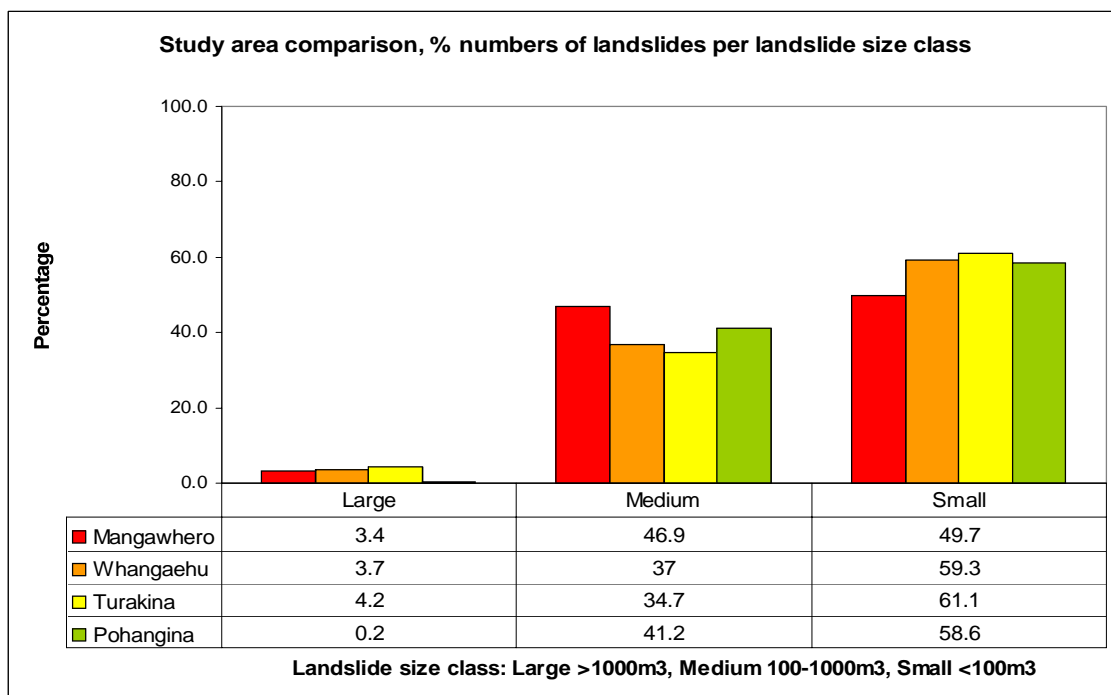
**Figure 25.** Graphs showing the number (%) of landslides in each size class.

A further analysis of the distribution of scar volumes and amount of material eroded was undertaken by assigning landslides measured one of three size classes as follows: *Large*: > 1000 m<sup>3</sup>; *Medium*: 100-1000 m<sup>3</sup>; and *Small*: < 100 m<sup>3</sup>. The landslide size data derived from this process was then analysed and plotted to show the proportion (numbers) of landslides (l/s) within each size class (Figure 25) and the proportion of landslide scar volume within each size class (Figure 26) for each of the study areas.

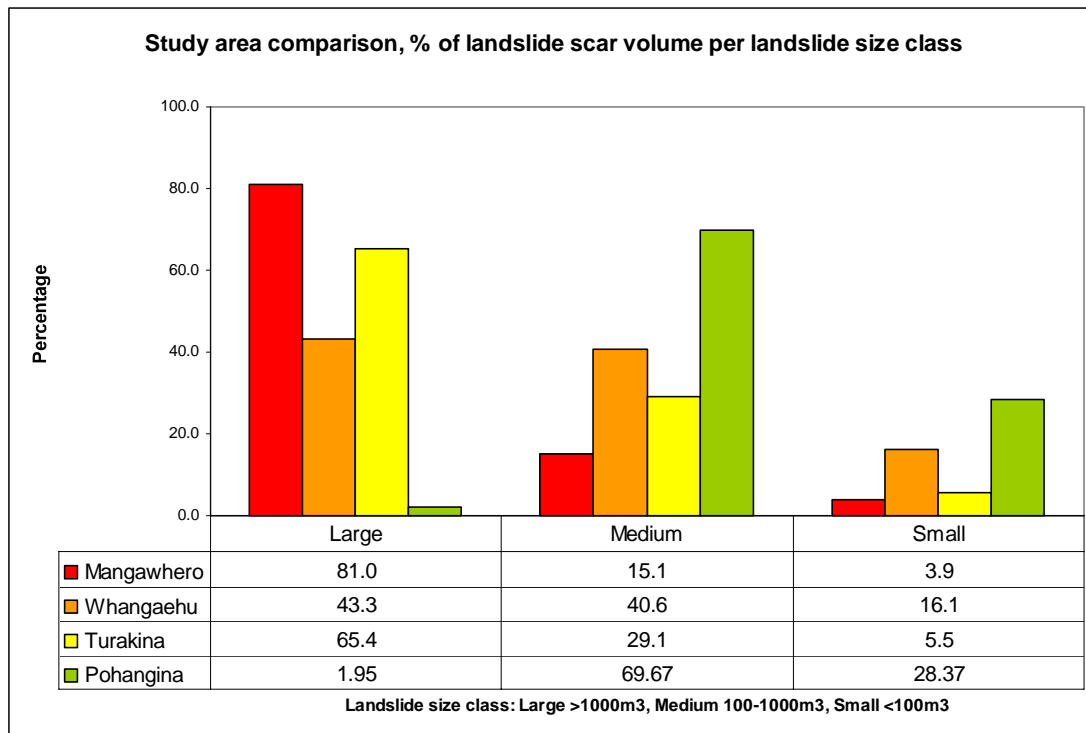
**Figure 26.** Comparison of the percentage contribution to total scar volume for each landslide size class, and for each study area shows greater variation between study areas than seen in Figure 24. The data table differentiates percentages that appear similar on the graph (particularly those of the Whangaehu study area).

There was some variation between the proportion of landslides in each size class in the Wanganui study areas (Mangawhero, Whangaehu and Turakina), but there was greater variance between those study areas and the Pohangina study area. For example, the proportion of large landslides for the three Wanganui study areas was found to be (east to west) 3.7 %, 3.4 %, and 4.2 %, while the percentage of large landslides in the Pohangina study area was only 0.19 % (these data in graphic format are presented in Appendix 8). Greater variation was found for the proportion of scar volume per size class. Only in the Pohangina area was it found that the large landslides did not contribute the greatest volume of landslide debris, where slides of medium size were of most significance in slide debris mobilisation.

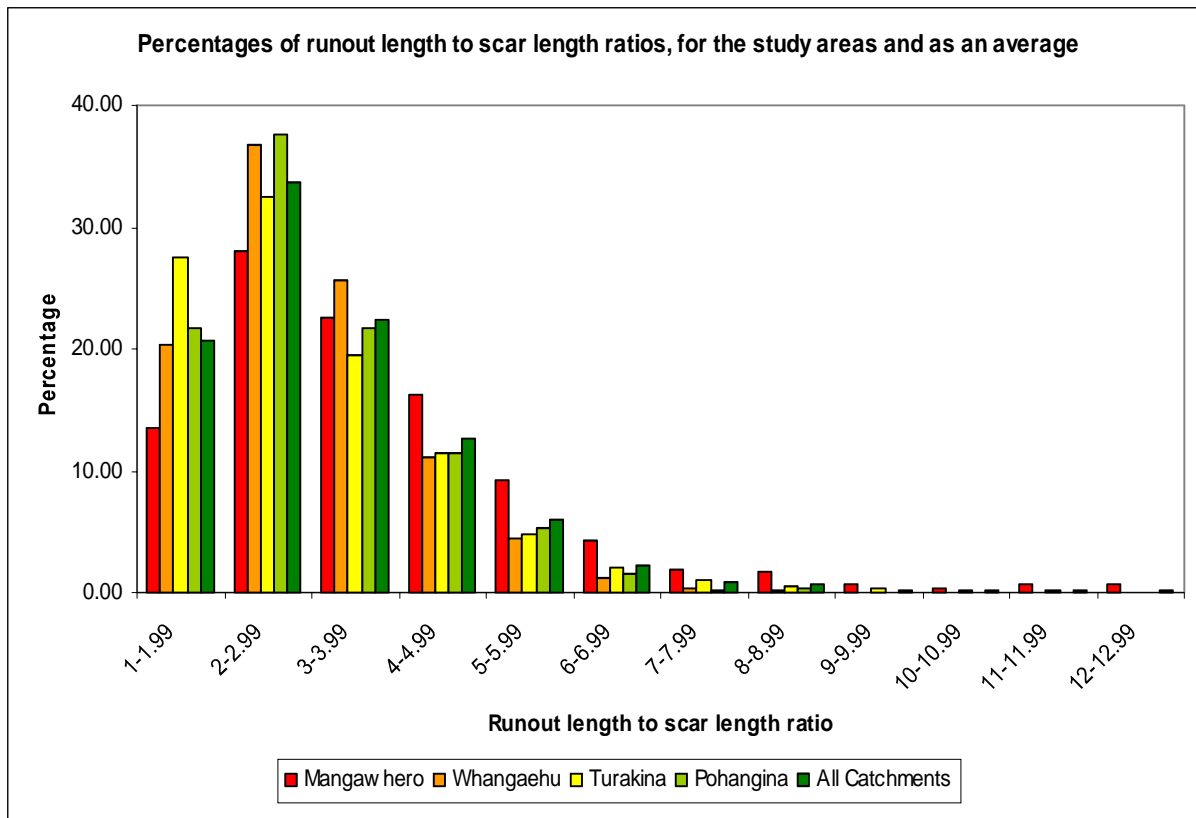
**Figure 28.** Graph showing the spread of landslide runout length to scar length data for the four sample areas. The Mangawhero area has very high ratios ( $>10:1$ ), and fewer low ratios ( $<2:1$ ). In general a similar spread of data and predominance of higher ratios applies to all four sample areas.

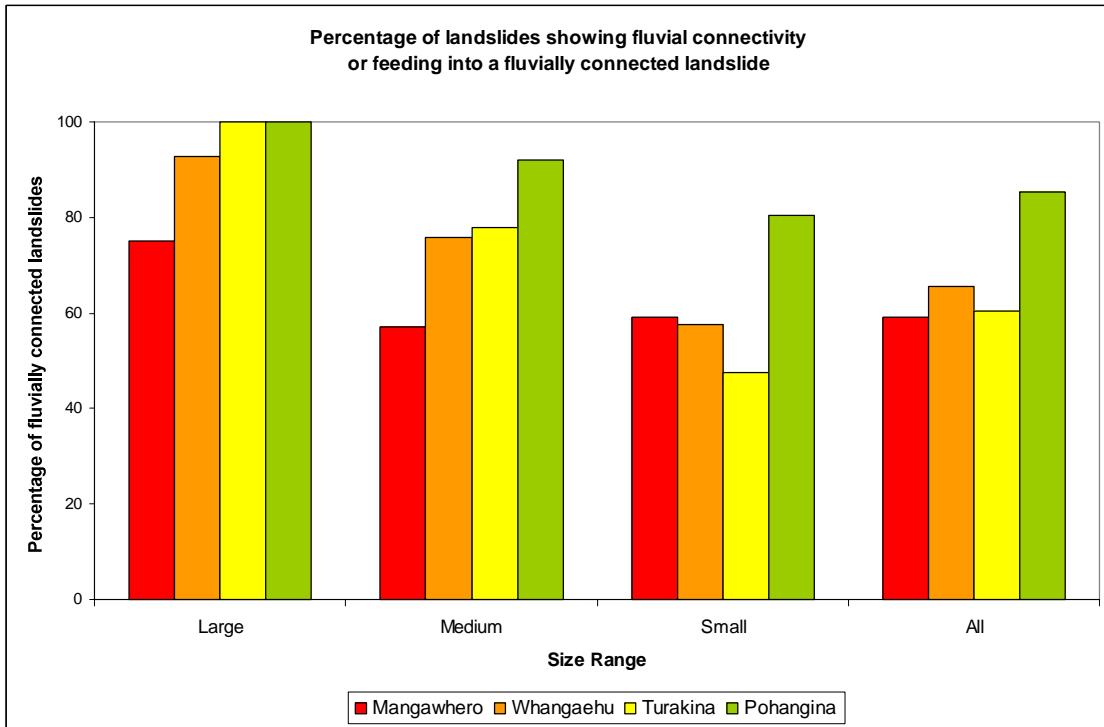
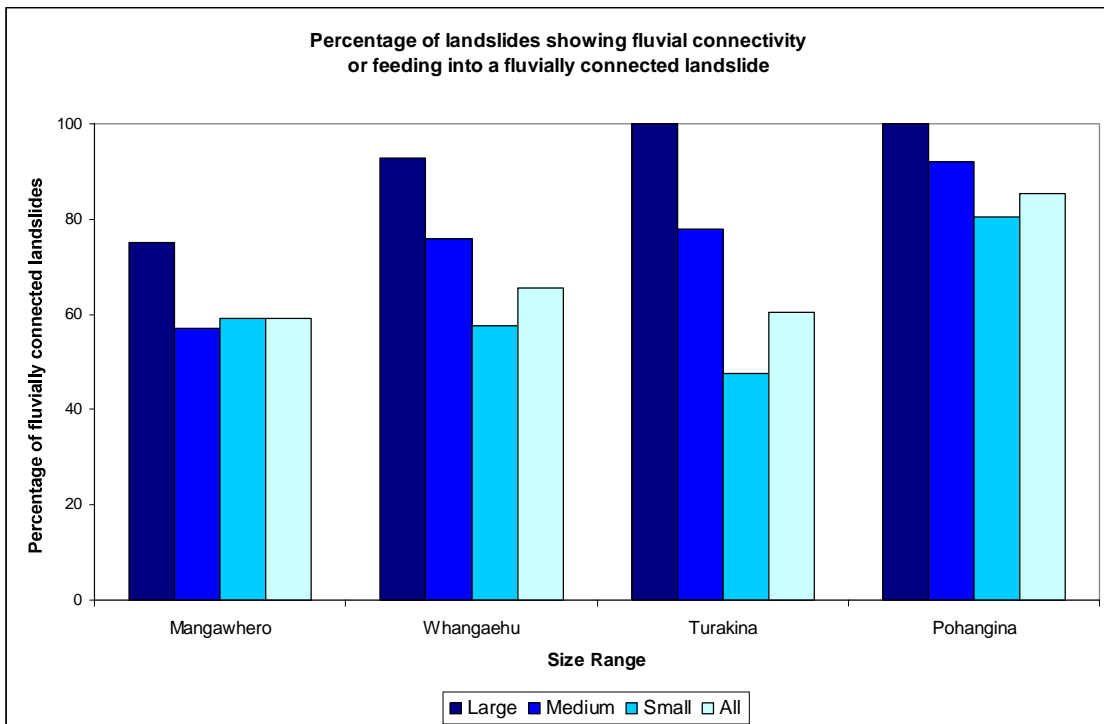
*Appendix 8: (b) Landslide size and fluvial-connectivity data*

*Note: Average values relate to fluvial connectivity (averages of all landslide data, not the different size classes)*
