Response to request for additional information pursuant to section 92 of the Resource Management Act 1991

This letter provides a response to the request for further information pursuant to section 92 of the Resource Management Act 1991 (RMA) received on 3 April 2020 (**Attachment 1**) in regard to the Application (APP-2017201552.00), for resource consents required to authorise the Te Ahu a Turanga: Manawatū Tararua Highway ('the Project').

Te Ahu a Turanga Project Response to request for further information under section 92

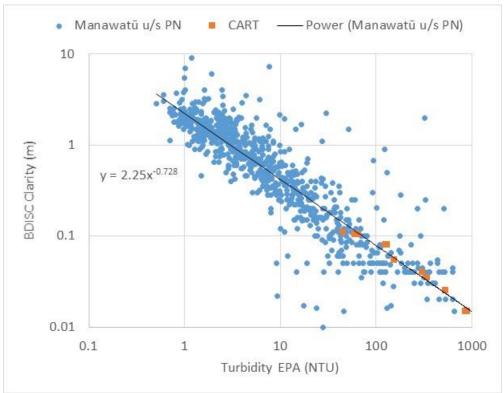
Figure 2: Relationship between turbidity and black disc clarity in the Manawatū River at Teachers College site, and in 1 hour CART bench tests (Appendix 1.A of Erosion and Sediment Control Plan).

Some caution is needed if using relationships between TSS and turbidity or clarity derived from the Manawatū River to apply as an end-of-pipe standard from erosion and sediment control devices. Figure 2 demonstrates that individual measurements show considerable scatter around the general relationship between turbidity and clarity. Consequently, the uncertainty of estimating a 'true' value will be higher when applying equations to a single spot measurement that might be used for comparison with a water quality standard, as compared to applying it to a mean or median of multiple measurements. The application proposes that turbidity and clarity are measured from sediment control devices and the results used to assess treatment effectiveness and to trigger management responses.

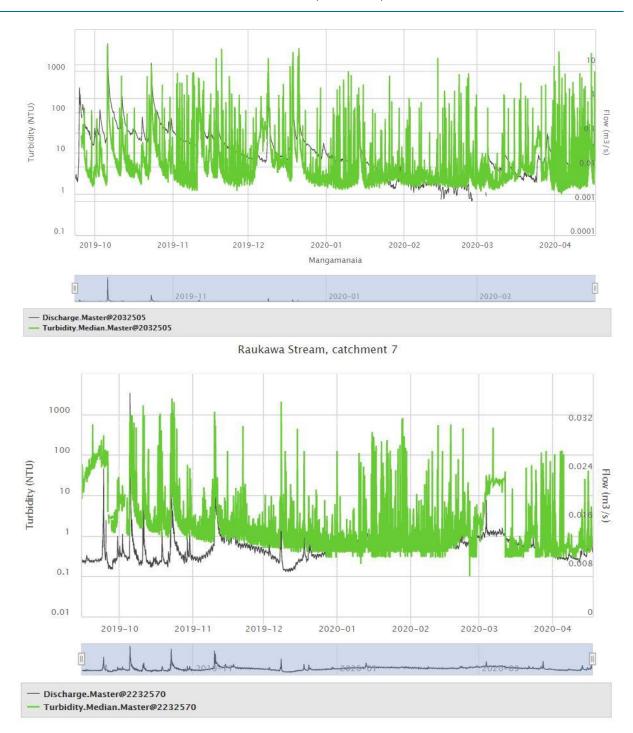
Figure 3: Turbidity in Top Graph - Catchment 2 (Mangamanaia Stream) and Bottom Graph - Catchment 7 (Raukawa Stream)

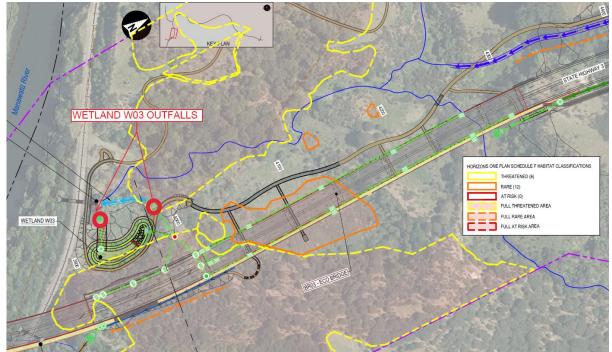
Figure 4: Wetland W03 discharge points

This is the only the stormwater treatment device located within a Schedule F habitat.

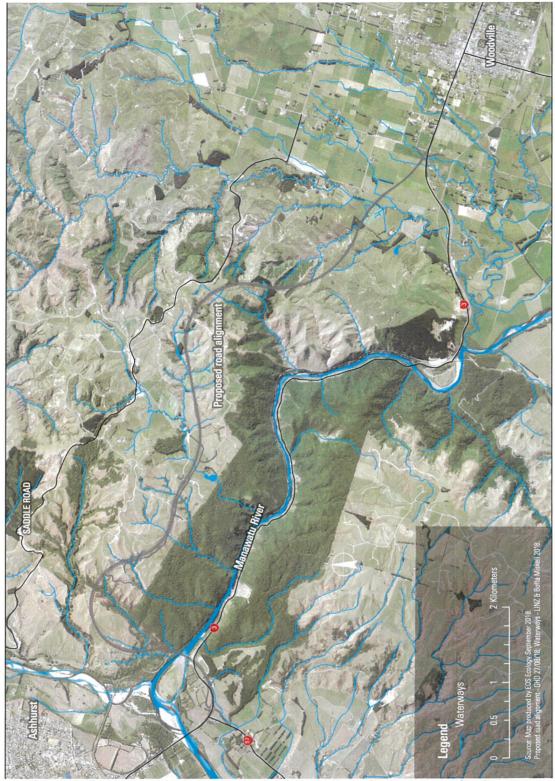
Figure 1 General overview of the Te Ahu a Turanga road alignment indicating the many waterways along the route.

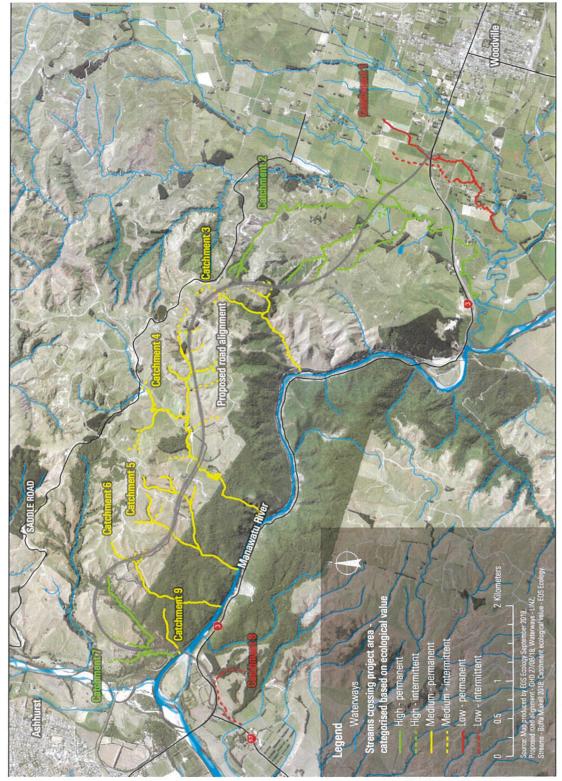
Figure 2 Map showing ecological values –risk ranking categories of the catchments affected by Te Ahu a Turanga.

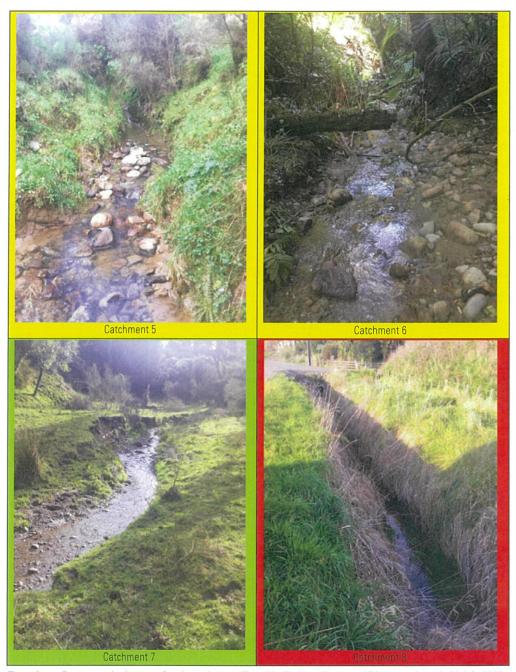
Figure 3

Representative images of each catchment affected by Te Ahu a Turanga. All images taken 16–20 July 2018 by Boffa Miskell. Shading reflects the ecological value groupings of the catchments (green = highest, yellow = medium, and red = low values) as identified in Table 2. An image of Catchment 9 is missing as to date no one has visited this catchment.

Based on the sum of the ranked parameters three ecological value-risk groupings were apparent (Table 2; Figure 2; Figure 3). Catchments 2 and 7 had the lowest sum of ranks (indicating the highest ecological value-risk conditions) and were clearly separated from all other sites (Table 2). These two catchments had relatively high fish and macroinvertebrate values, moderate to high overall SEV scores, and relatively long sections of the project within their catchments (Table 1). Catchments 5, 4, 3, and 6 form a medium ecological value-risk grouping (Table 2). These four sites include a range of conditions with Catchment 6 scoring relatively high for the macroinvertebrate and SEV parameters but only having a small section of the project within its catchment in contrast to Catchment 4, which scored low for macroinvertebrates and SEV but has some 2,250 m of project length with its catchment. Catchments 1 and 8 form a low ecological value-risk grouping with sum of ranks substantially higher than all other catchments (Table 2). An

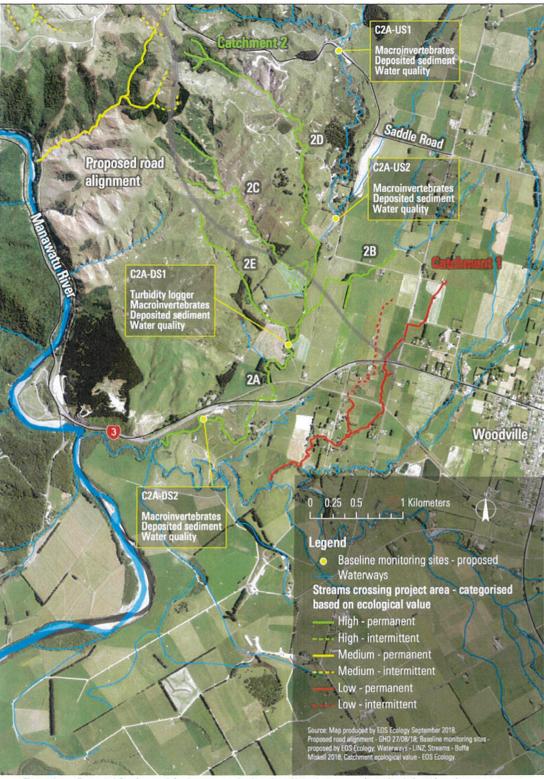
Figure 4

- » Water quality monitoring. Spot water quality samples will be collected and water clarity measured with a clarity tube in Catchment 2 from the four aquatic macroinvertebrate sites mentioned above (Figure 4).

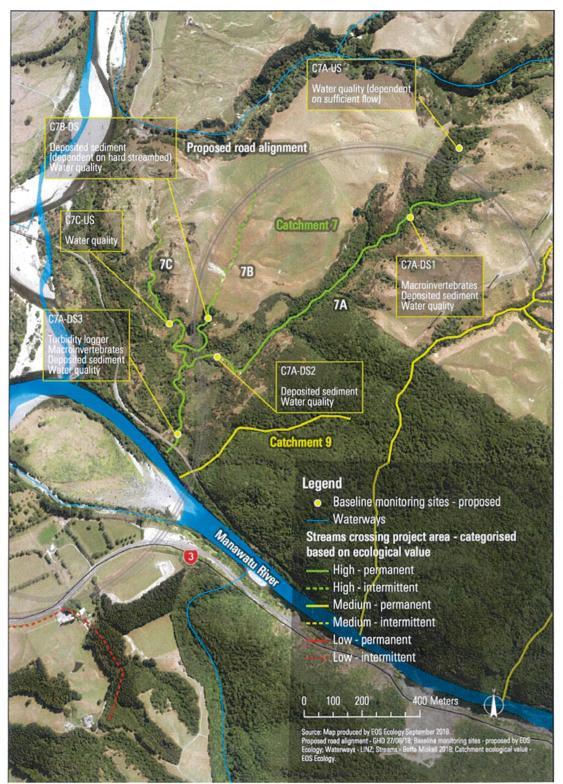
Figure 5

- Water quality monitoring. Spot water quality samples will be collected and water clarity measured with a clarity tube in Catchment 7 from five sites, three on the main stem (Sites C7A-DS1, C7A-DS2, and C7A-DS3), and two from small tributaries (C7B-DS and C7C-US). The C7C-US site is upstream of the project and will be a catchment control site (Figure 5). If possible samples will also be taken from the top of the catchment in the main branch (7A) from Site C7A-US although this will depend on sufficient surface water for accurate sampling being present.

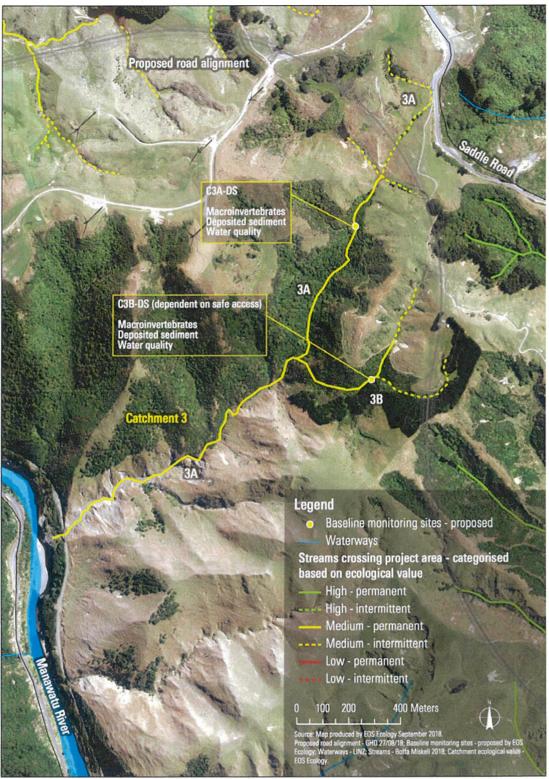
Figure 6

- » Water quality monitoring. Spot water quality samples will be collected and water clarity measured with a clarity tube in Catchment 3 from the same sites as the macroinvertebrate sampling. The data will form a baseline against which construction period and post-construction monitoring can be compared.

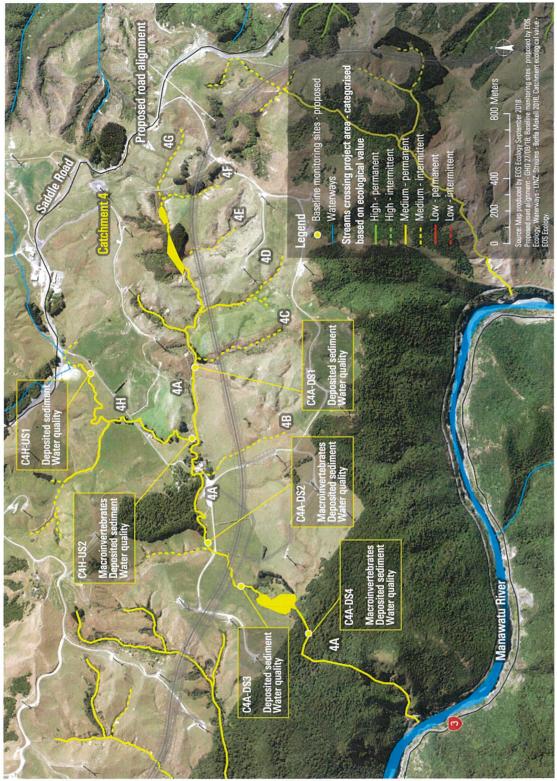
Figure 7 Proposed Catchment 4 freshwater monitoring sites. EOS Ecology added the "4H" channel label, as this channel was unlabelled in the Boffa Miskell GIS information.

- » **Water quality monitoring.** Spot water quality samples will be collected and water clarity measured with a clarity tube in Catchment 4 at the same deposited sediment sites mentioned above (Figure 7).

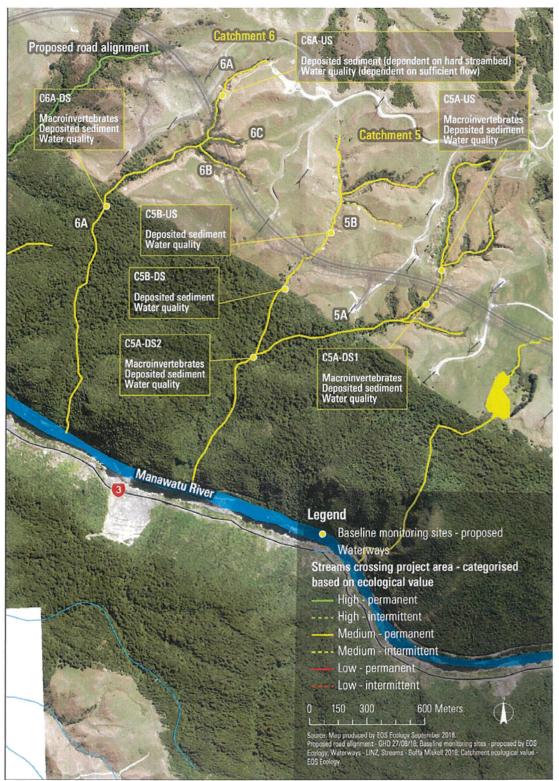
Figure 8

- » Water quality monitoring. Spot water quality samples will be collected and water clarity measured with a clarity tube in Catchment 5 at the same five deposited sediment monitoring sites mentioned above (Figure 8).

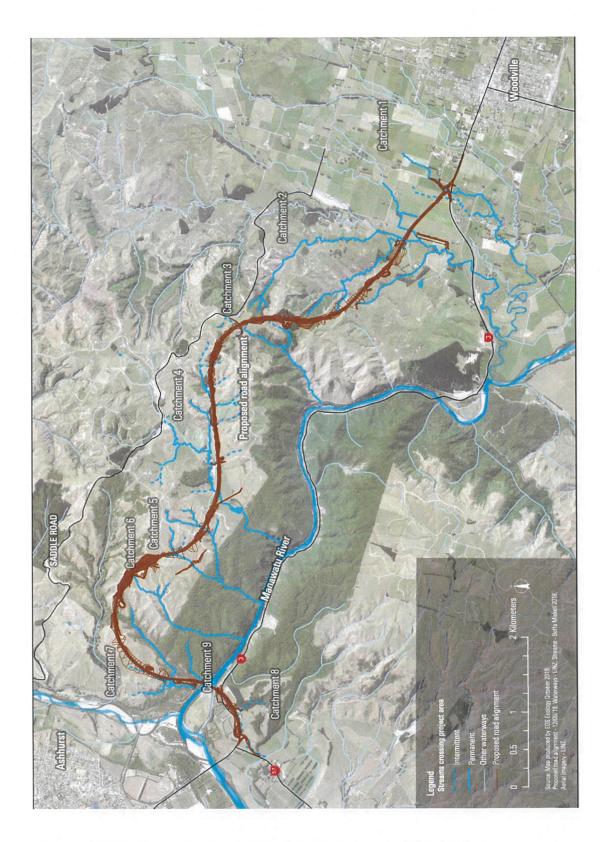
Figure 1 General overview of the Te Ahu a Turanga road alignment and location of affected catchments.

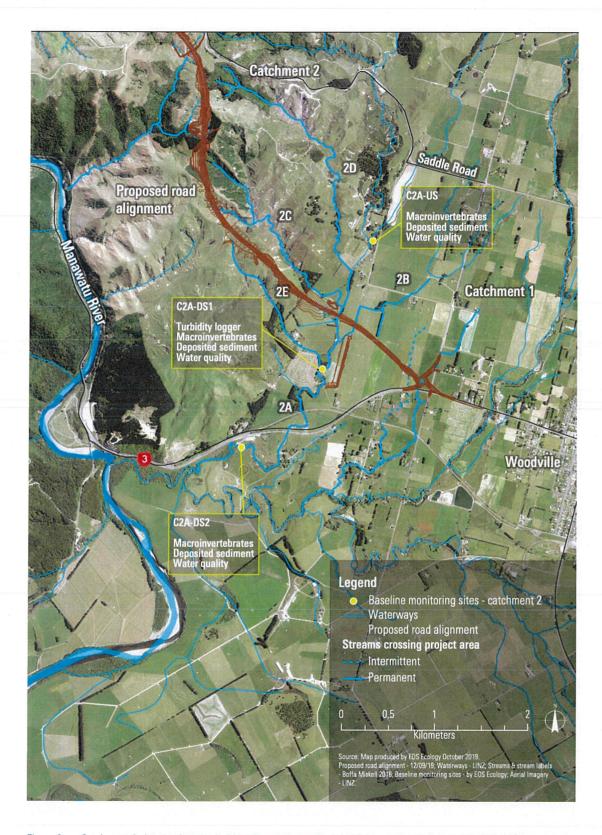
Figure 2 Catchment 2 showing locations of baseline water quality monitoring sites and proposed Te Ahu a Turanga alignment.

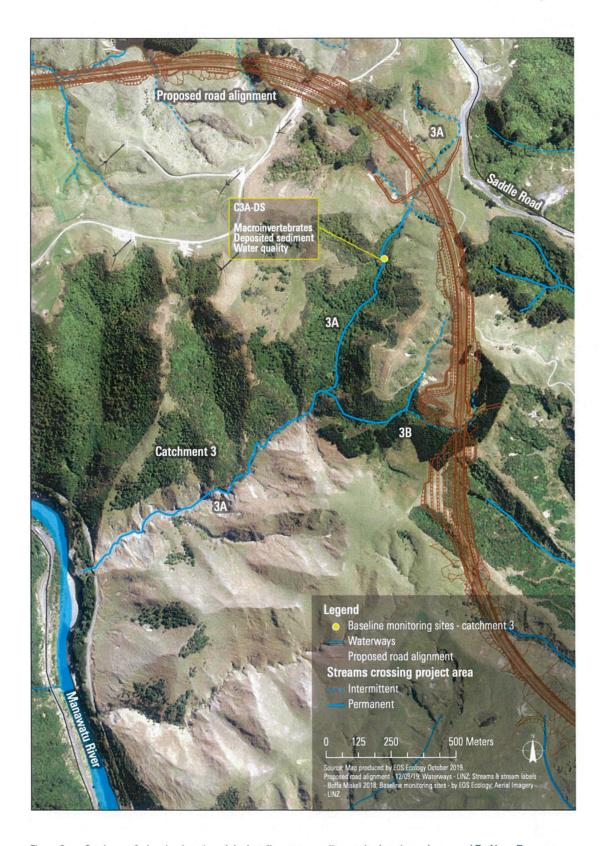
Figure 3 Catchment 3 showing location of the baseline water quality monitoring site and proposed Te Ahu a Turanga alignment.

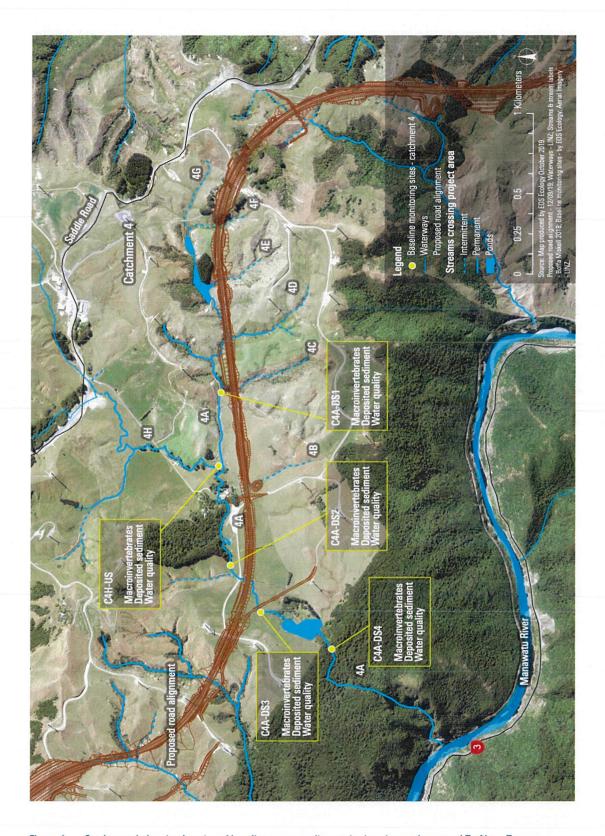
Figure 4 Catchment 4 showing location of baseline water quality monitoring sites and proposed Te Ahu a Turanga alignment.

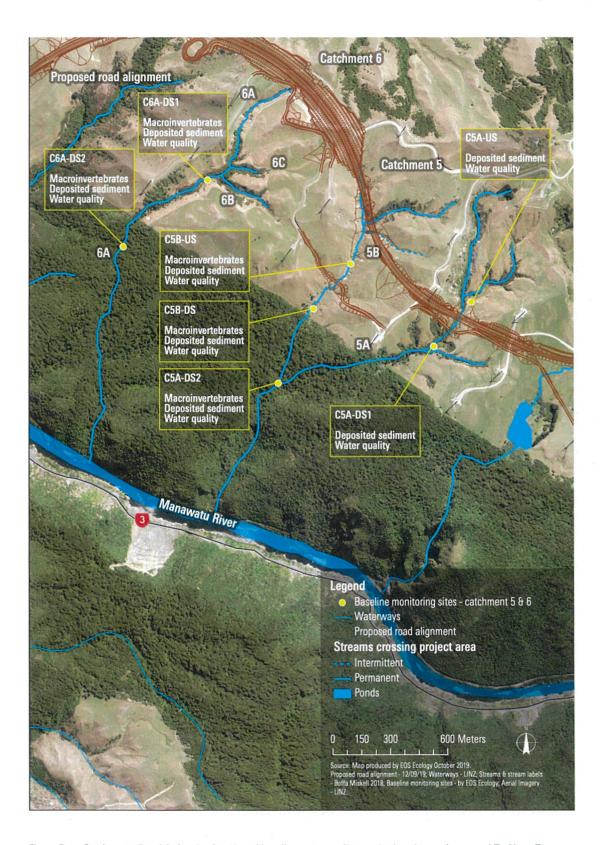
Figure 5 Catchments 5 and 6 showing location of baseline water quality monitoring sites and proposed Te Ahu a Turanga alignment. Note the proposed alignment has been shifted since sites were established such that site C5B-US is no longer upstream.

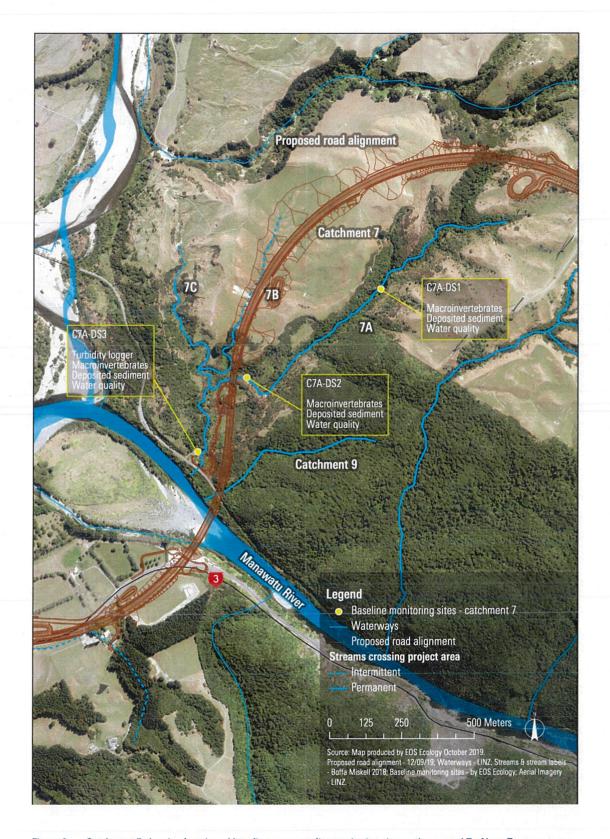
Figure 6 Catchment 7 showing location of baseline water quality monitoring sites and proposed Te Ahu a Turanga alignment.

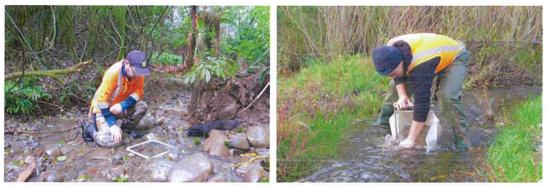
Figure 8 Some methods used during the Te Ahu a Turanga baseline freshwater monitoring survey.

Visually estimating deposited fine sediment cover

Collecting a macroinvertebrate Surber sample

Deposited fine sediment was measured on six occasions at each site using the "SAM 2 – In-stream visual assessment of sediment" of Clapcott *et al.* (2011). As most of the streams were too small to enable measurements across transects, we instead recorded deposited fine sediment cover percentage within 20 quadrats along a 50 m stream reach (Figure 8). We had originally planned to also use the "SAM 5 – Resuspendable sediment (Shuffle index)" method, however the small size and shallow water depths of most of the streams did not allow this to be effective. One site (C5A-US), which had an intermittently flowing channel and appeared to have a naturally bare earth streambed was not monitored, as this method is only for use in hard-bottomed, stony streams. Additionally, at another site (C4H-US) we missed a single sampling round as at the time of sampling the water was too turbid to adequately observe the stream bed. This was during low flow conditions and all other sites in the catchment were not overly turbid so there may have been cattle in the channel or some other disturbance upstream.

Spot water quality samples were collected at all sites and tested for total suspended solids (TSS) and turbidity by Central Environmental Laboratories (CEL) (Figure 8). At the same time, three replicate measurements of visual water clarity were taken using a clarity tube. Dry weather conditions were sampled on eight occasions from all sites, except for the intermittent site (C5A-US) which was only sampled when flowing. Wet weather samples were collected during rainfall events at all sites in Catchments 2 (four occasions), 4 (three occasions), and 7 (three occasions). After the programme had begun, we were asked by NZTA to add aluminium to the analysis, to obtain baseline concentrations of this metal which is often a component of flocculants used in sediment control systems. At this time pH was also added as the toxicity of aluminium varies with pH.

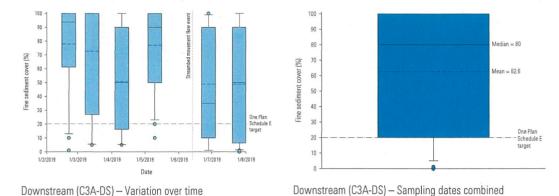
Figure 10 Deposited fine sediment cover at the single Catchment 3 sampling site. The graph on the left shows results over time, while the right graph combines sampling dates. The variation over time graph also includes a line indicating when a large rain event that caused streambed movement at some sites occurred. Dashed blue lines indicate mean values. All data collected by EOS Ecology.

The single Catchment 3 sampling site generally had fine deposited sediment percentages well above the One Plan Schedule E target of 20% cover, even after the mid-June high flow event (Figure 10). Combining sampling dates median and mean values were very similar to the upstream Catchment 2 site (C2A-US) (Figure 9, Figure 10).

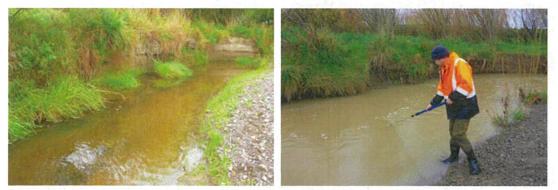
Figure 15 Representative images of Catchment 2 during dry weather conditions and wet weather events.

Site C2A-DS2, 14 March 2019 - dry weather

Site C2A-DS2, 6 September 2019 - wet weather

Mean water clarity in Catchment 2 during normal dry weather flows was in the "good" (C2A-US and C2A-DS1) to "fair" (C2A-DS2) categories (Figure 15; Figure 21). During rain events water clarity was in the "very poor" category, and there was a statistically significant difference between dry weather and wet weather samples (Figure 15; Figure 21; Table 4). Following rainfall, Catchment 2 had the lowest clarity values recorded across all catchments.

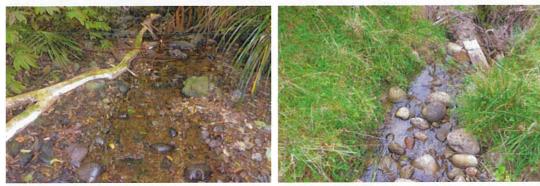
Figure 18 Representative images of Catchment 5 during dry weather conditions.

C5A-DS2, 11 April 2019

C5B-US, 11 April 2019

Mean water clarity at all the Catchment 5 sites were in the "poor" category during dry weather conditions, with no statistically significant differences among the sites (Figure 18; Figure 21; Table 4).

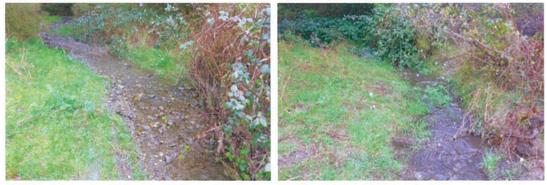
C7A-DS3, 13 September 2019 - dry weather

C7A-DS3, 14 March 2019 - wet weather

During dry weather conditions, mean water clarity in Catchment 7 was greatest (in the "good" category) at the upstream-most site (C7A-DS1), while the other two sites were in the "fair" category (Figure 21). Water clarity had statistically significant higher measurements at the upstream-most site (C7A-DS1) compared to the middle site (C7A-DS2) (Table 4). All sites in the catchment had significantly lower water clarity during rain events than during dry conditions (Figure 20; Figure 21; Table 4). However, during rain events the upstream-most site had average water clarity near the top of the "poor" category, which contrasts strongly with the "very poor" clarity observed at the other two sites (Figure 21).

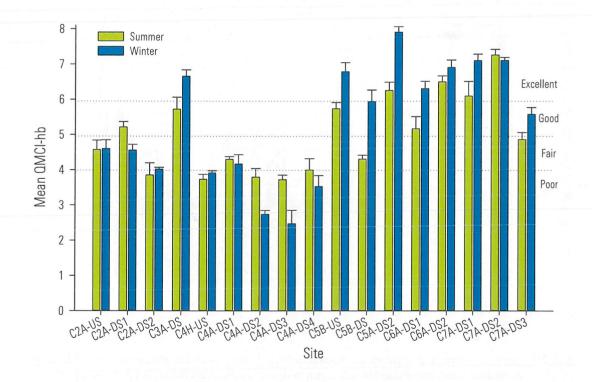
Figure 25 Mean MCI-hb and QMCI-hb scores for the 17 Te Ahu a Turanga baseline water quality sites where macroinvertebrates were sampled by EOS Ecology in summer (February) and winter (May (Catchment 2 only) and June) 2019. Error bars are one standard error.

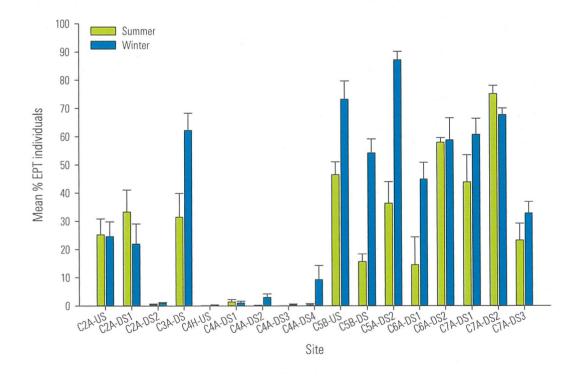
Figure 26 Mean EPT taxa richness and percentage EPT individuals for the 17 Te Ahu a Turanga baseline water quality sites where macroinvertebrates were sampled by EOS Ecology in summer (February) and winter (May (Catchment 2 only) and June) 2019. Error bars are one standard error.

EPT taxa richness and percentage EPT individuals were clearly least at the Catchment 4 sites (Figure 26). EPT taxa richness was greatest at two Catchment 2 sites (C2A-US, C2A-DS1), one Catchment 5 site (C5A-DS2), and was particularly high at the C7A-DS2 Catchment 7 site during the winter sampling (Figure 26). EPT percentage individuals were generally highest in Catchments 3, 5, 6, and 7, with values typically being greater during the winter sampling (Figure 26).

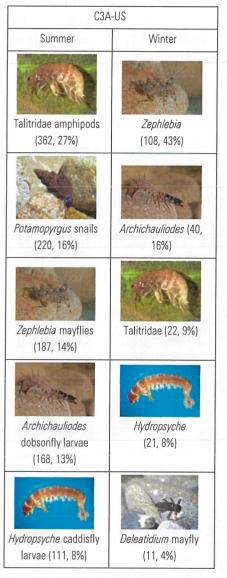
Figure 29 The five most abundant macroinvertebrate taxa at the sampling site in Catchment 3 during summer and winter. The values shown are the total densities from five Surber samples (0.45 m²) and the percentage relative abundance. The *Hydropsyche* caddisfly larvae present would have been *Orthopsyche* prior to the reclassification of New Zealand hydropsychidae genera by Geraci *et al.* (2010).

The Catchment 3 site was dominated by a mix of taxa tolerant (e.g., Talitridae amiphipods, *Potamopyrgus* snails) and relatively intolerant (e.g., *Hydropsyche* caddisflies and *Deleatidium* mayflies) of elevated fine sediment deposition (Figure 29). Four of the five dominant taxa were common between the summer and winter samplings. MCI and QMCI scores were indicative of "good" conditions in summer, with this raising to "excellent" in winter (Figure 25). Catchment 3, with full forest cover for much of its length, is one of the higher quality waterways affected by the project.

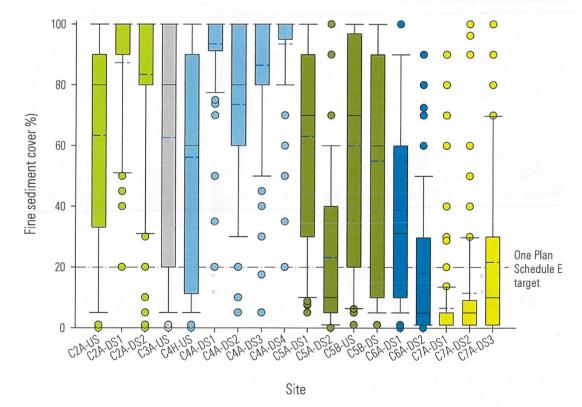
Figure 34 Deposited fine sediment cover from the 18 Te Ahu a Turanga baseline water quality sampling sites measured on six occasions between February and August 2019. All six sampling occasions for each site are combined. Dashed blue lines indicate mean values. The One Plan Schedule E target for deposited fine sediment of 20% cover is shown to give context to the results.

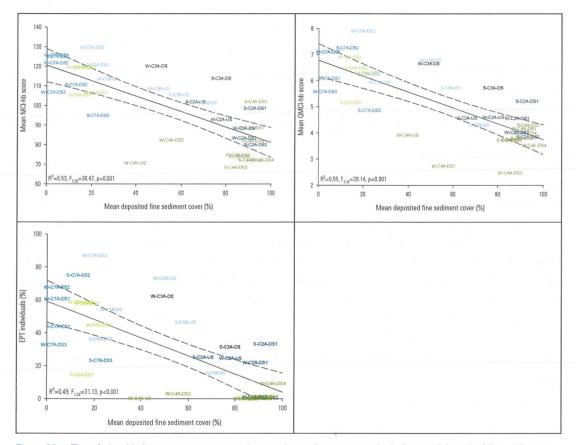
Figure 35 The relationship between common aquatic macroinvertebrate community indices and deposited fine sediment cover from the 17 baseline sites where macroinvertebrates were sampled in summer and winter 2019. Deposited fine sediment cover data from the day of macroinvertebrate sampling was used in the analysis. Linear regression results are shown. Dashed lines are 95% confidence levels.

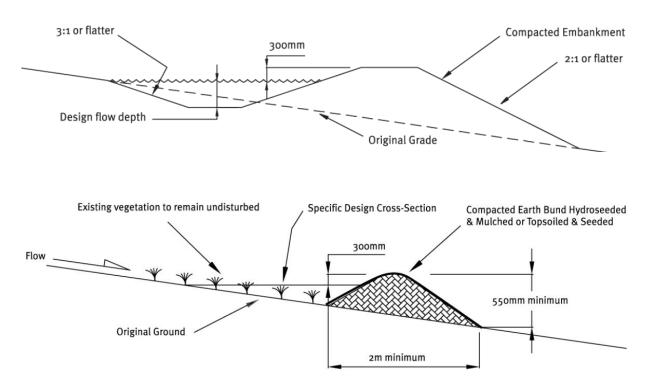
Figure 1: Perimeter bund cross-sections.

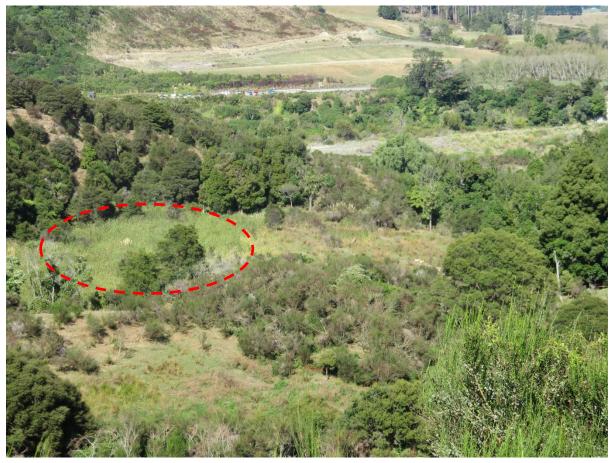
Figure 1-1 : Location of the raupō-dominated wetland on the elevated terrace above Stream 7.

Item 16 of Horizons' s92 request for further information relates to the maintenance of the hydrological integrity of the raupō-dominated seepage wetlands; located above the true left bank of the lower reaches of Stream 7. Specifically:

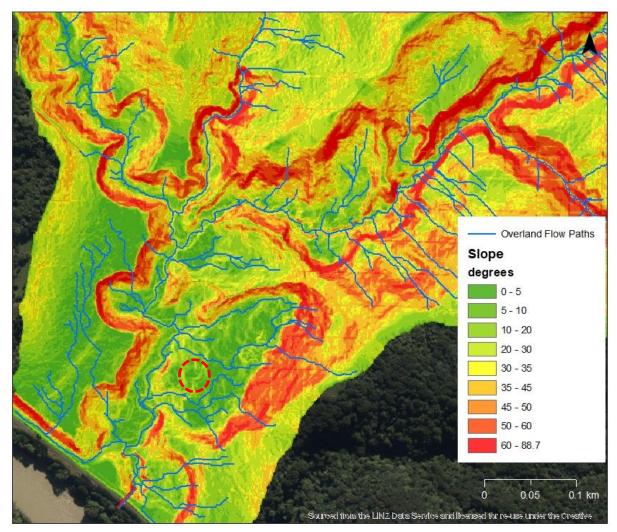
Figure 2-1: Slopes in the lower reaches of Stream 7. The area of generally 'flat' terrain that hosts the Raupō-dominated wetlands is highlighted (red circle).

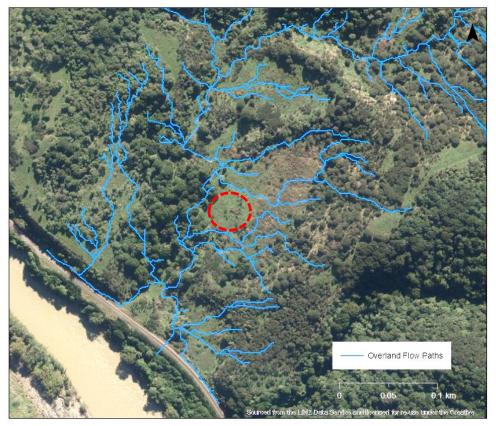
Figure 2-2: Potential overland flow paths. The area of generally 'flat' terrain with no drainage network that hosts the raupō-dominated wetlands is highlighted (red circle).

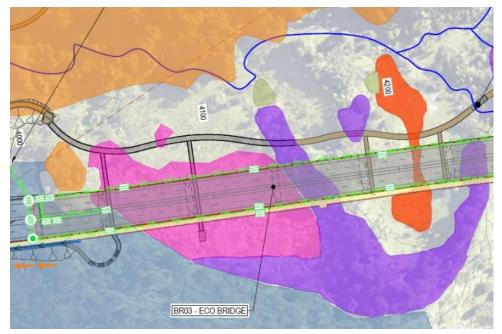
Figure 3-1: Proposed works near the raupō-dominated wetlands (preliminary drawings).

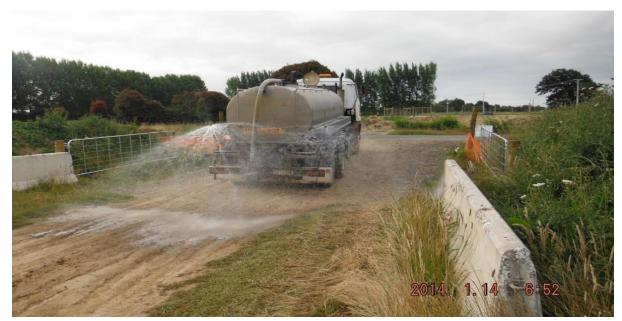
Photo 1: Water Cart in Operation

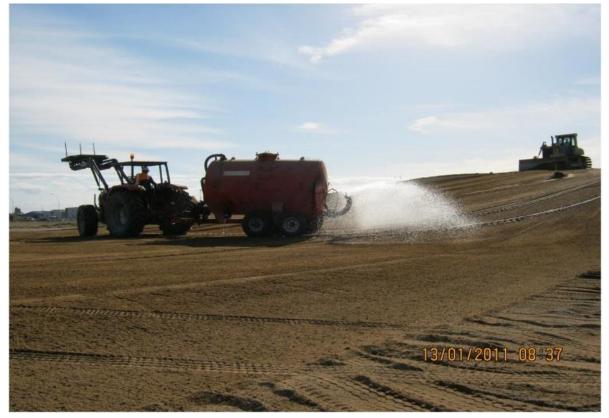
Photo 2: Water Tanker in Operation

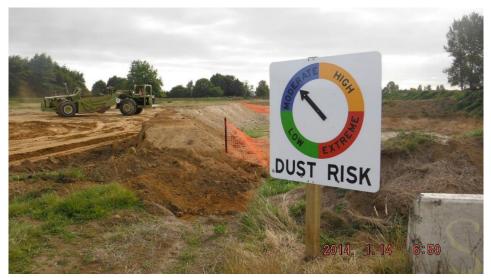
Photo 3: Dust Risk Signs will assist with Communicating the Risk to Construction Staff
