# Ohura Water Loss Analysis

Prepared for RDC  
Prepared by Veolia

July 2021

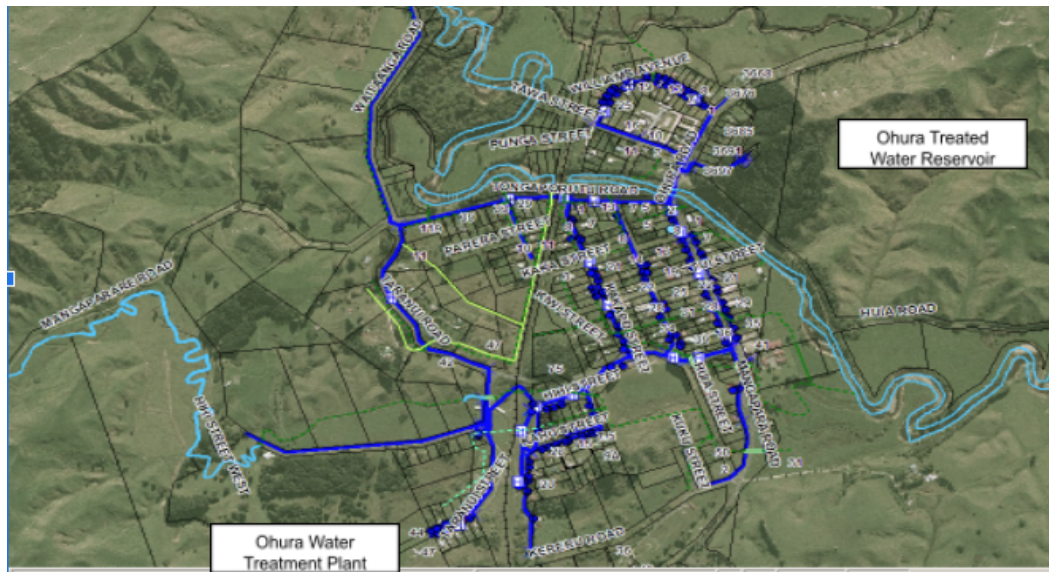
Ohura water network

On 08/07/2021 water shut downs were scheduled from 00:30am to 05:30 am. Over one night, three zones were isolated independently so the flow rate through the temporary meter could be recorded. Night time is when reservoir outflow is at its lowest and generally very consistent. Approximately  $5\text{m}^3/\text{hr}$  (this rate has been increasing over the last few months) has been recorded as the average night time demand.

The northern part of the network was isolated first. This zone is located at the northern part of the water network. One network isolation valve was operated to interrupt the flow from the reservoir into this part of the network which included Williams Ave and Matai Street. The flow through the meter was recorded once the flow rate was stable. During the time this area of the water network remained isolated, no significant changes were recorded to the reservoir outflow. An average flow rate of 4.6m<sup>3</sup>/hr was recorded.

The second zone was identified as the more central area in the network. Here is where the water demand significantly dropped while this zone was isolated from the supply. Four network valves were used to fully isolate zone 2. During the interval of time when zone 2 was offline, the flow through the meter dropped to approximately 1m<sup>3</sup>/hr. This area includes Ngarimu Road, Huia, Kakapo and Hihi Streets.

Finally, a third zone was assessed. This zone covered the largest covered area but with smaller diameter main pipes and fewer connections. This zone included the outskirts of the network, where there is a possibility of unknown connections possibly feeding farms and lifestyle properties. An average flow of 4.8m<sup>3</sup>/hr was detected through the meter. No significant drop was detected in flow rates while this zone was isolated.
