BY **WAKA KOTAHI NZ TRANSPORT AGENCY**

ŌTAKI TO NORTH OF LEVIN HIGHWAY PROJECT

TECHNICAL ASSESSMENT I: CONTAMINATED LAND

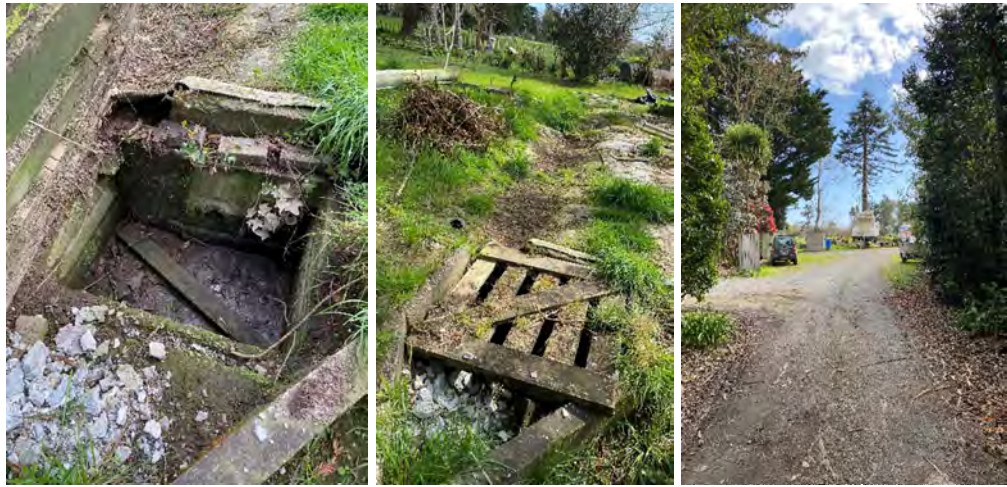
Figure I.3 Sump and soak away area at 380-386 Arapaepae Road (HAIL ID 10)

78. During the September site visit the storage tanks were located at 378 Arapaepae Road. These were in the ground at the northern corner of the site behind the residential building and well away from the designation boundary.
79. The tanks at 380-386 Arapaepae Road were no longer present. The tenant was present at the site at the time of the inspection and confirmed that the fuel storage was associated with a machinery building that used to be located in the northwest corner of the property. The tenant located an old sump (Figure I.3) and soak away area which he believed drained the machinery area. This flowed in a northern direction and away from the Ō2NL Project designation area.

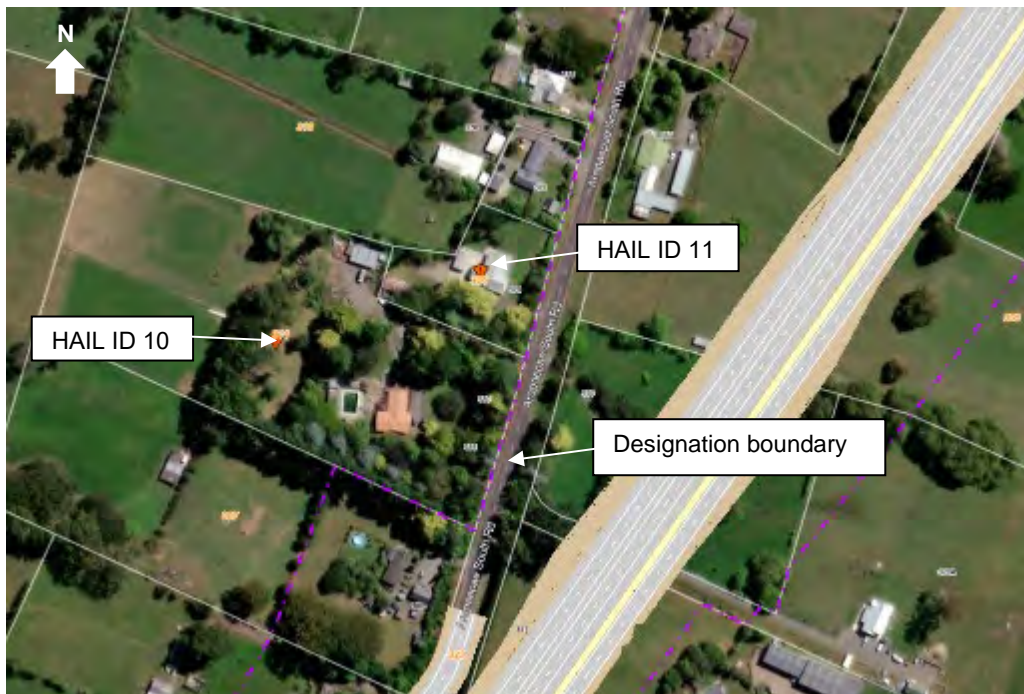
Figure 11: HAIL sites at 378 and 380-386 Arapaepae Road

The HAIL sites at 378 and 380-386 Arapaepae Road, Levin (Figure 11) were noted as having fuel storage tanks present and therefore the potential for losses of petroleum hydrocarbon-based fuels associated with refuelling of farm vehicles to be present within soils. These sites are outside the proposed designation and hydraulically downgradient in terms of groundwater flow direction and therefore the direction of possible contamination migration from any of these known sites is likely to be away from the proposed works. The likelihood of encountering petroleum hydrocarbons contaminants from these two HAIL sites as part of the works is therefore considered to be low.

During the September site visit, the location of the storage tanks at 378 Arapaepae Road was determined. These tanks were in the ground at the northern corner of the site behind the residential building (Figure 12), approximately 40m west of the designation boundary.

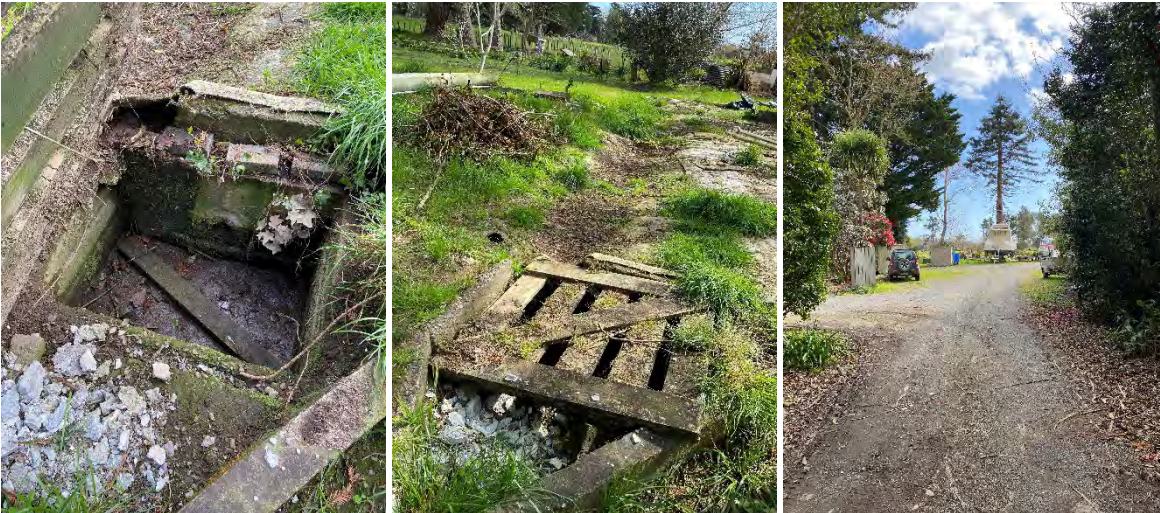
Figure 13 Sump and soak away area at 380-386 Arapaepae Road (HAIL ID 10)

The tanks at 380-386 Arapaepae Road were determined to be no longer present. The tenant was present at the site at the time of the inspection and confirmed that the fuel storage was associated with a machinery building that used to be located in the northwest corner of the property. The tenant located an old sump (Figure 13) and soak away area which he believed drained the machinery area. The sump outlet drained in a northern direction and away from the Ō2NL Project designation area.

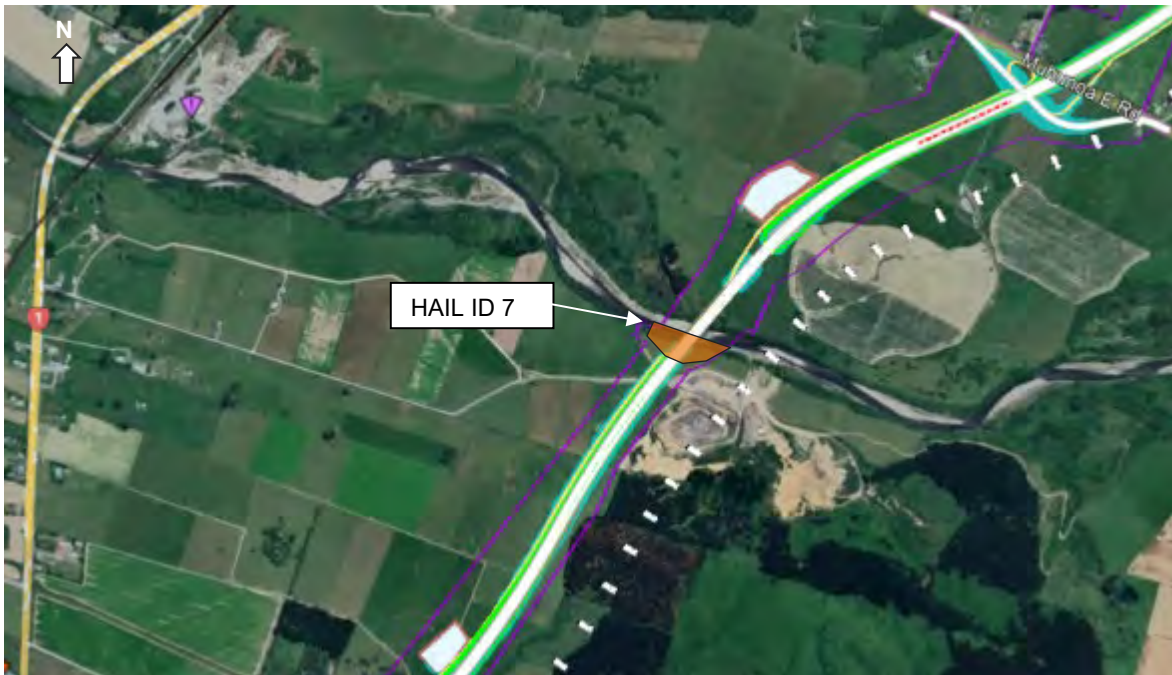
Figure 21: Location of historic landfill within the southern approach to the Ohau River bridge

This site is not on the Council HAIL records. There is no evidence within the historical photos available that show ground disturbance at this location other than for quarry operations. The riverbed can be observed across part of the site in 1940 as the river meandered naturally.

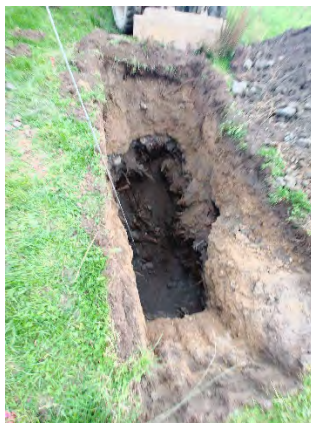
Left image: Site TP235 showing a sudden change in soil colour indicating there may have been disturbance at some point in time.
