Memorandum

To	Tabitha Manderson
Copy	Jack McConchie
From	Samwell Warren
Office	Wellington Environmental Office
Date	2 May 2018
File	
Subject	Potential losses from the Woodville WWTP pond– a water balance approach

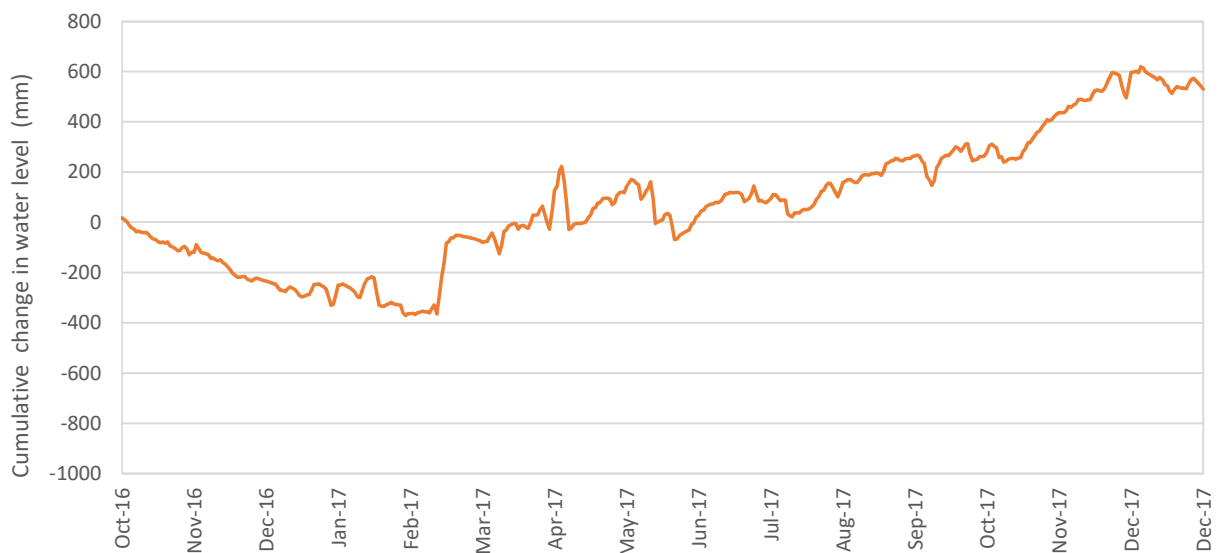
Figure 7: Cumulative change in volume in the treatment ponds, converted to water level (mm) for the period since October 2016.

These results show that over a 14-month period, there was a net cumulative surplus of water entering the treatment pond. This surplus was equivalent to a total level change of 530mm; with a maximum single daily change in water level being an effective loss of 111mm.

The results, which show a net gain and not a net loss of water, indicate that there is no significant loss of effluent through the lining of the ponds i.e. there is no leakage. Any movement of water through the lining must be into, rather than out of, the pond. This is considered unrealistic, **certainly the gains of water of the magnitude indicated in this analysis.**
