Active fault mapping and fault avoidance and awareness zones for the Whanganui District

DB Townsend

NJ Litchfield

GNS Science Consultancy Report 2020/73
October 2020

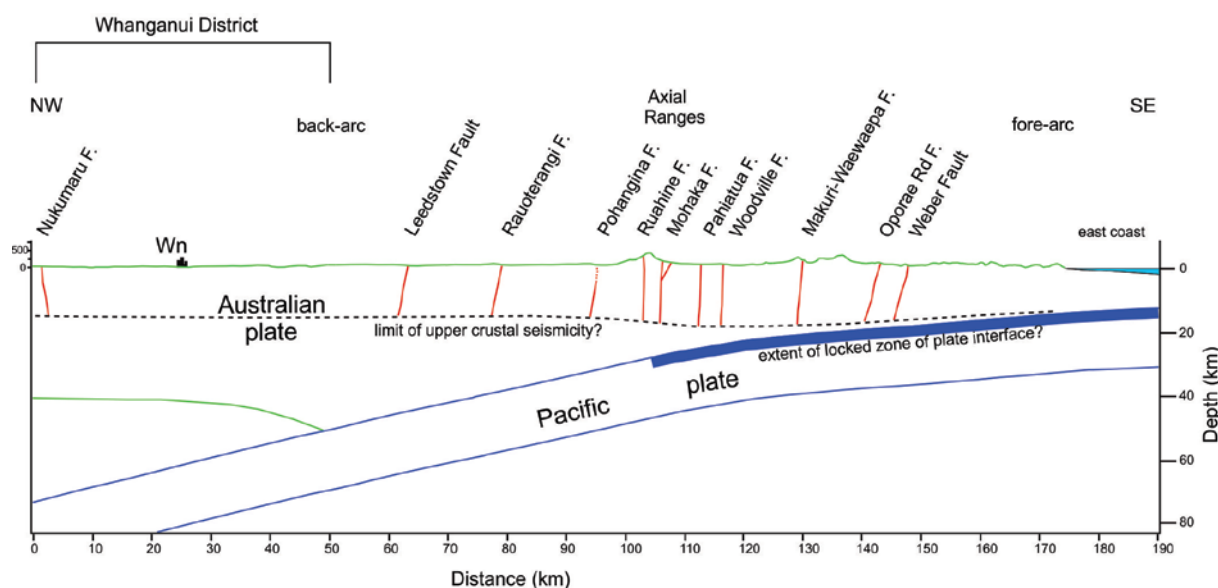
Figure 2.1 Simplified cross-section of southern North Island from west of Whanganui (Wn) to offshore of Cape Turnagain in the east, showing the tectonic features that are relevant to the Horizons Region. The cross-section intersects several active upper crustal faults and includes the Hikurangi Subduction Margin or Zone. Modified from Langridge and Morganstern (2020).

The largest fault in the region is the Hikurangi subduction interface, which represents the surface between the Pacific and Australian plates beneath the North Island (Figure 2.1). The plate interface is considered capable of generating a 'great' earthquake ($M_w > 8$) and possibly a megaquake ($M_w > 9$; Wallace et al. 2009; Stirling et al. 2012). In such a scenario, rupture of the Hikurangi subduction interface (i.e., as a gently dipping thrust fault plane) would propagate to the seafloor off the east coast of Tararua District (Figure 2.1) and a significant tsunami impacting the east coast and beyond could be generated. In addition, a magnitude M_w 8–9 earthquake on the plate interface would generate severe ground shaking throughout much of central New Zealand and beyond.

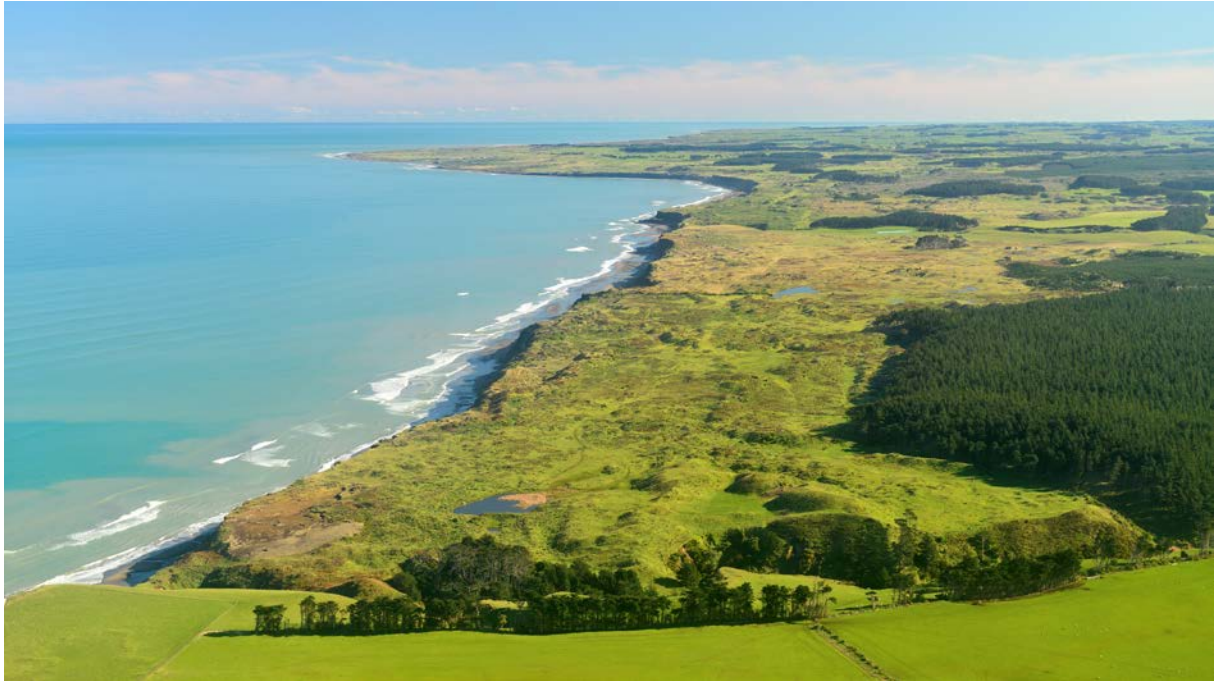
Figure 2.2 The well-preserved marine terraces and coastal cliffs near Kai-Iwi, north of Whanganui City, exemplify the district's coastline. The jutting headland exposes Pleistocene-aged Nukumarū Limestone (Fleming 1953), which has been faulted and possibly folded by the Nukumarū Fault. Holocene sand dunes (e.g. at centre) form lumpy deposits on many of the terraces, making identification of active faults difficult. Photo: D Townsend / GNS. D02_1473.

The paleo-shorelines are marked by topographic steps that separate older and younger terraces, and are generally gently curved and parallel with the modern coastline along the South Taranaki Bight (Figure 1.1). However, in the west of the Whanganui District, the risers display local complexity in association with the Nukumarū Fault. This suggests that these geomorphic features have been affected by local tectonics, either through uplift and folding of the terraces and risers themselves, or that the erosion-resistant Nukumarū Limestone, which has been deformed and exposed within this long-lived fault zone (Fleming 1953), has influenced the coastal dynamics and formation of the contemporaneous coastlines (e.g. Nukumarū Limestone is exposed along the protruding headland at Waiinu Beach, just west of Whanganui District; Figure 2.2).

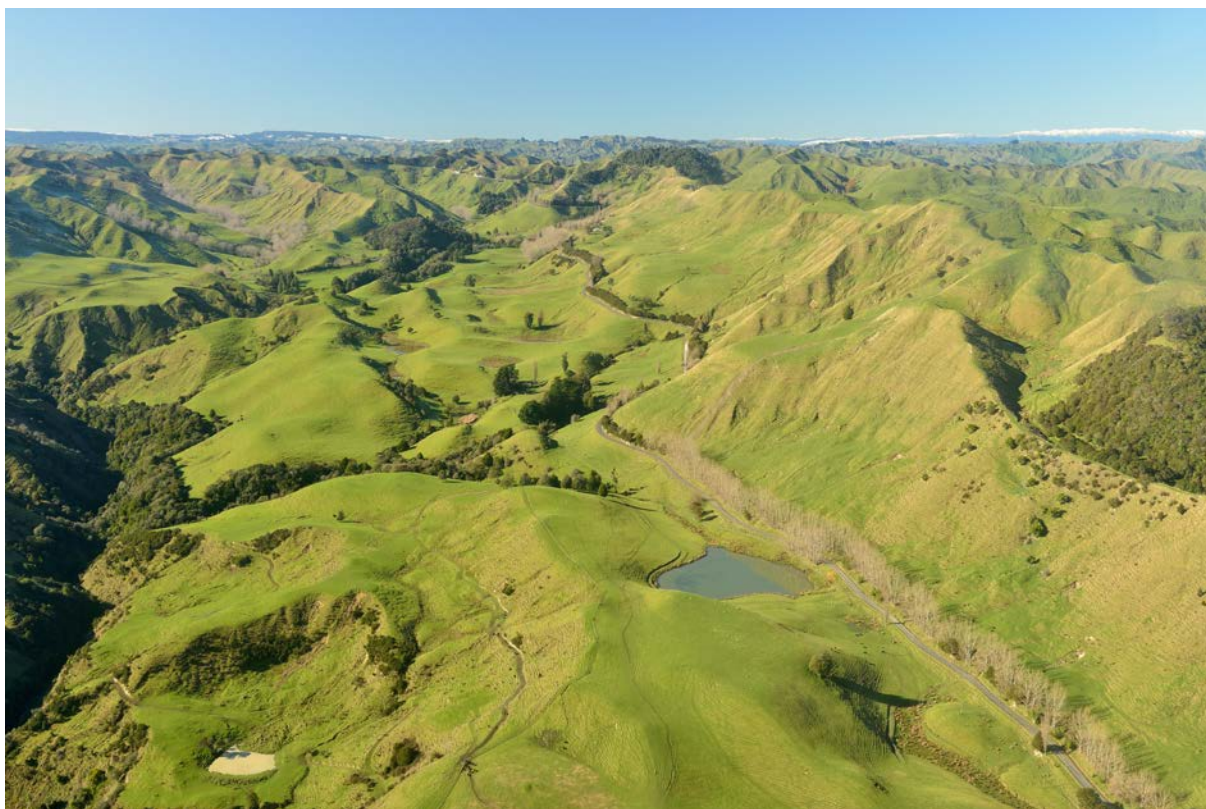
Figure 2.3 Landsliding in the hill country of inland Whanganui District has formed characteristic lumpy topography. Extra care must be taken in such areas to distinguish gravitational (landslides) from tectonic (faulting) landscape features. The road shown is Fields Track, just east of the Whanganui River, and the view direction is to the northeast. Photo: D Townsend / GNS. D02_1628.

These forms of erosion can rapidly alter the landscape, often removing or burying evidence of faulting activity, especially in areas underlain by young, soft bedrock such as most of the Whanganui District. Additionally, landslide scarps may have the appearance of tectonic fault features, so extra care must be taken with interpretations of features in terrain that is susceptible to landsliding (e.g. Figure 2.3).
