Active fault mapping for planning purposes across the western part of the Tararua District

RM Langridge
GL Coffey

**GNS Science Consultancy Report 2021/03
December 2021**

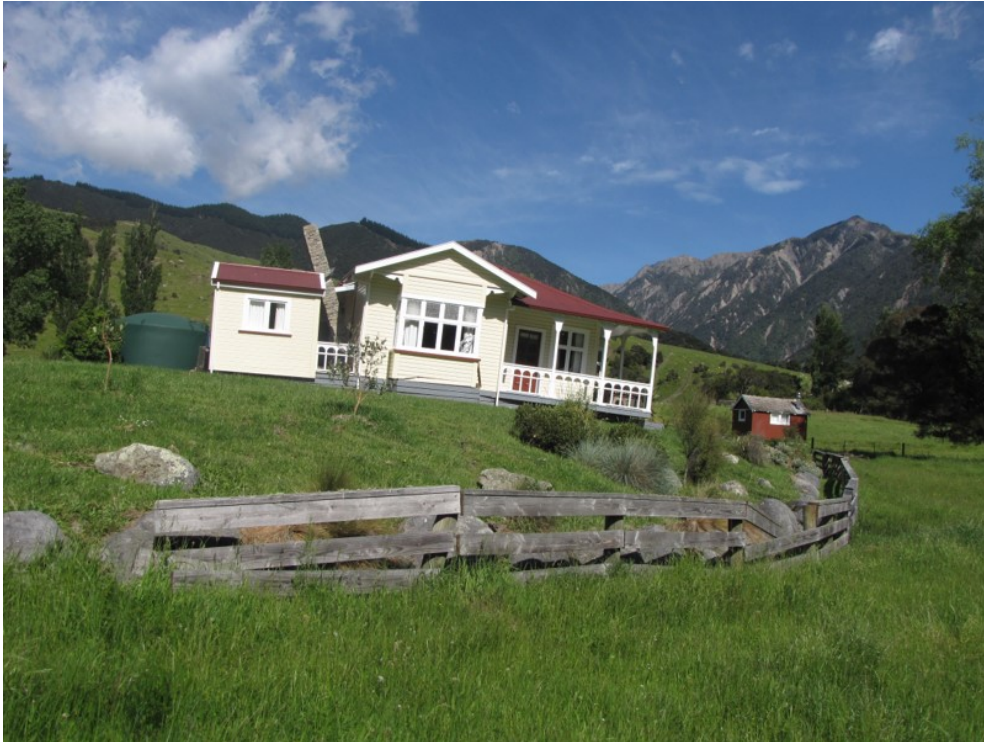
Figure 1.2 A house built along the scarp of the Papatea Fault in the Clarence River valley, Kaikōura District. The scarp is broadly defined by the pre-existing fence and line of boulders. Surface rupture across the fault in the 2016 Kaikōura earthquake resulted in vertical and horizontal ground deformation that warped and tilted the ground (to the right), damaging the house and causing the chimney to separate from it. There were no occupants in the house at the time of the earthquake. Image from Van Dissen et al. (2019).

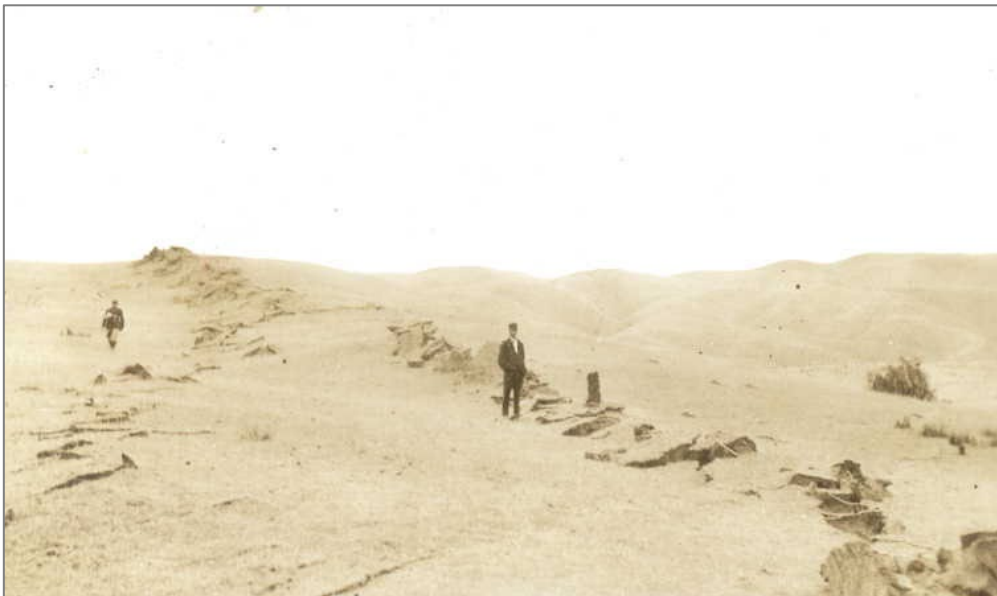
Figure 1.3 Ground surface rupture south of the Heretaunga Plains associated with the 1931 Hawke's Bay earthquake. The style of movement on the faults in the 1931 event was dominantly reverse, causing the pictured surface 'moletrack'. Image from Henderson (1933).

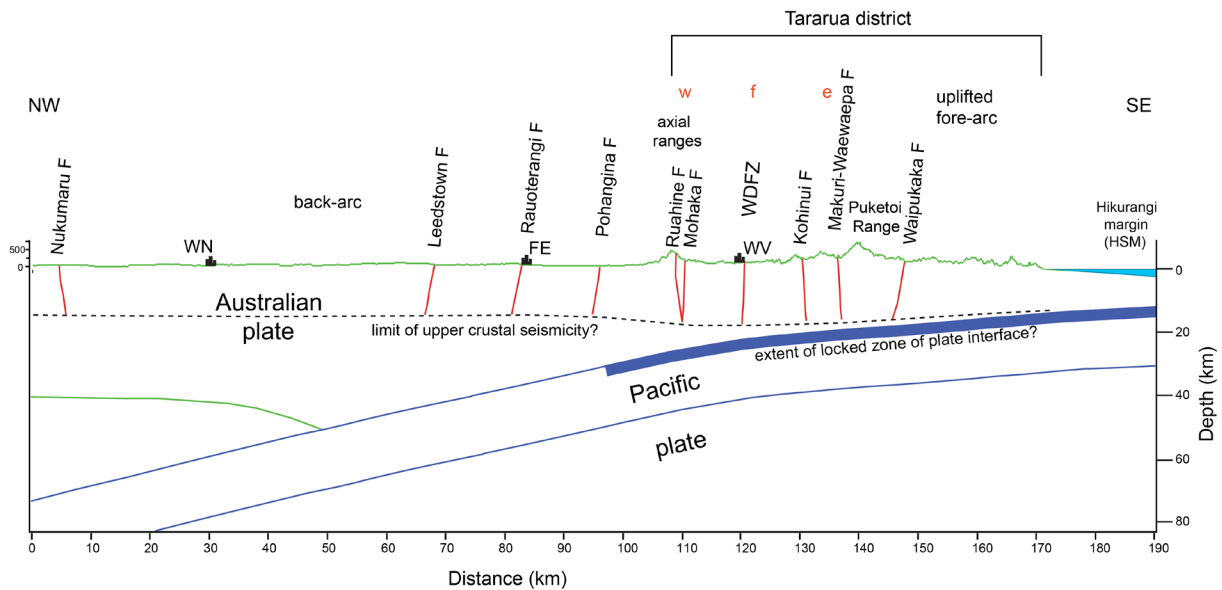
Figure 2.1 Simplified cross-section showing major tectonic features of the lower North Island in the Horizons region from offshore of Owahanga in the east to near Whanganui (WN) in the west. The cross-section intersects several active upper crustal faults and includes the Hikurangi Subduction Margin or Zone. Abbreviations: WDFZ, Woodville-Dannevirke Fault Zone; w,e, western and eastern strands of the NIDFB; f, forearc basin. The towns of Feilding (FE) and Woodville (WV) are also indicated. Vertical exaggeration is about two times.

The largest fault in the region is the Hikurangi subduction interface (dark blue bold line on Figure 2.1), where the Pacific Plate subducts to the northwest under the Australian Plate, beneath the North Island. The plate interface is considered capable of generating a 'great' earthquake ($M_w > 8$) and possibly a 'giant' earthquake ($M_w \geq 8.6$). In such a scenario, surface rupture of the Hikurangi subduction interface (i.e. as a gently dipping thrust fault) would occur at the seafloor off the east coast of the Tararua District (Figure 2.1), and a significant tsunami would be generated. In addition, a magnitude M_w 8–9 earthquake on the plate interface would generate severe ground shaking throughout much of the North Island and beyond.

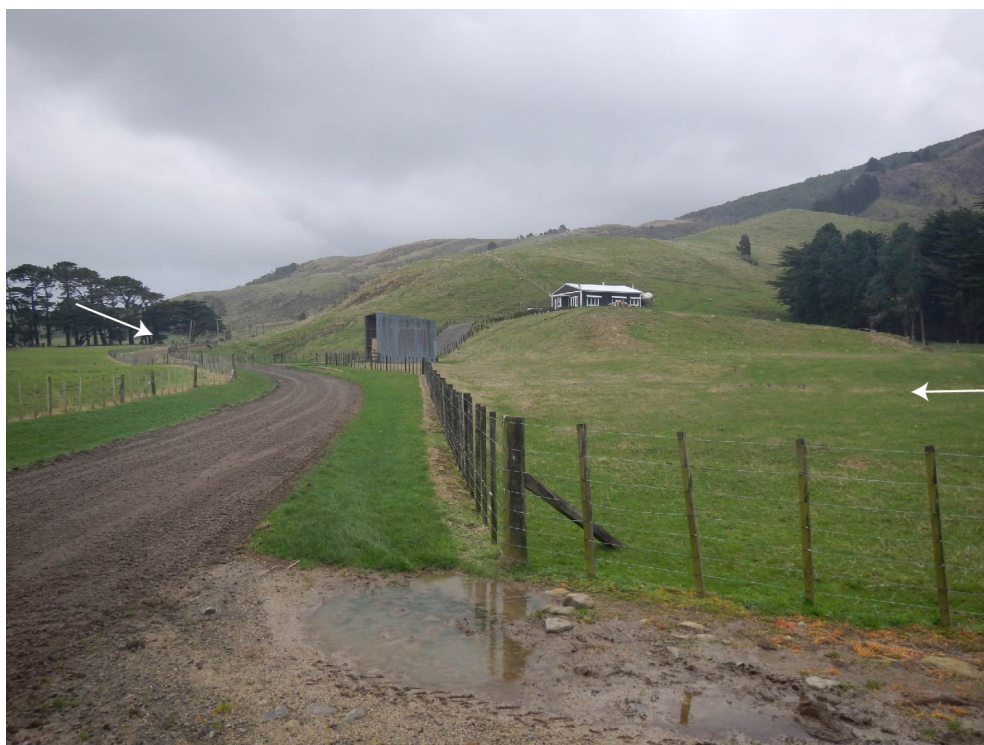
Figure A1.3 The rangefront and trace (between arrows) of the Wellington Fault at the end of Kakariki West Road. The house has been built on an uplifted alluvial surface that is elevated on the west side of the fault.

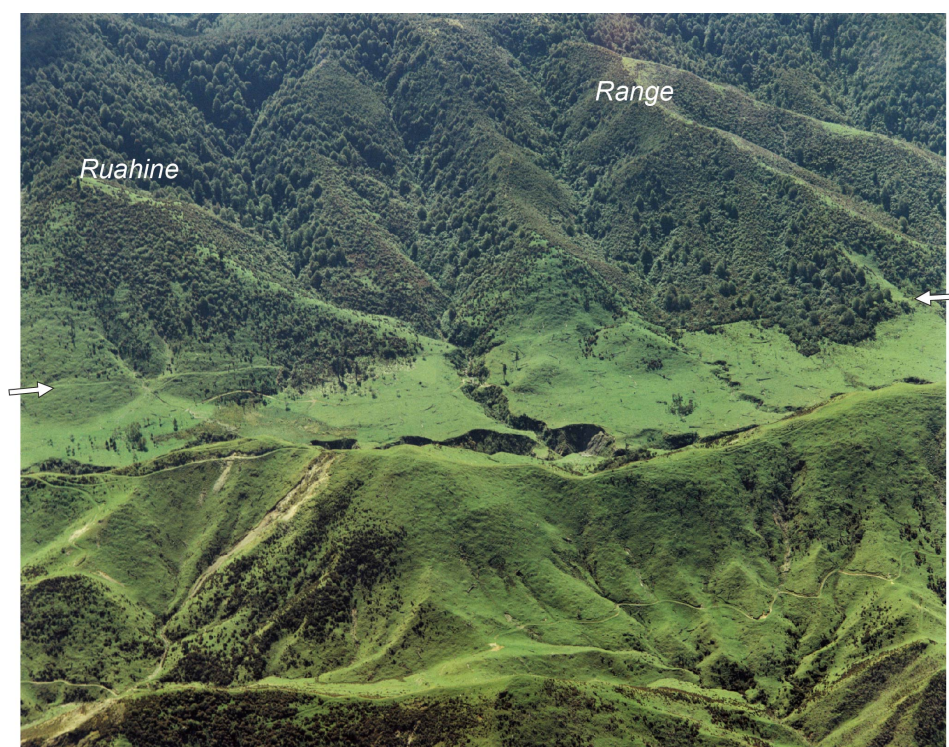
Figure A1.5 Oblique aerial photograph of the active trace of the Mohaka Fault along the foot of the Ruahine Range (between arrows) at Moorcock Stream in the Central Hawke's Bay District. Photo: L Homer, GNS Science.

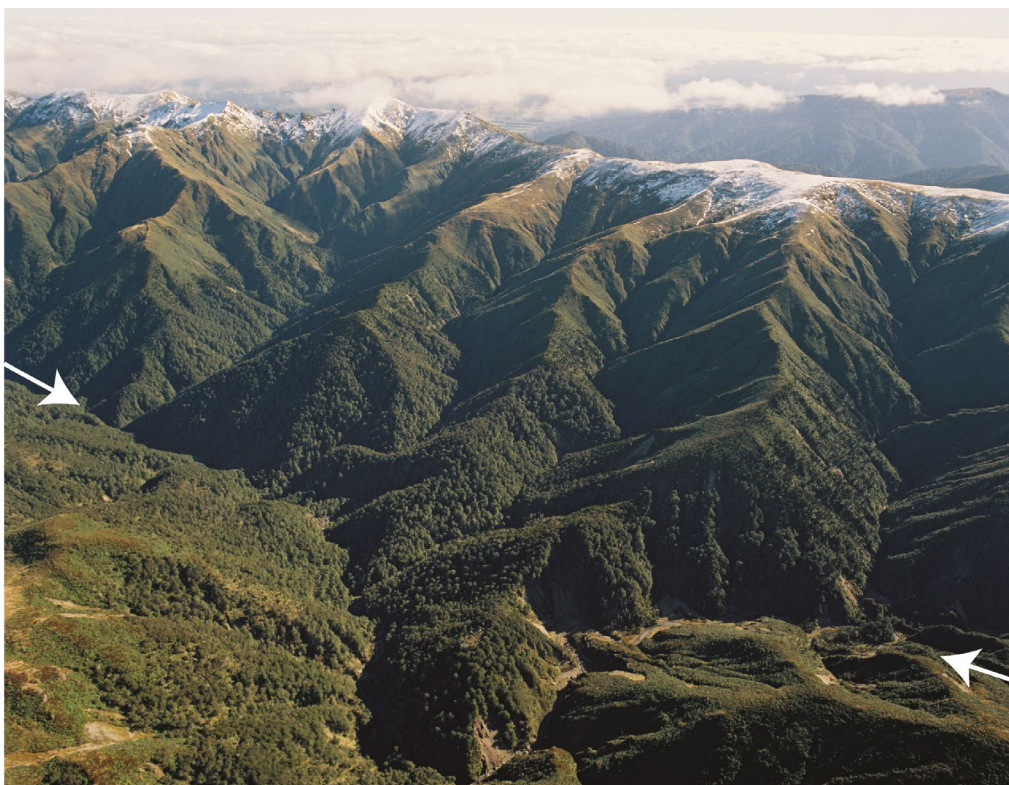
Figure A1.10 View to the south of the Ruahine Range from Rocky Knob, looking toward Tunupō peak (in cloud). The Ruahine Fault is indicated between the arrows in rugged country in the headwaters of the Pohangina River (in the Manawātū District). Photo: L Homer, GNS Science.

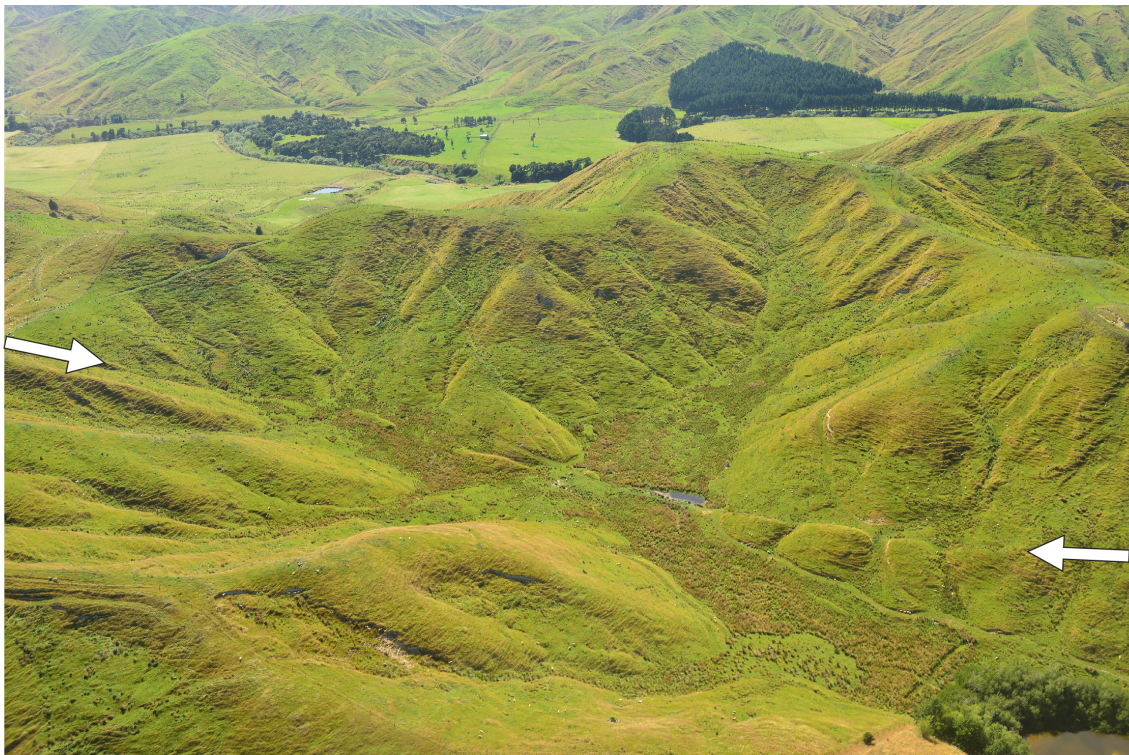
Figure A1.11 One of the active strands of the strike-slip Pa Valley Fault near Pa Valley Road (between arrows). The fault forms an uphill-facing scarp, behind which a pond has formed (at centre). Photo: D Townsend, GNS Science.

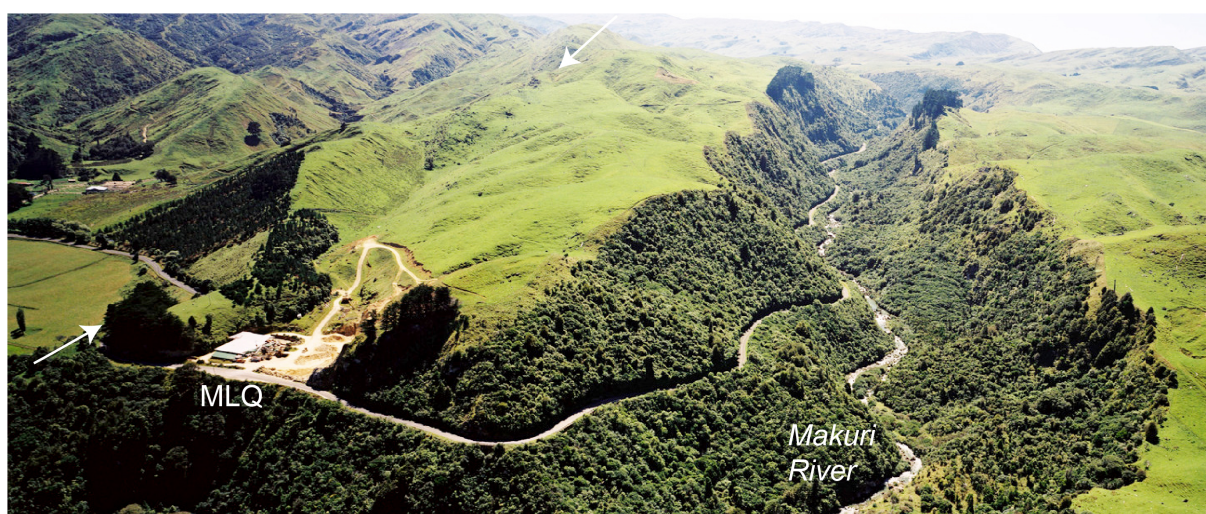
Figure A1.13 The Makuri-Waewaepa Fault (between arrows) in the Makuri area. MLQ, Makuri Limestone quarry. Photo: L Homer, GNS Science.

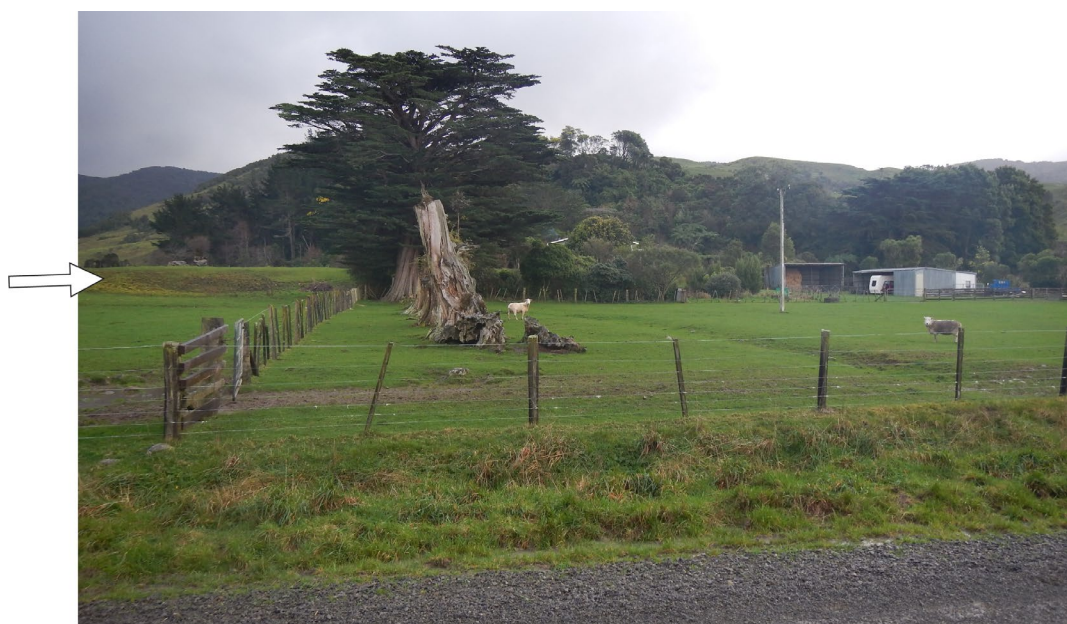
Figure A1.14 Fault scarp of the Hukanui fault along Mangaraupiu Road, east of Eketāhuna. The scarp (arrowed) runs from left to right, directly behind the large macrocarpa tree in the middle of the photo.

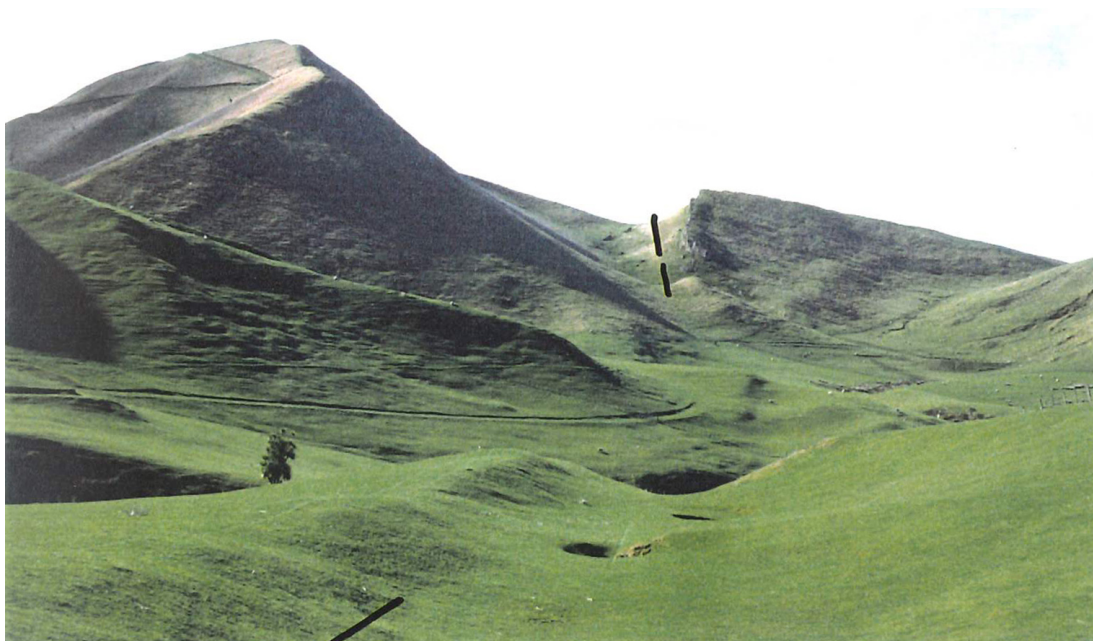
Figure A1.16 View to the northeast along the trace of the Oruawhoro Fault (marked by lines). The photo shows the greywacke basement of the Oruawhoro Range to the west and a limestone ridge to the east. Photo: S Beanland.

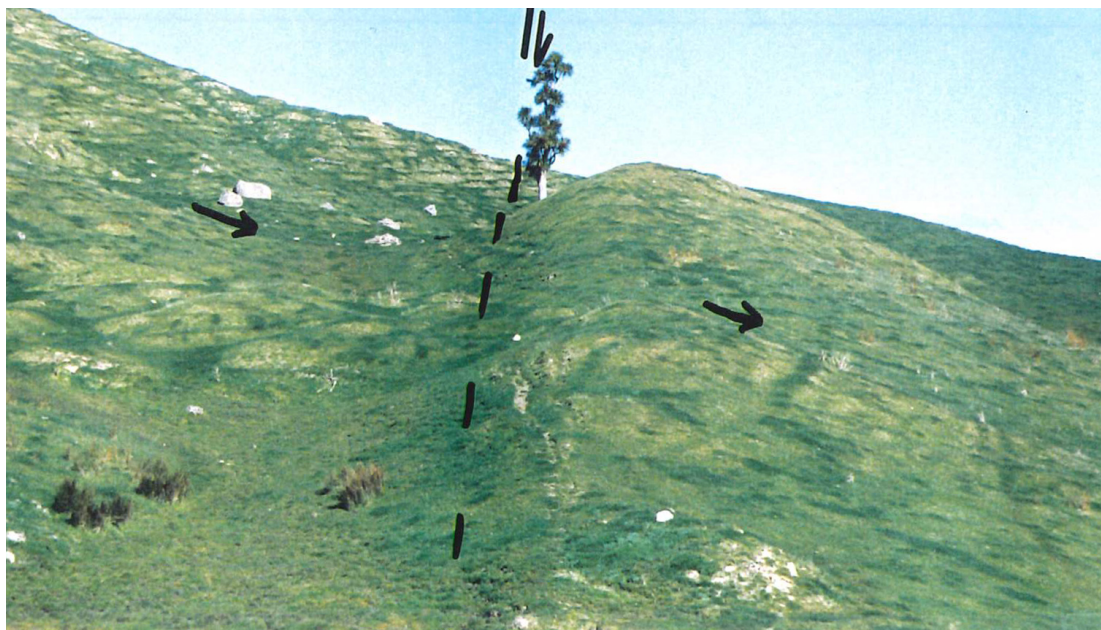
Figure A1.17 View to the southwest along the trace of the Oruawhoro Fault (marked by lines). The image shows an uphill-facing scarp, with arrows indicating dextrally offset channel topography. Photo: S Beanland.

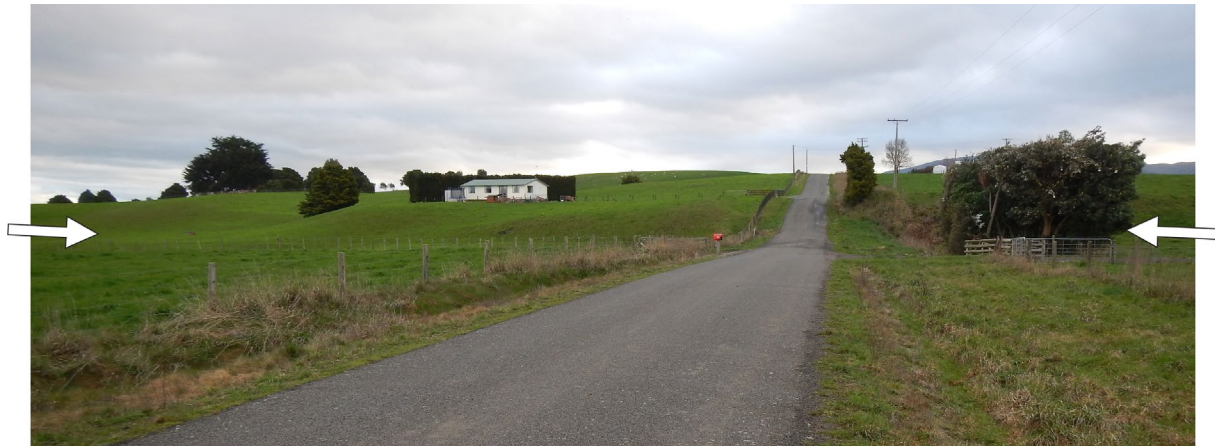
Figure A1.19 Double fault scarp of the Woodville-Dannevirke Fault Zone (WDFZ) along Heretaunga Road, northeast of Woodville. The active trace of the WDFZ is mapped here at the base of the scarp between the arrows.

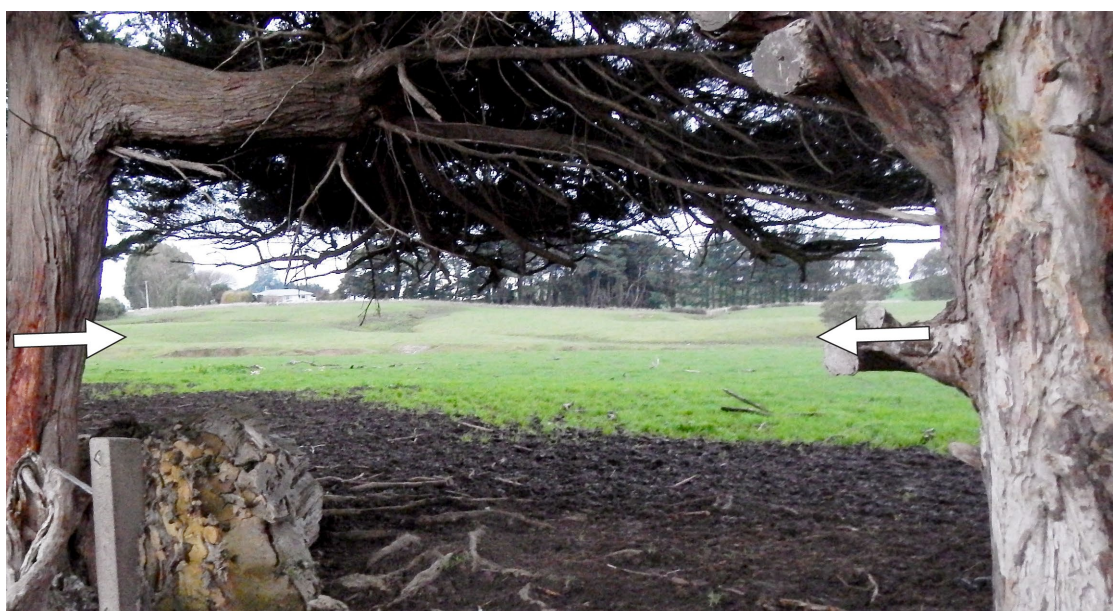
Figure A1.20 View through trees to fault scarp of the Mangarawa fault along Conduit Road, northeast of Woodville. The fault trace is mapped at the base of the scarp between the arrows.
