Pohangina – Oroua Catchment Control Scheme Scheme Review

AMENDED REPORT

June 2006

Author
John Philpott
of
John Philpott & Associates Ltd

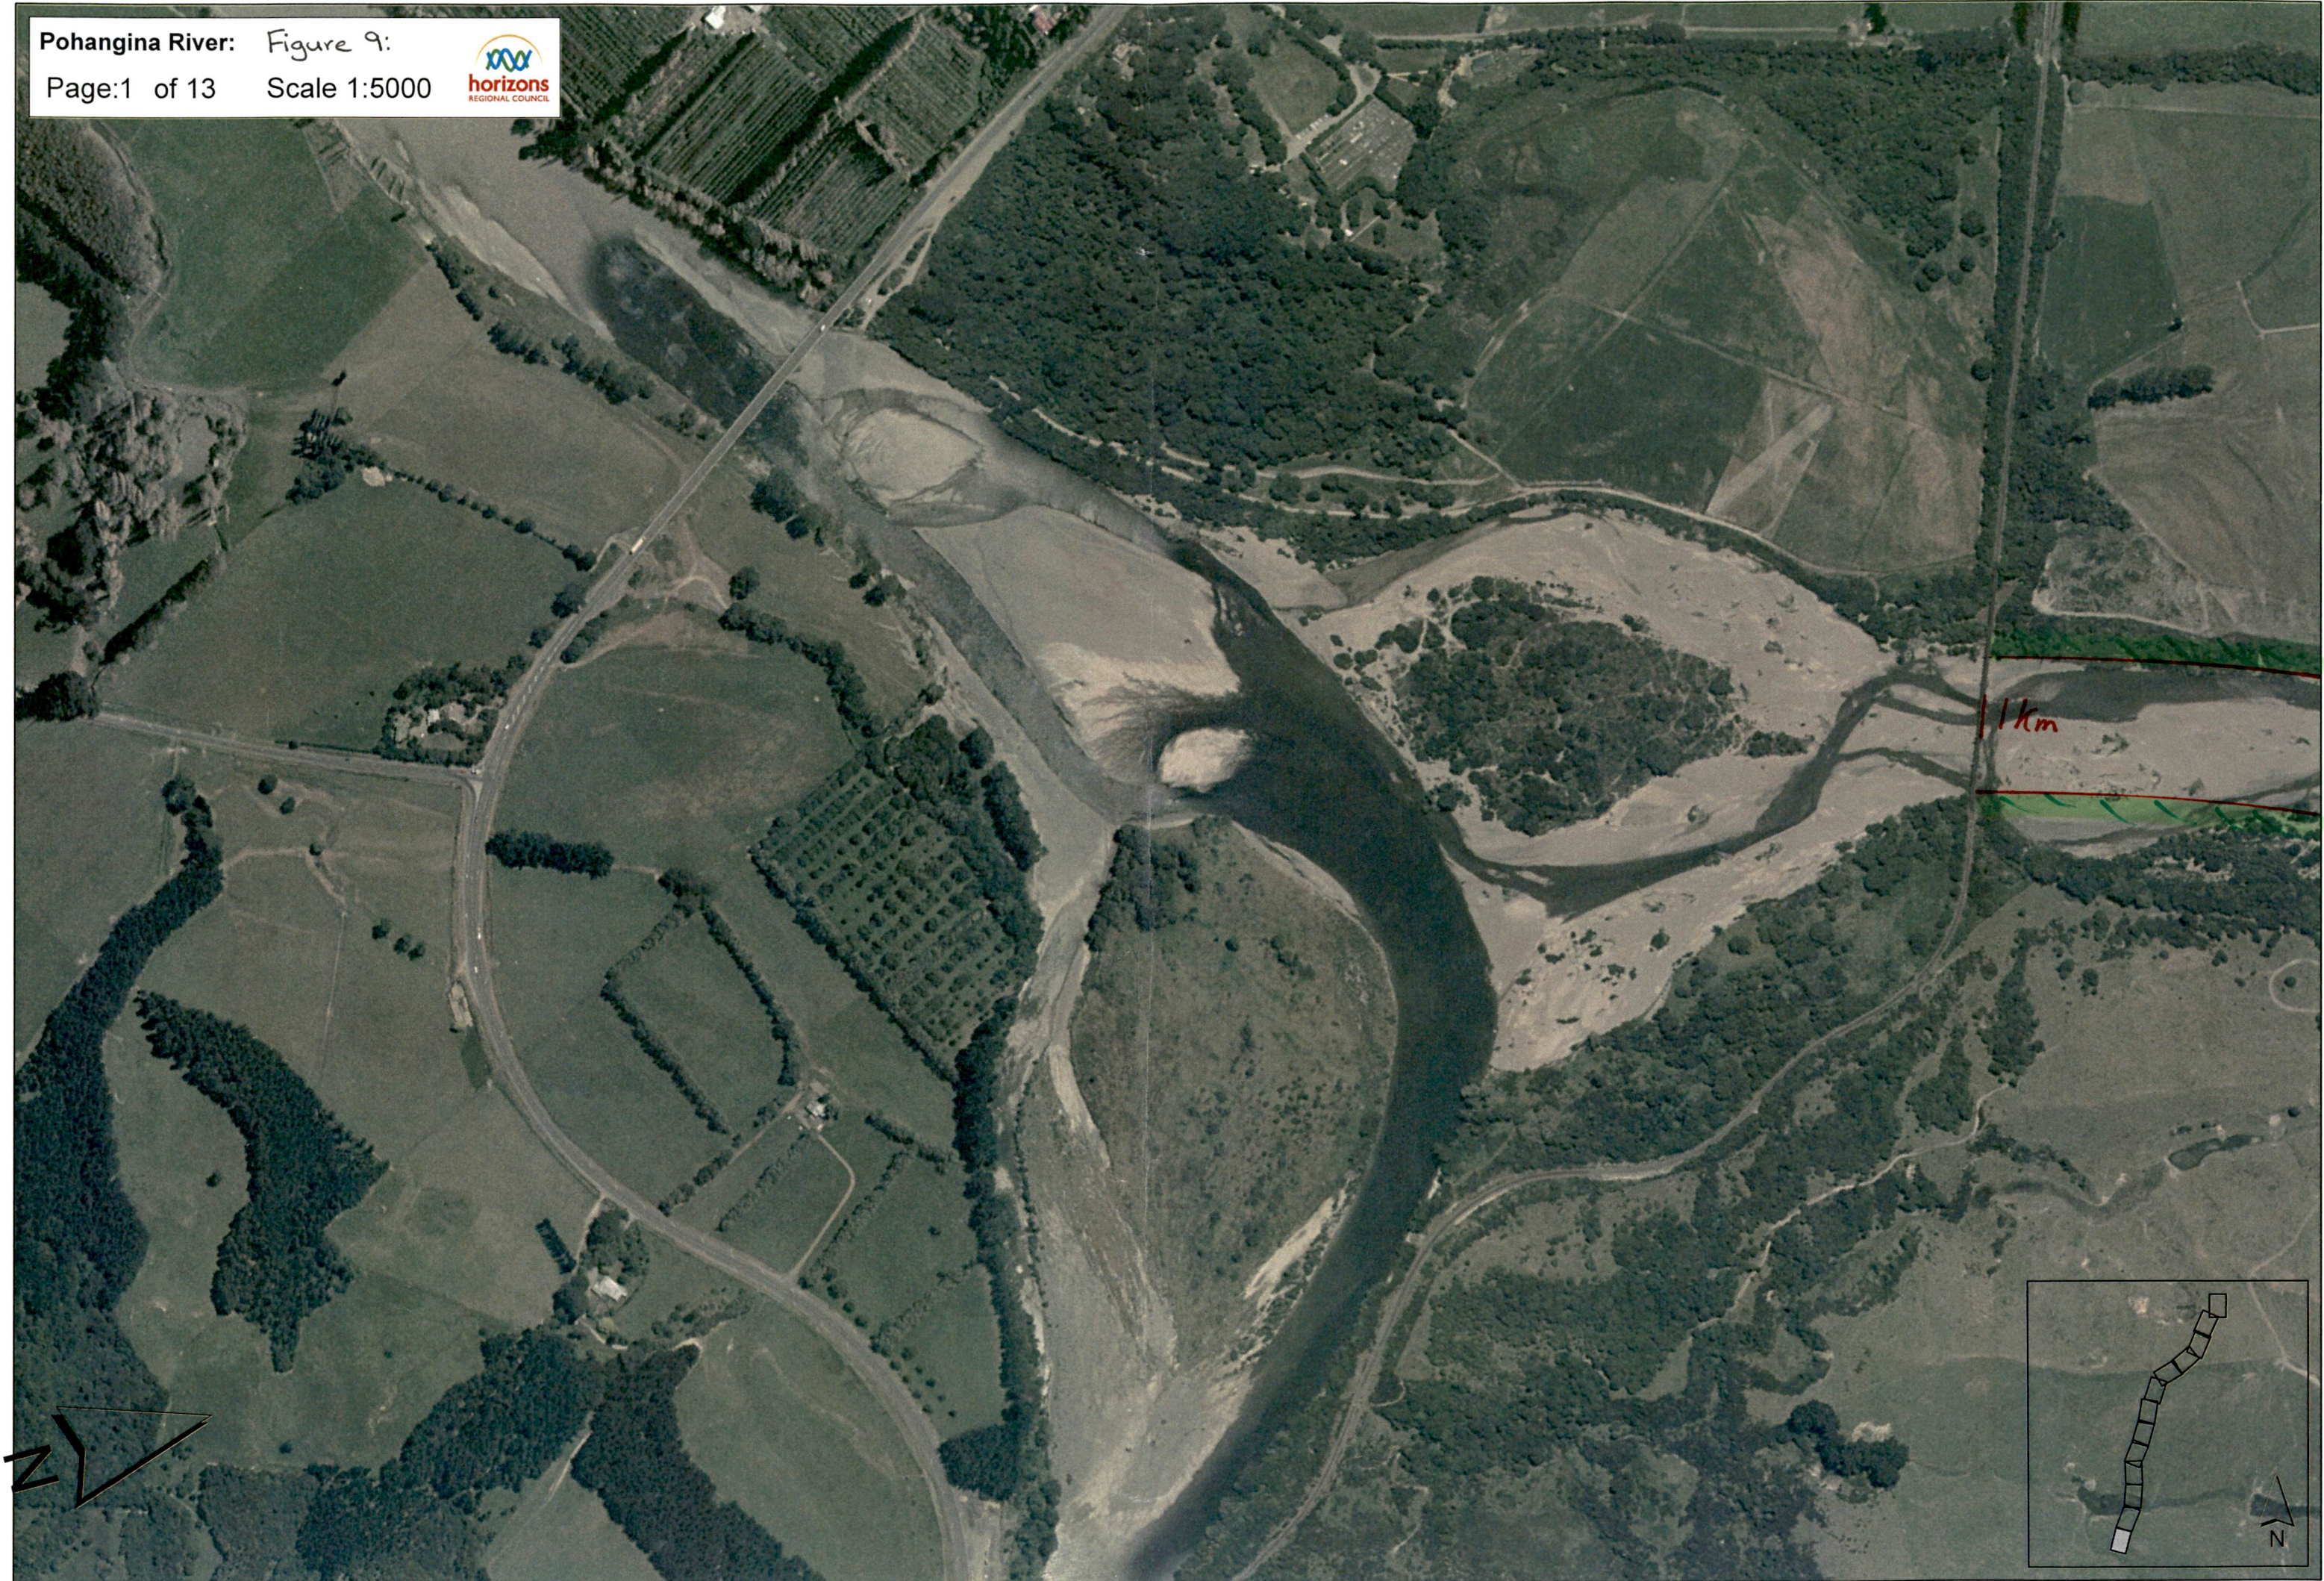
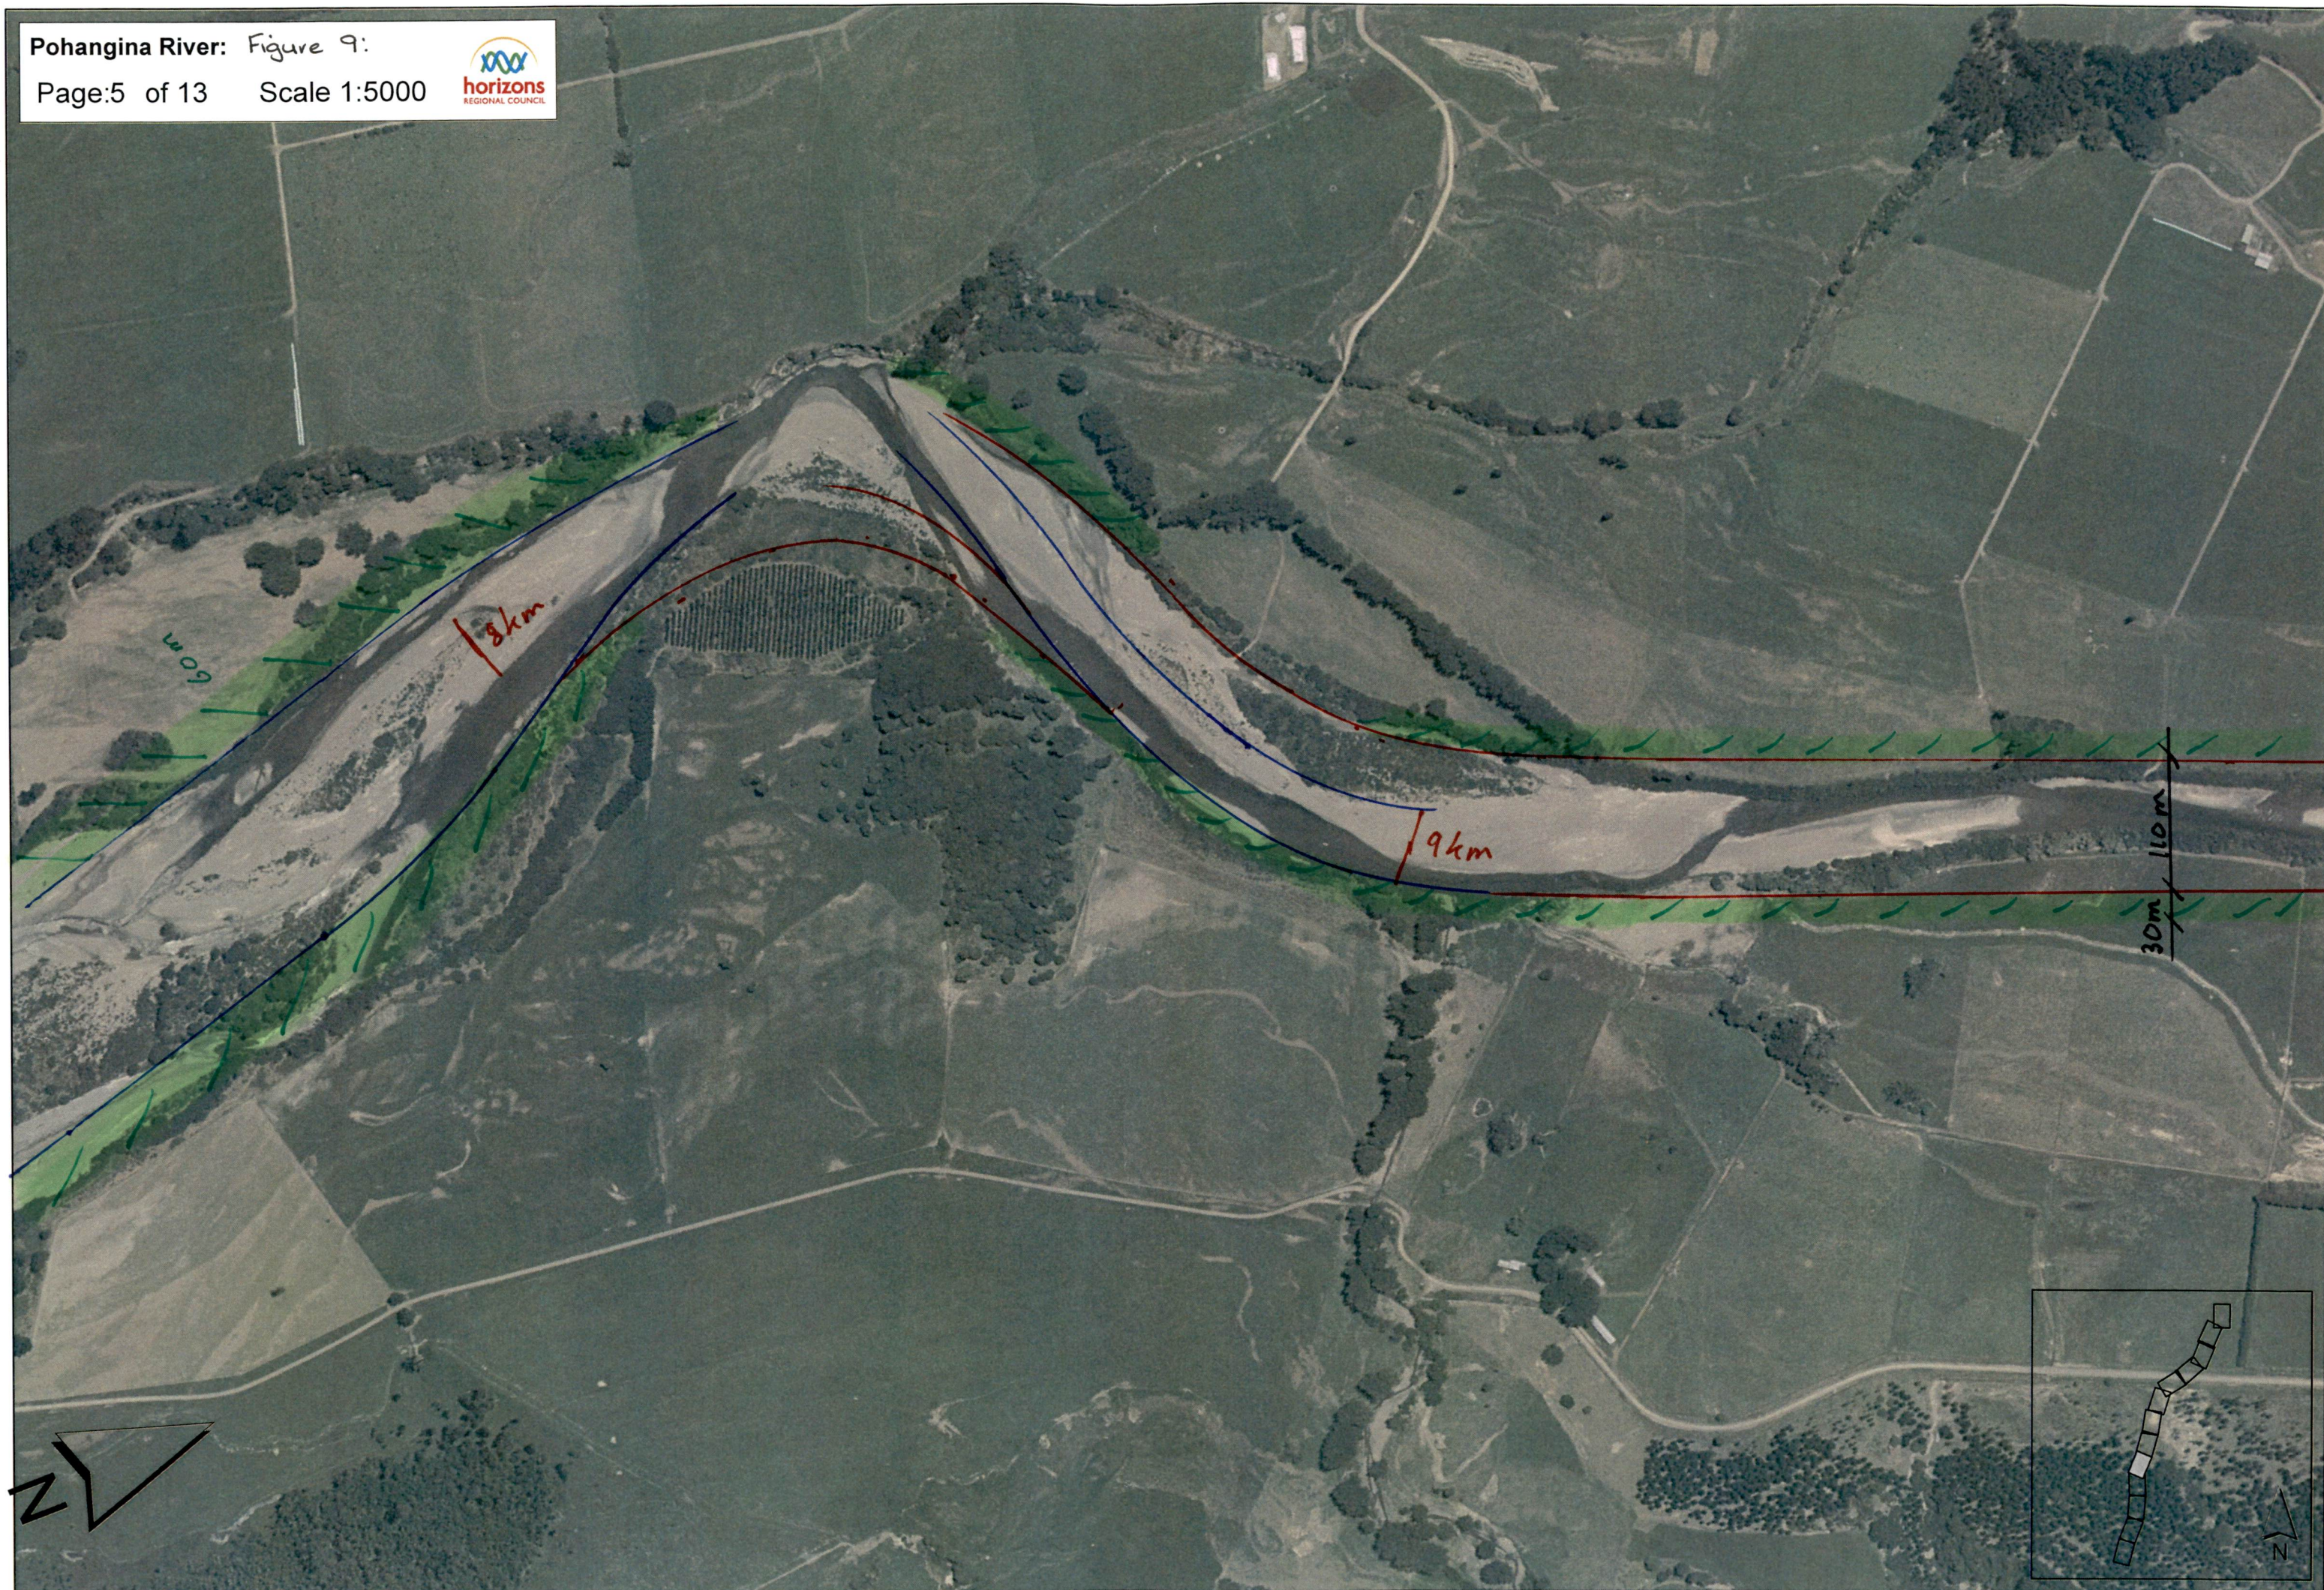
- a. adopt the Pohangina River design alignment as detailed in Section 12 of the Review and as shown on Figure 9;
- b. undertake the protection works in priority order unless flood damage requires work on a reach of the river to be done out of sequence with its priority;
- c. undertake the planting programme on each reach of the river along with the protection works on that reach, and layer and maintain existing trees as part of this work;
- d. assign any surplus funds in any year to planting and channel maintenance;
- e. maintain beaches and clear vegetation to ensure the design fairway is kept clear;
- f. carry out changes to work priorities in the future if required using the principles set out in the Review;
- g. obtain, as far as possible, agreements with landowners in regard to protection plantings.

Detail design works will be undertaken on the erosion control works required early in 2006-2007 and a design channel alignment will be prepared and added to sheets 12 and 13 of Figure 9.

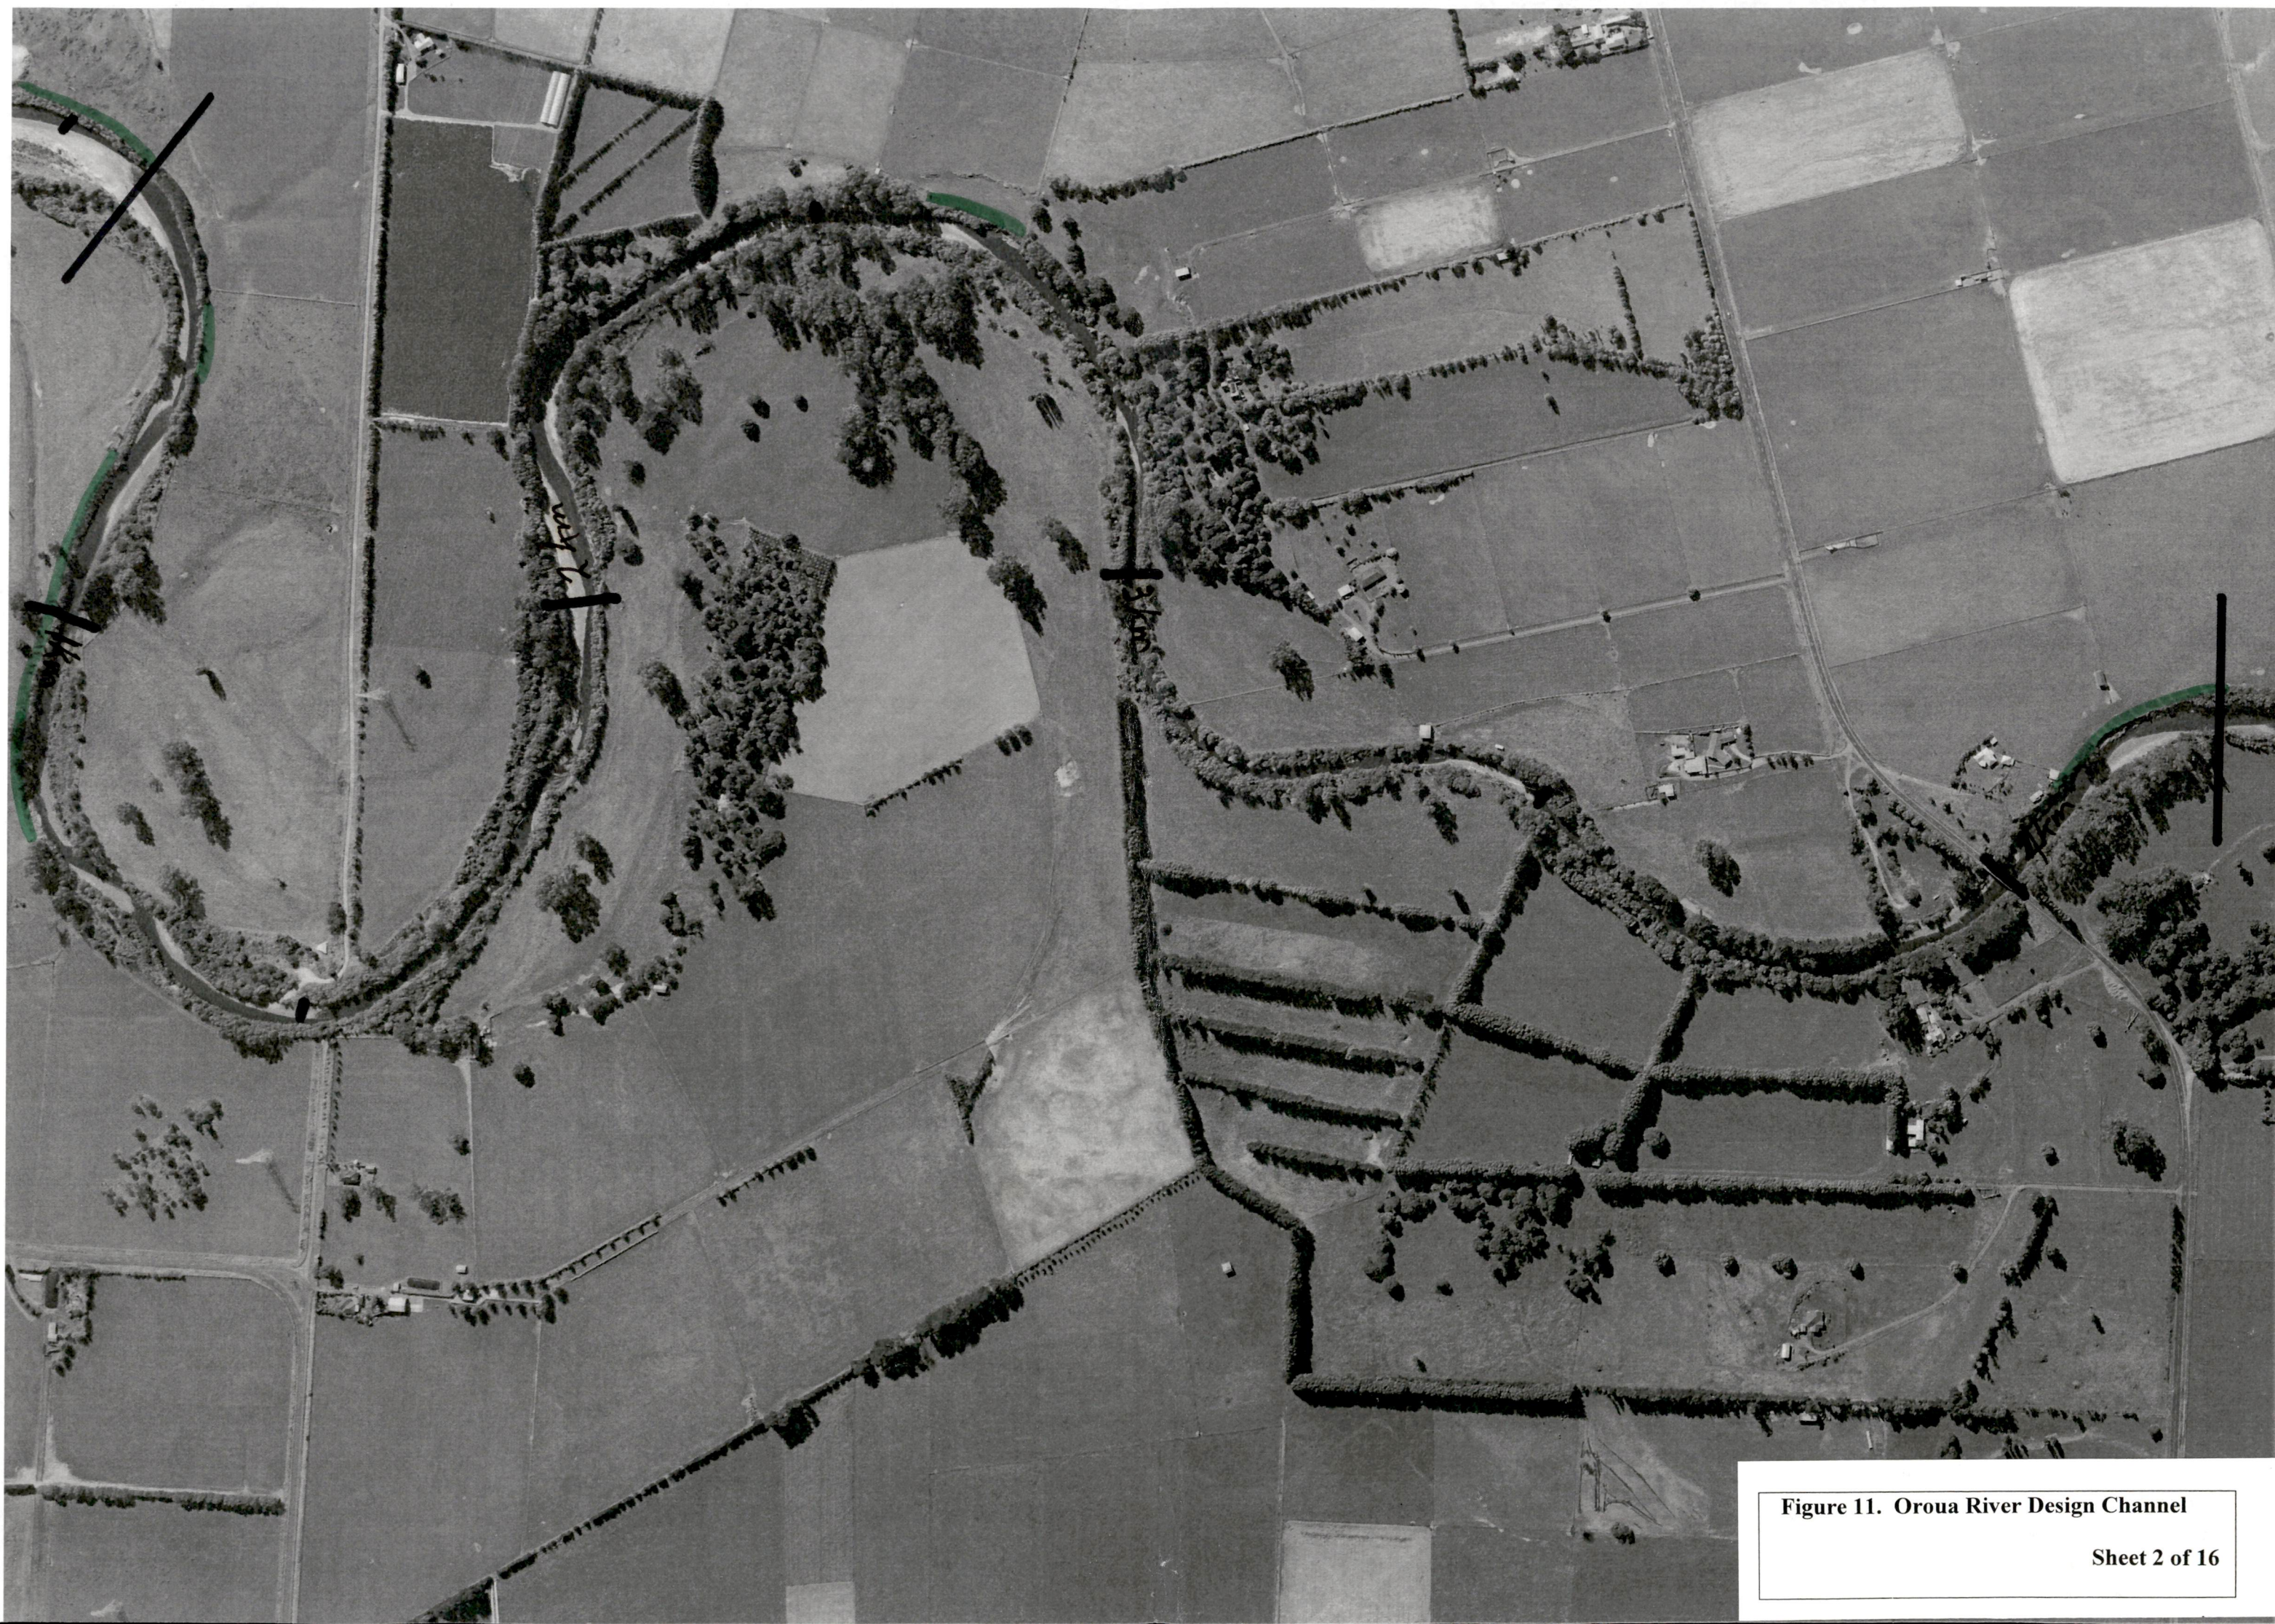
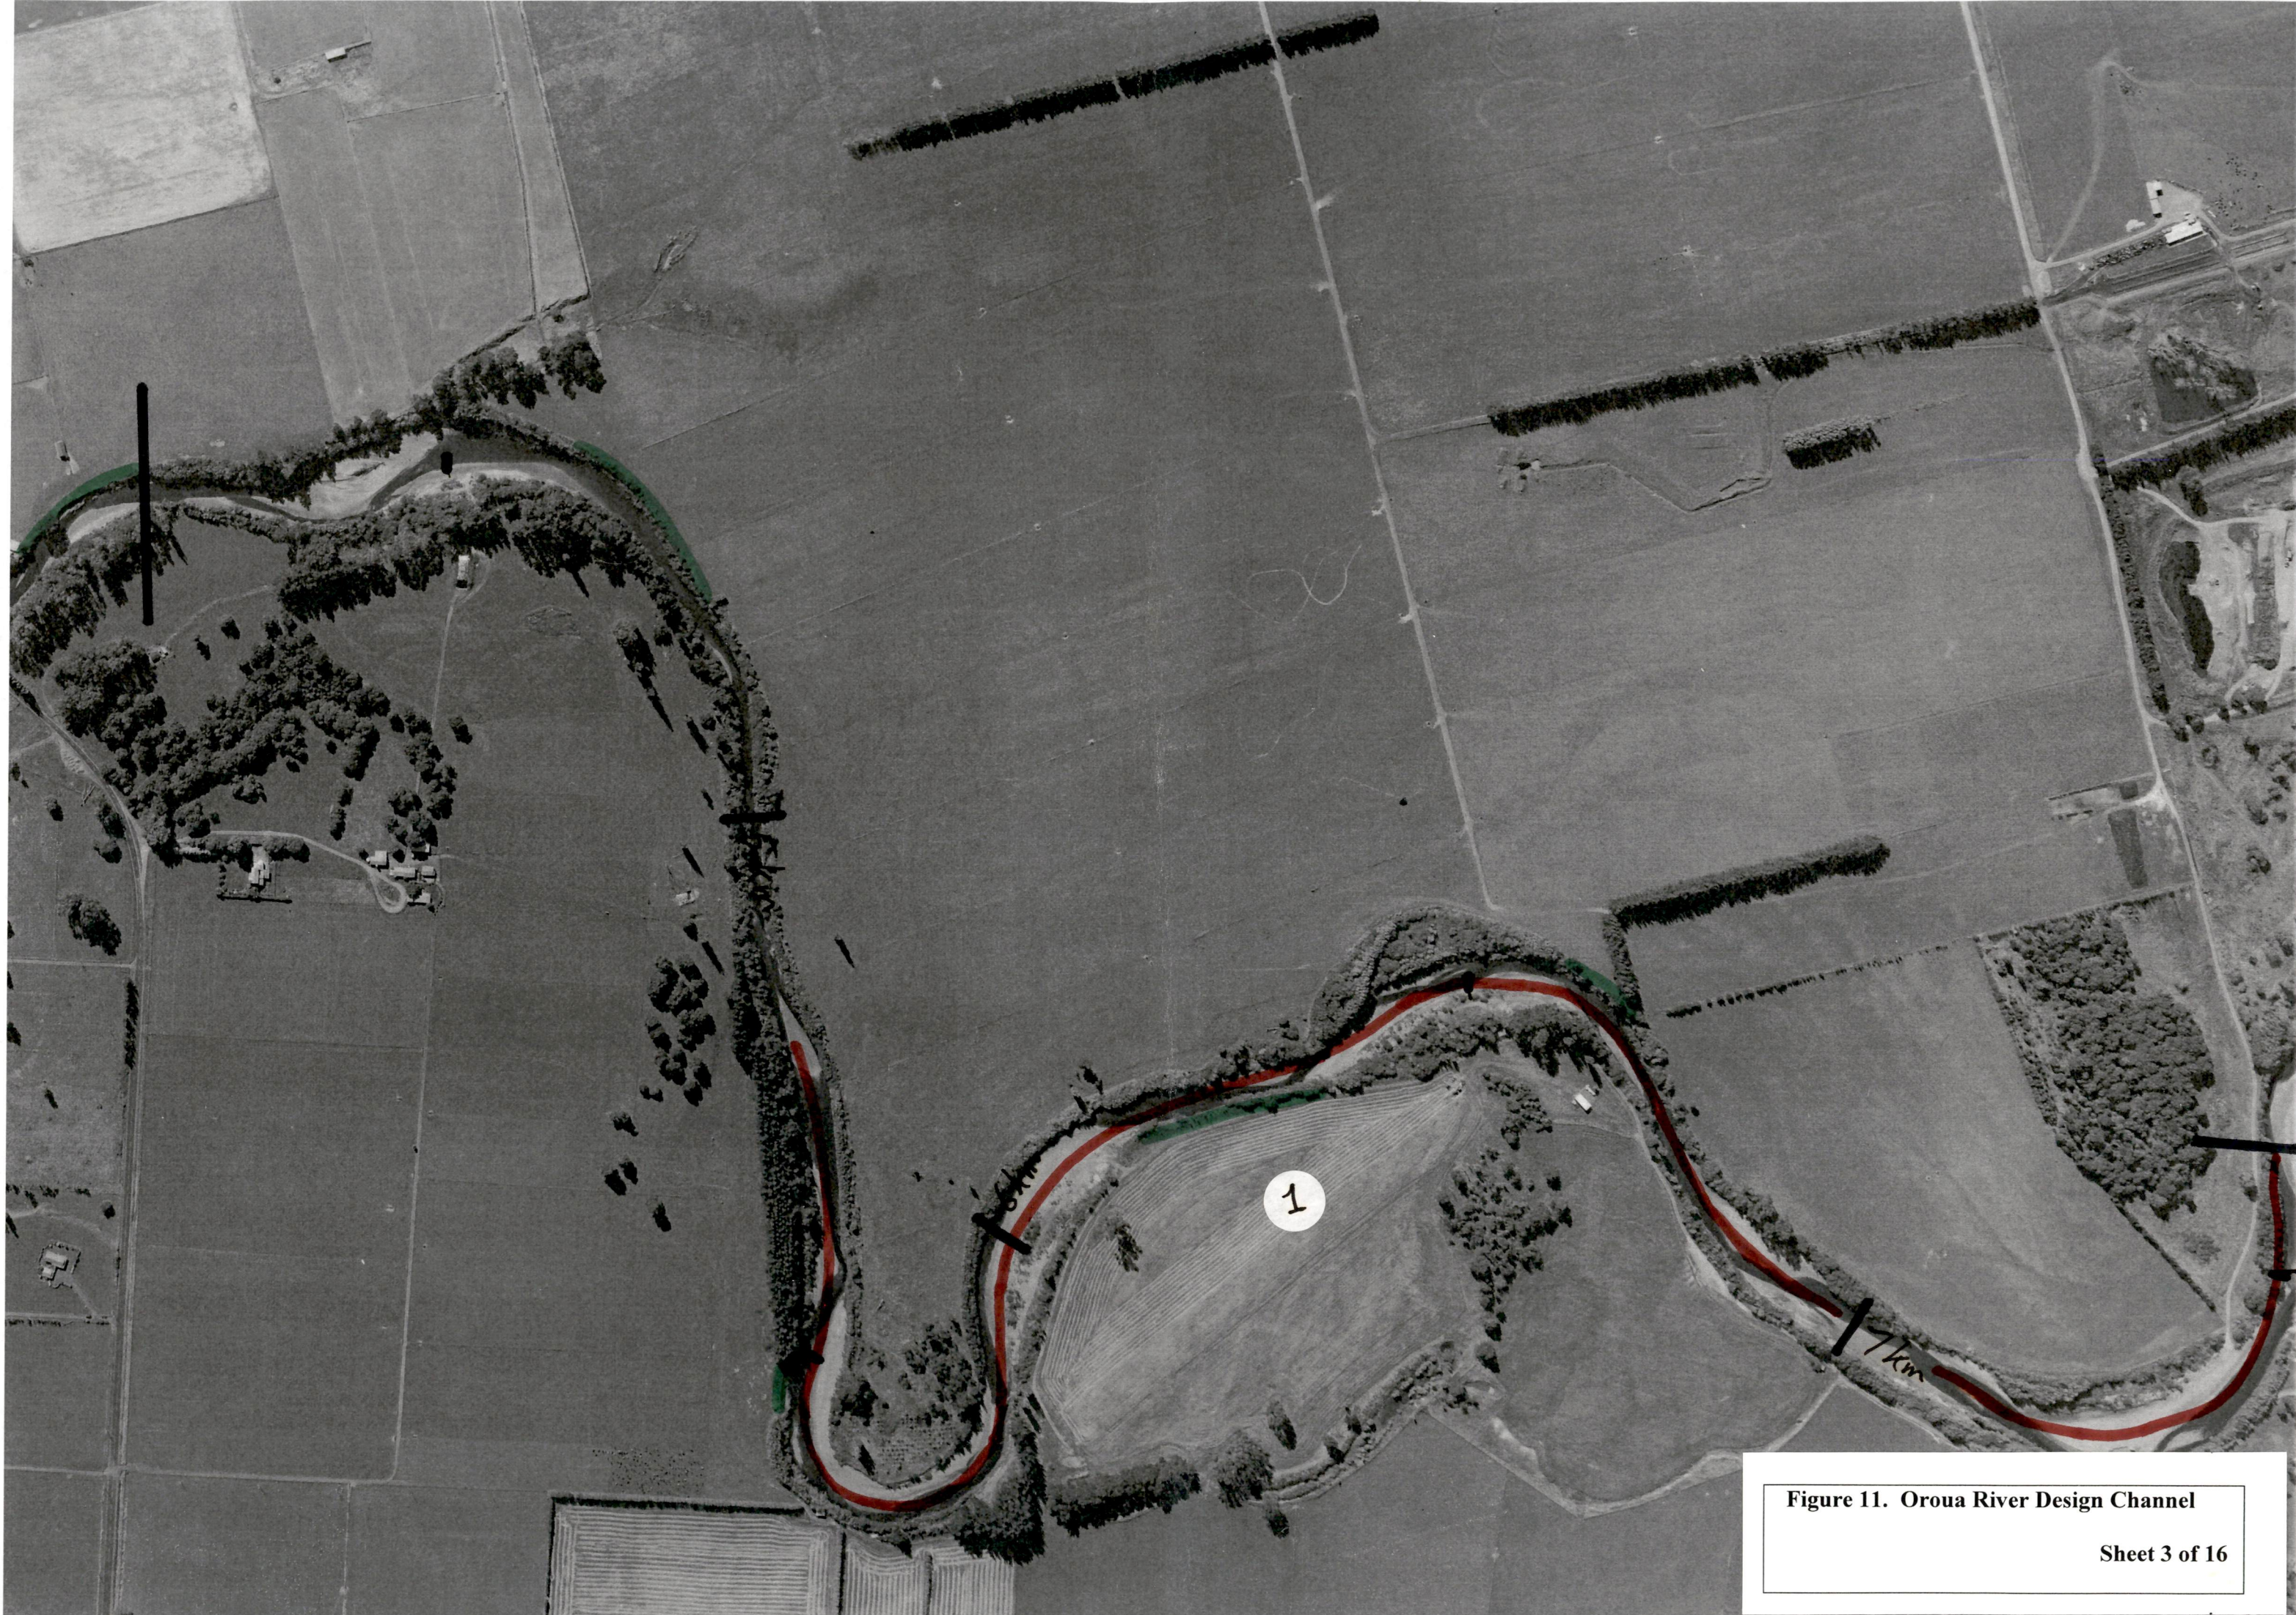
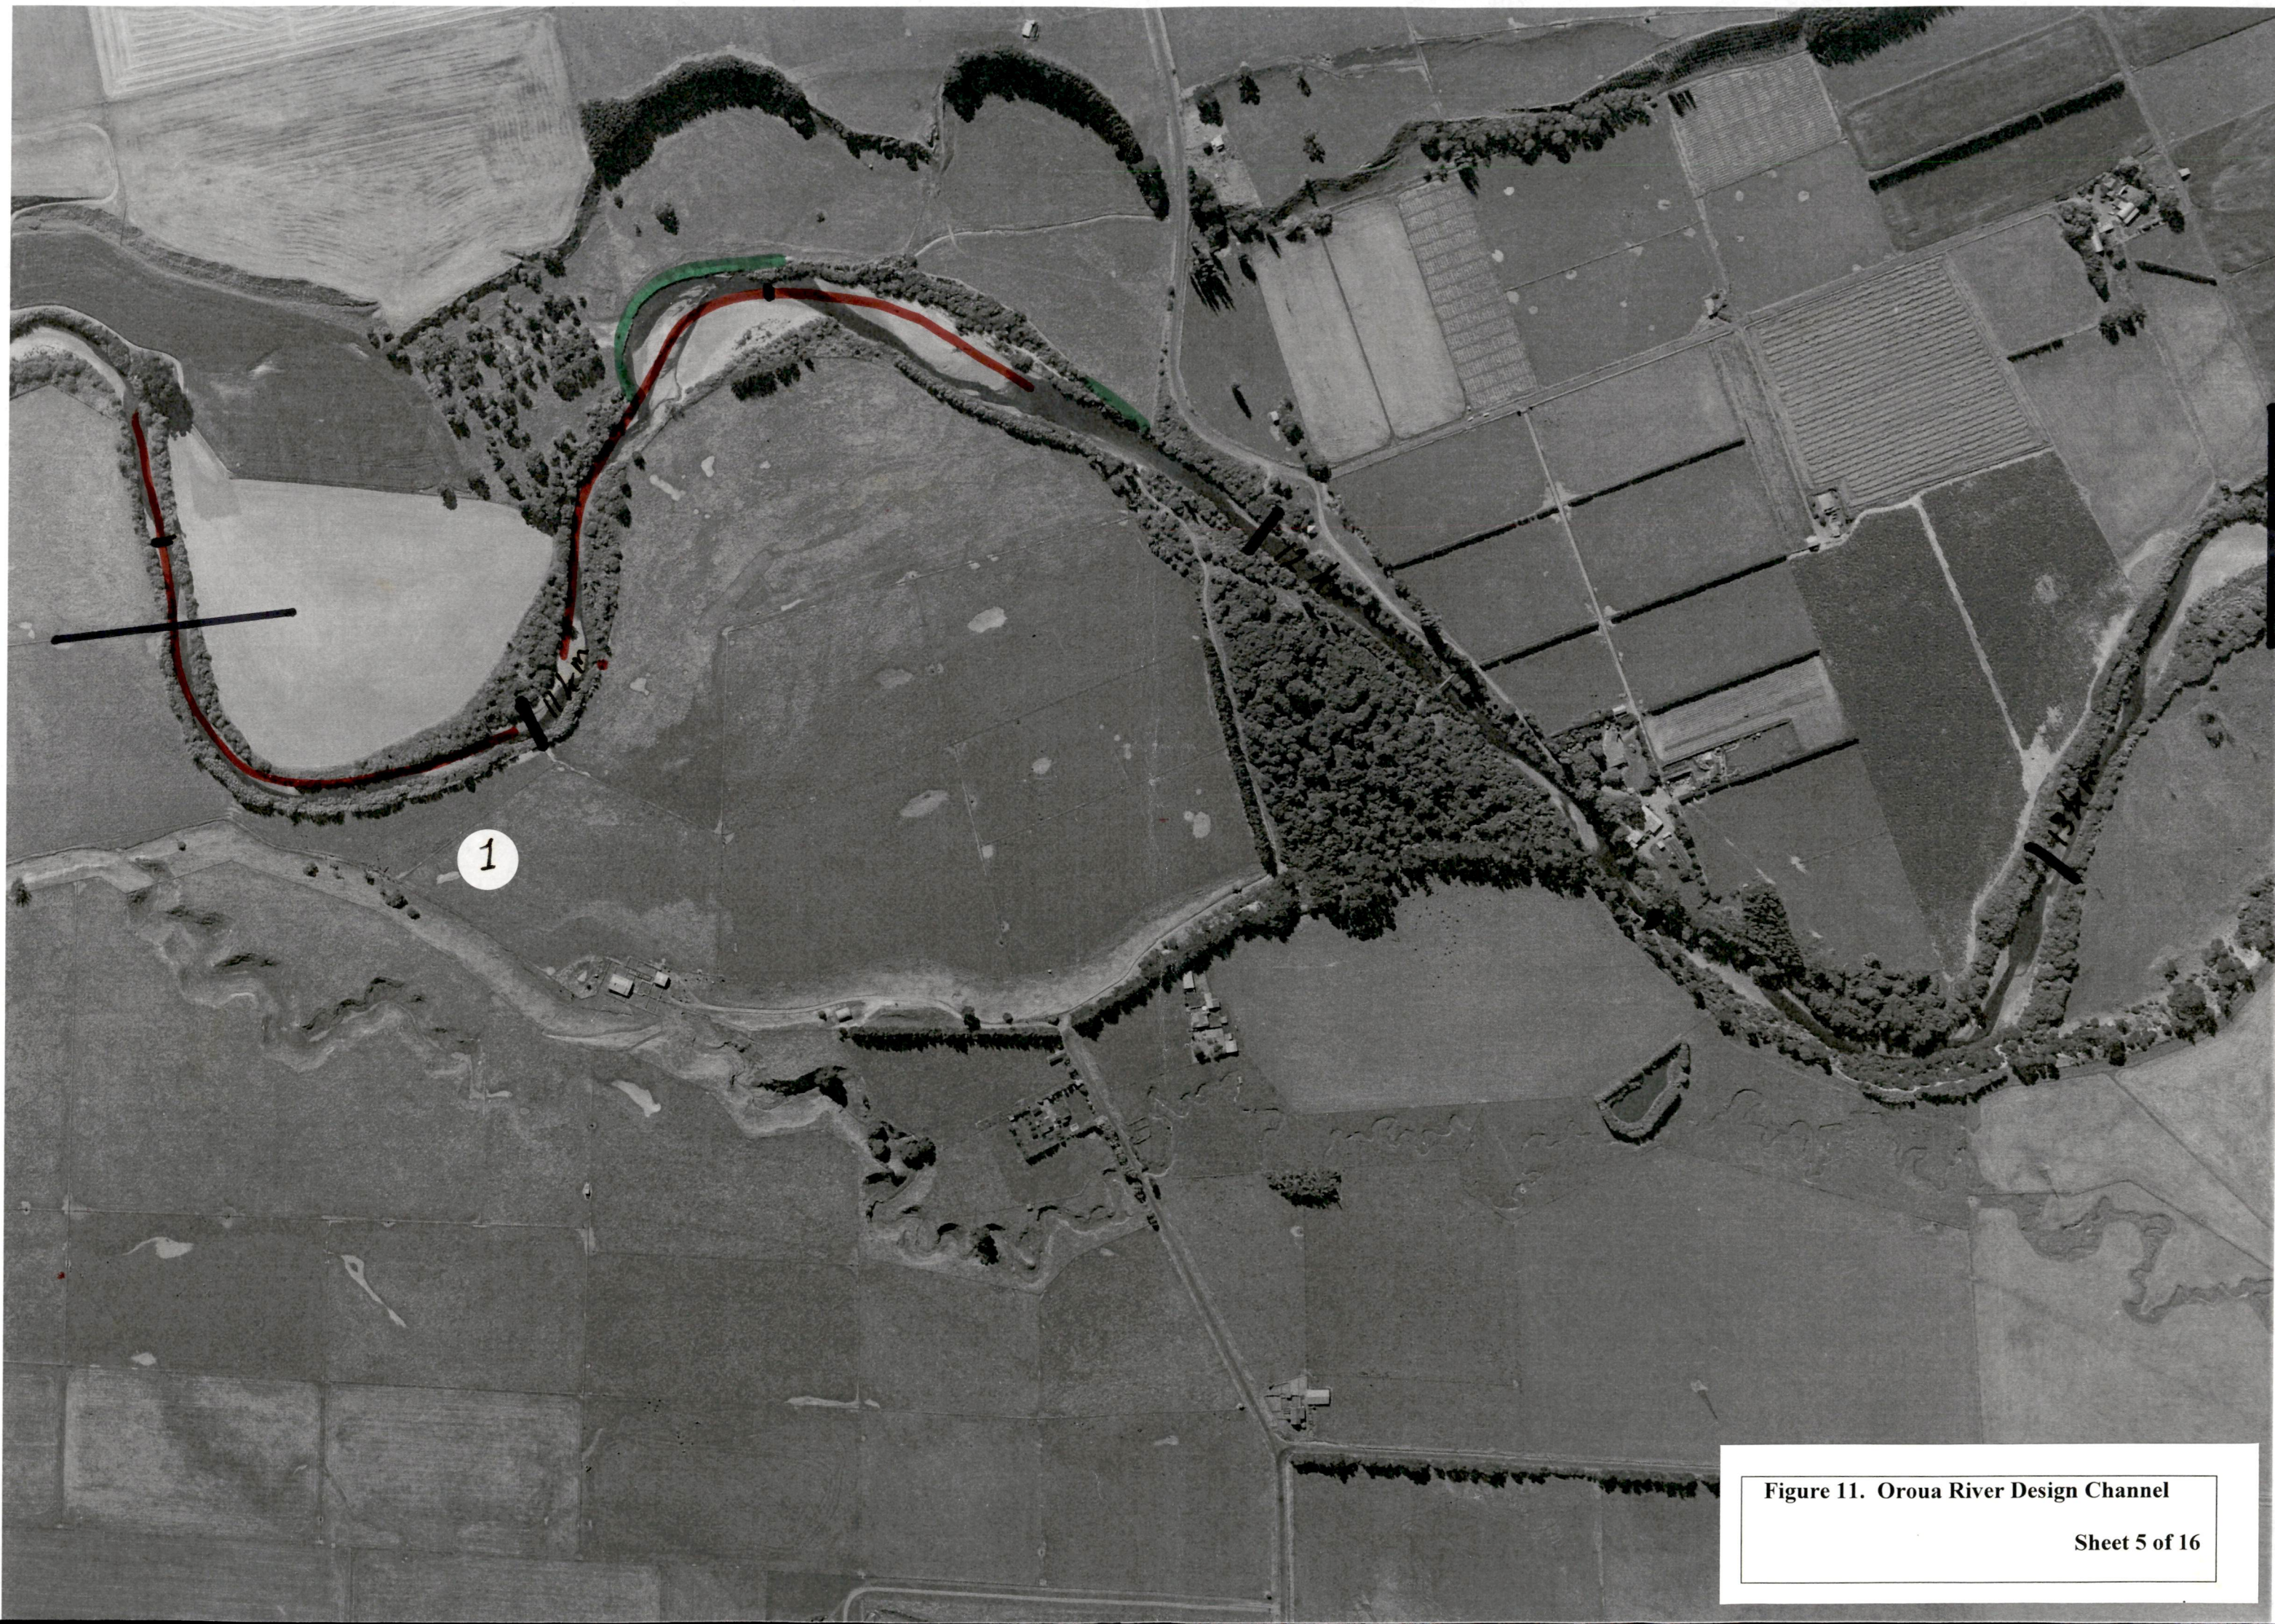
Figure 11. Oroua River Design Channel

As noted in Section 9 the overall alignment of the Oroua River cannot be significantly improved because the river is constantly being restarted from bend distortions and areas of harder materials. Design channels have however been drawn up for representative reaches and these can be used as a guide to management, site by site. Refer to sheets 13 & 14 of Figure 11.

○	Indicates Priority of various reaches of river
—	Indicates Priority reaches
—	Plantings
Km	River Distance
