Pohangina – Oroua Catchment Control Scheme Scheme Review

AMENDED REPORT

June 2006

Author
John Philpott
of
John Philpott & Associates Ltd

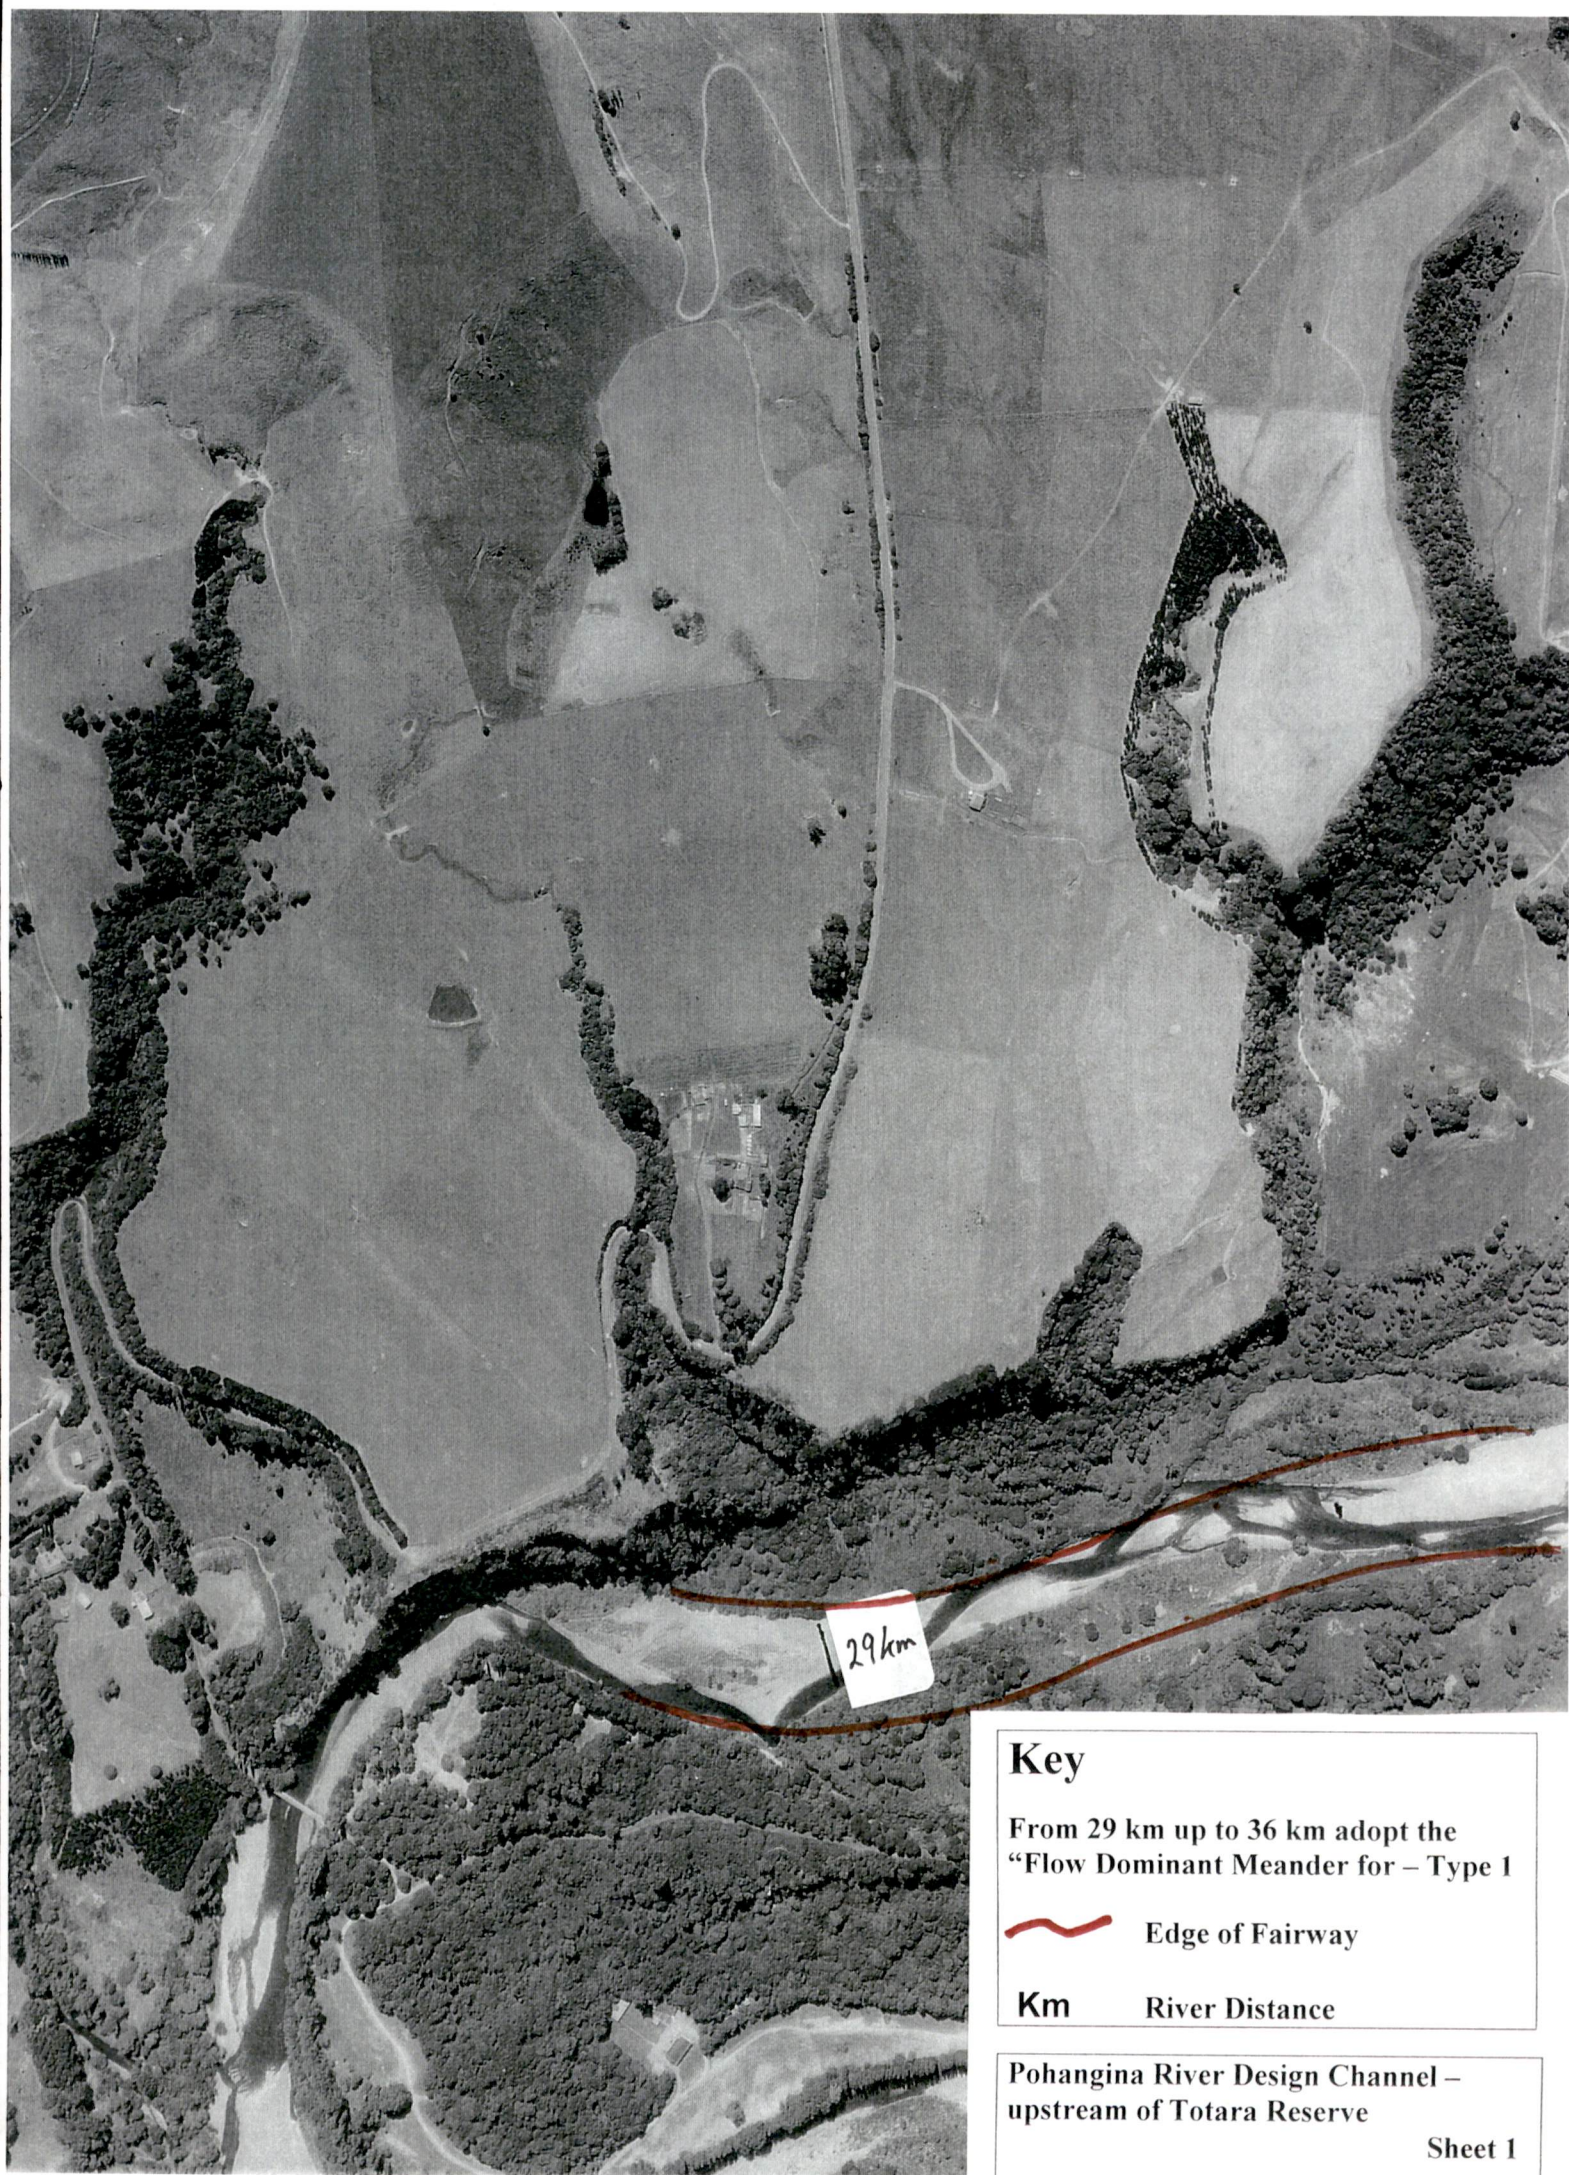
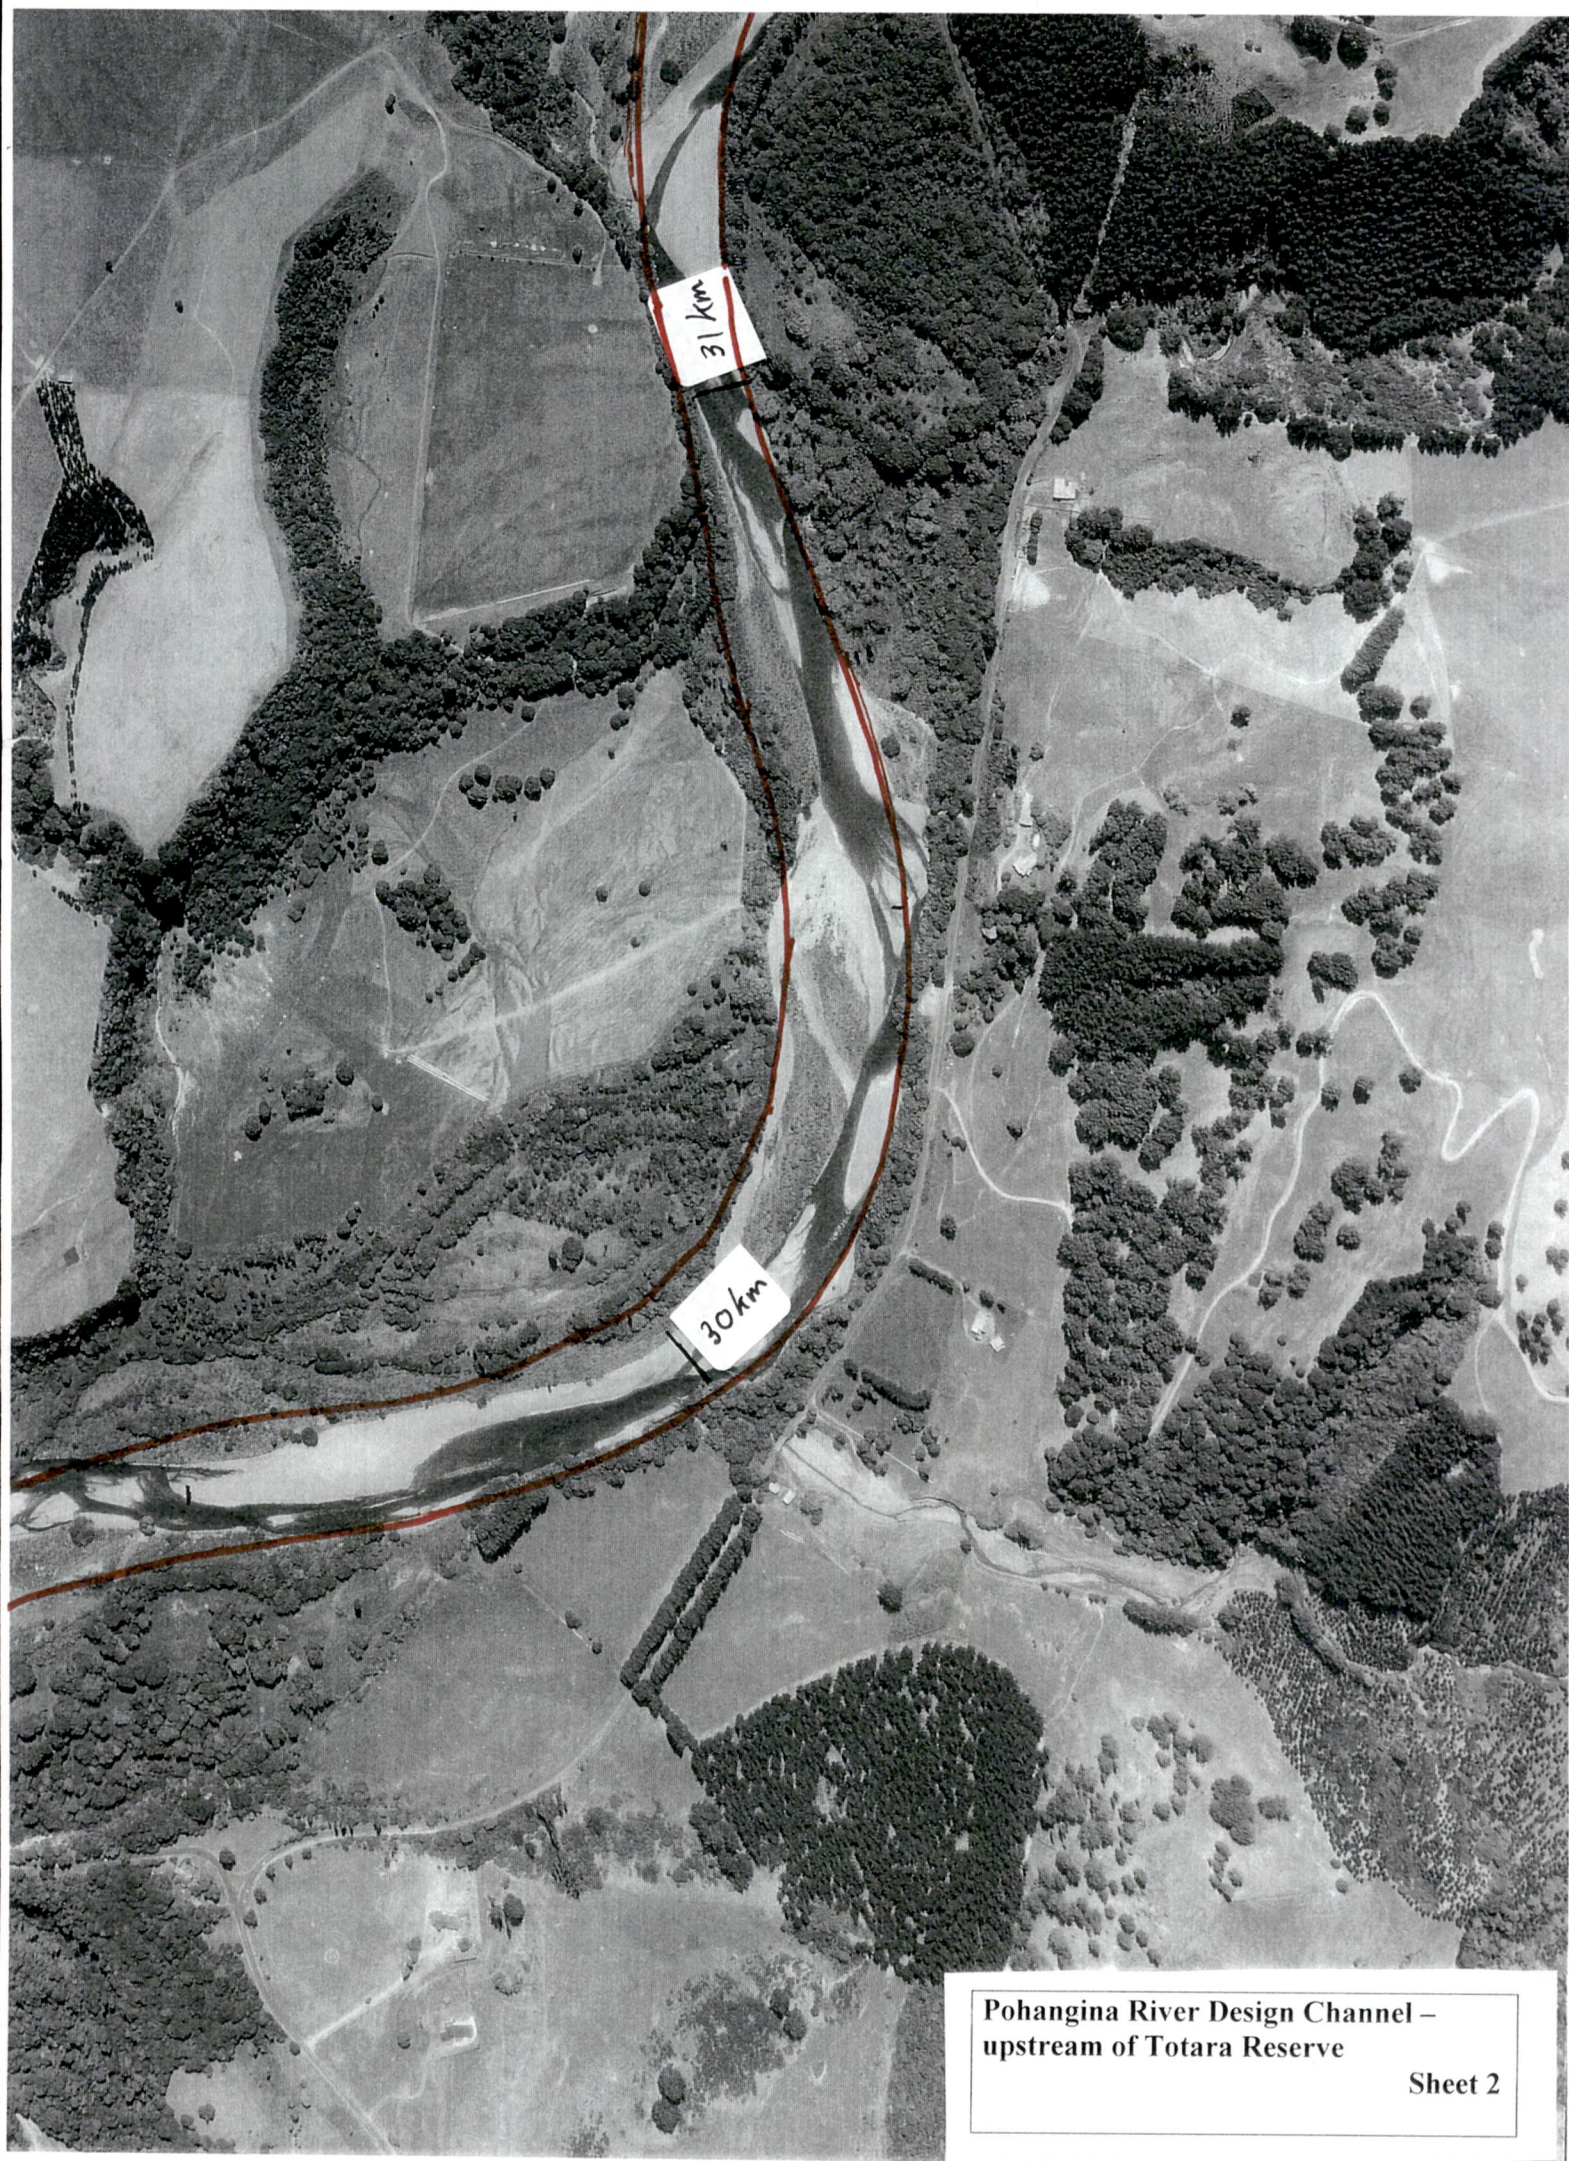
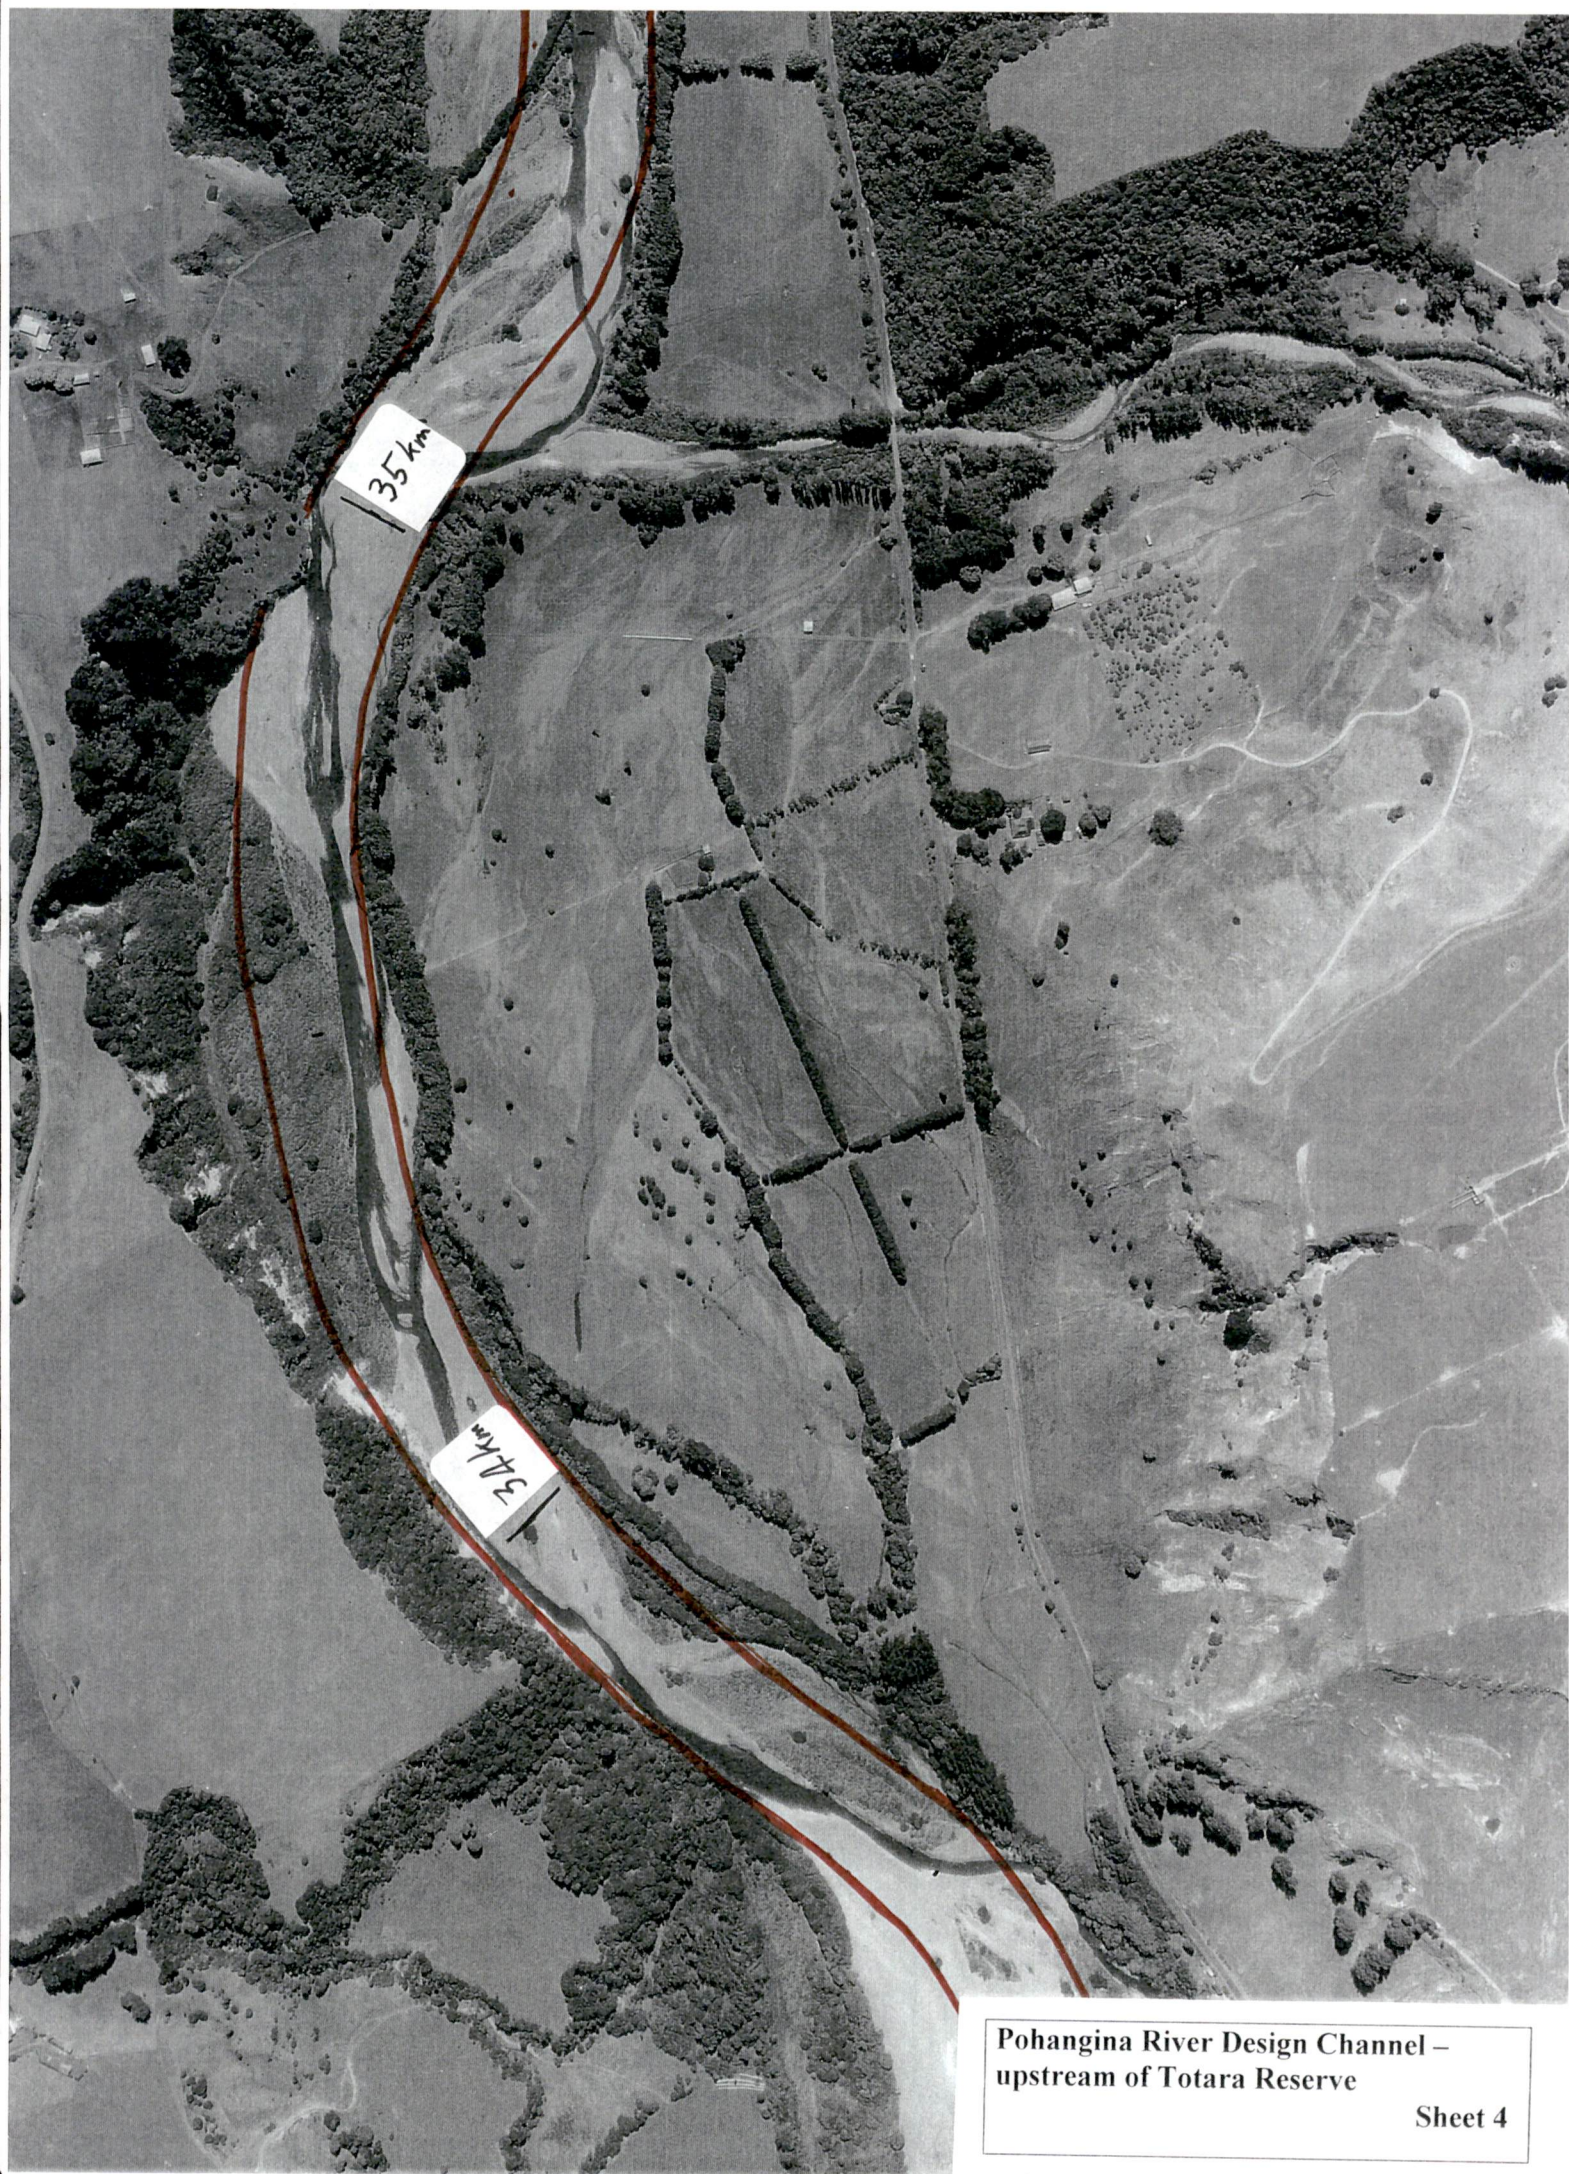
Pohangina River Design Channel –
upstream of Totara Reserve

From 29 km up to 36 km adopt the
"Flow Dominant Meander for – Type 1
