**HORIZONS REGIONAL COUNCIL**

**POHANGINA-OROUA SCHEME AUDIT**

**JULY 2013**

Report No: 2013/EXT/1316

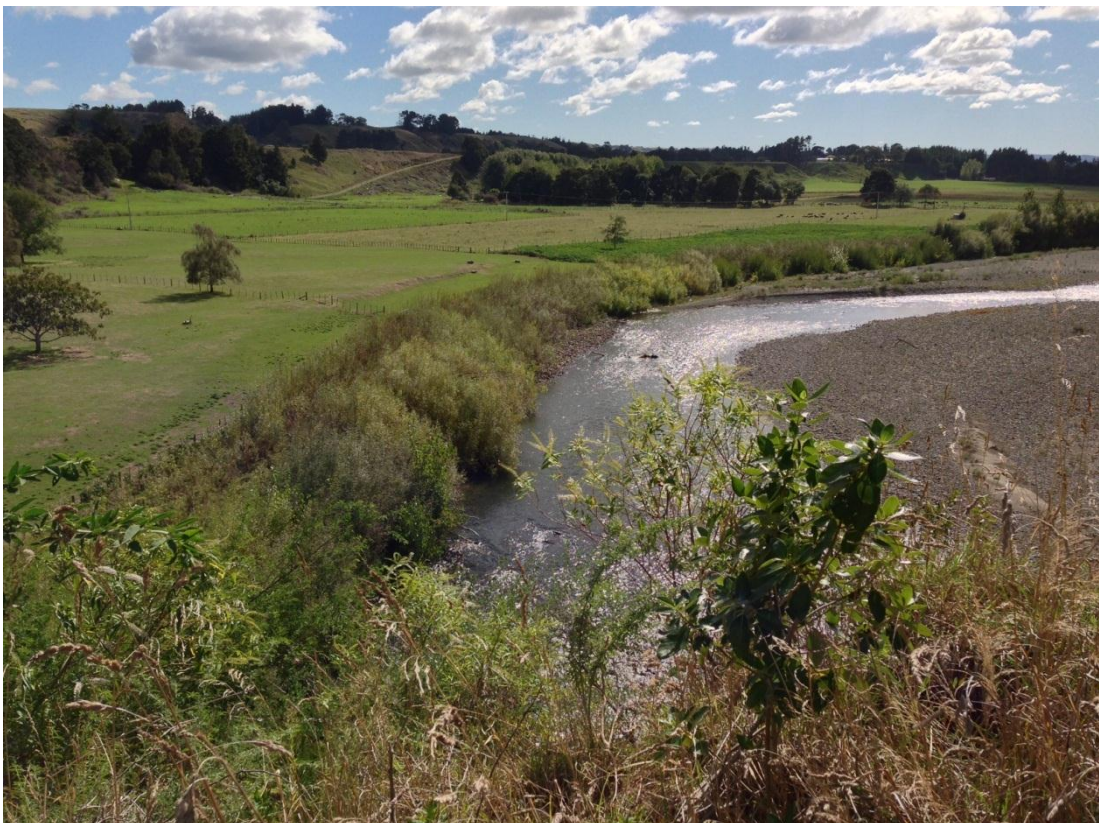
Plantings establishing well on right bank of Pohangina River at 5 km

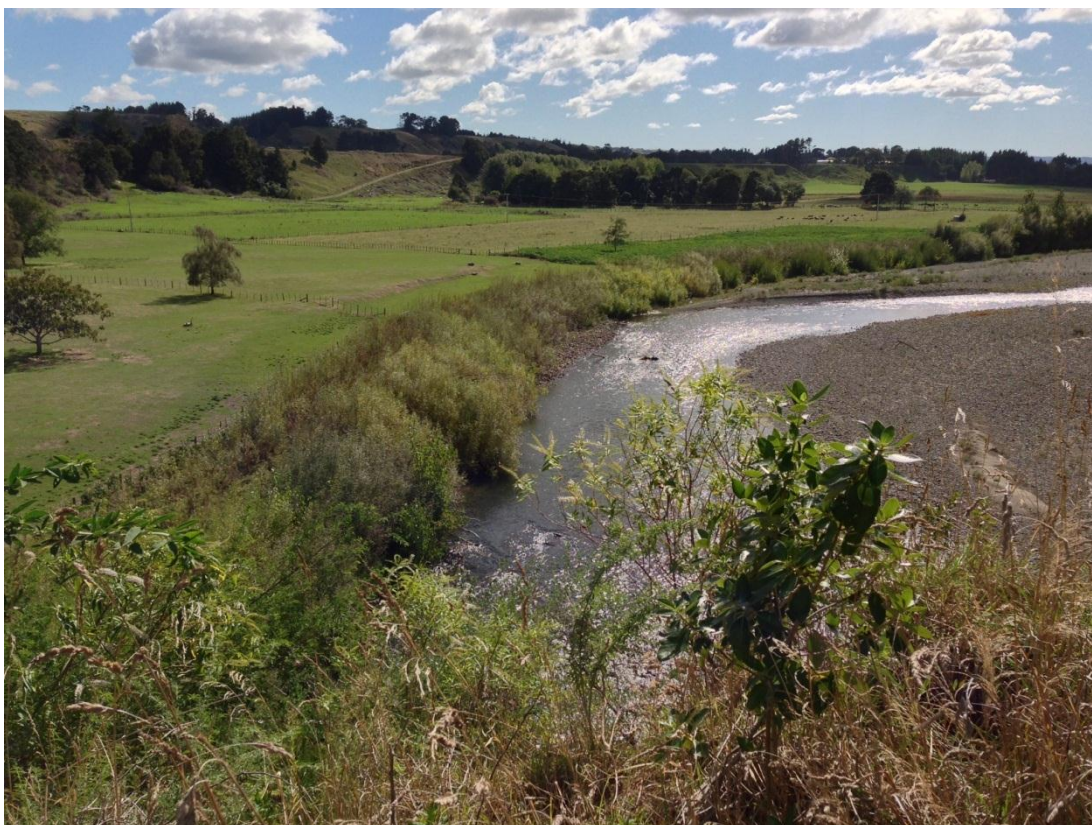
Currently the riverbank is protected by plantings and a small buffer zone and these are establishing well with good growth. It will be most important to increase the width of this buffer zone, to ideally the design width of 30 m, and periodically layer the willows. This is the most practical and affordable option.

**Photograph 1: Plantings establishing well on right bank at Helen Johnson's 5 km Pohangina River**

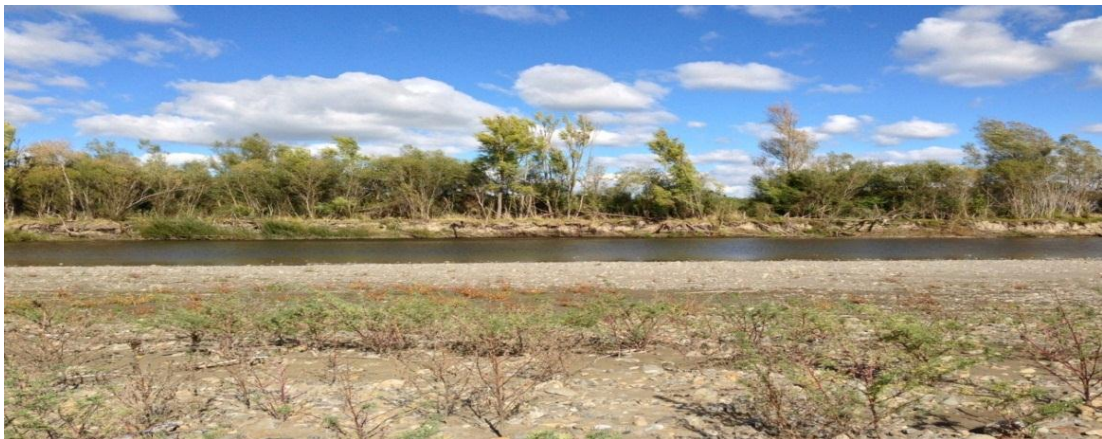
**Photograph 2: Erosion on left bank at McDonald river distance 14.6 km**

It will take a concerted and cooperative effort between landowners on both banks here to attempt to mitigate this erosion. The erosion on the left bank is shown in Photographs 2 and 3.

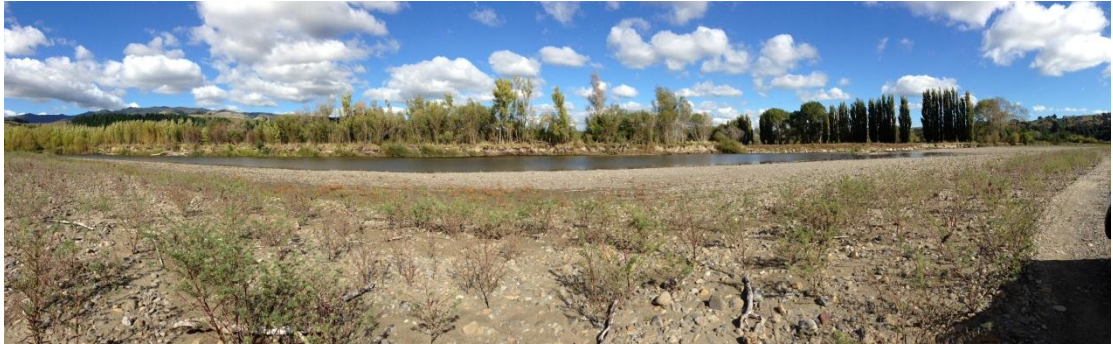
**Photograph 3: Panorama of erosion on left bank at McDonald river distance 14.2-14.8 km**

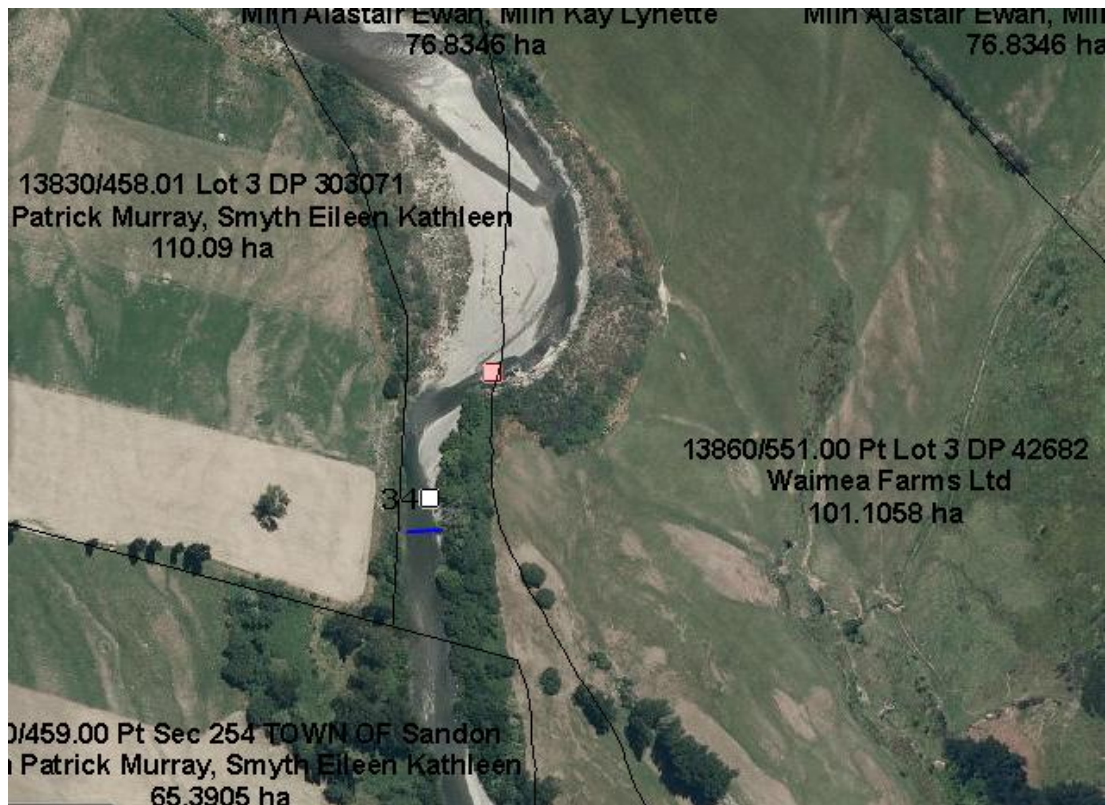
There is a high beach on the right bank in this reach and this is putting pressure on the opposite riverbank. However, the root cause is the very narrow reach immediately downstream. This reach is as narrow as 20 m wide and is a major obstruction to flow. The consequence is that the throttled river slows down and deposits on the beach upstream, with consequent erosion on the opposite riverbank (refer photo imagery).

**Photograph 4: Aggrading beach upstream of 34 km and narrow reach throttling flow (blue line)**

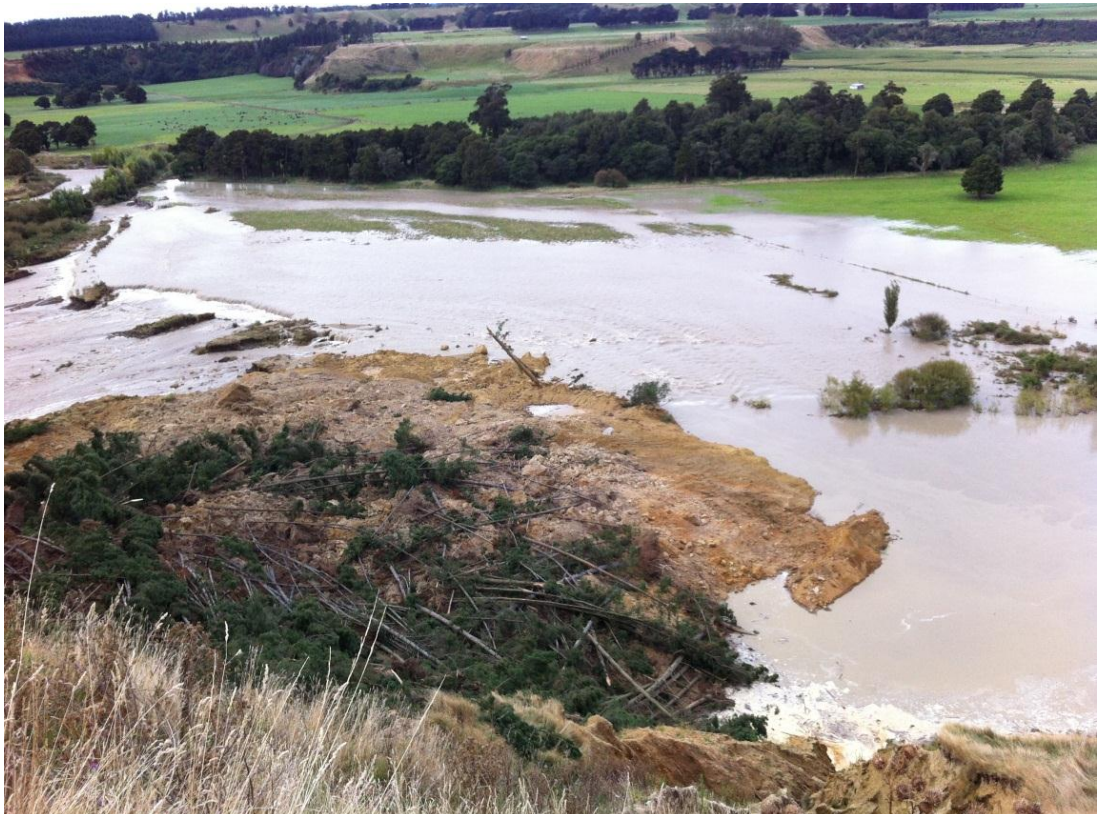
Through this reach several slips are evident on the true left bank. Some smaller slips are active through the reach from 23.5 to 24.2 km, but these appear to currently be stable. There is a very large slip from river distance 19.7 to 20.0 km below a forestry block. During a storm on 20 and 21 March 2012, this slip had a substantial collapse and completely blocked the river. The Oroua River was forced to travel across the adjoining pasture on the right bank, until a diversion channel was cut to return it to the old course. The flood event was 170 cumecs - almost exactly a mean annual flood.

**Photograph 7: Large slip off forestry block at river distance 20 km**

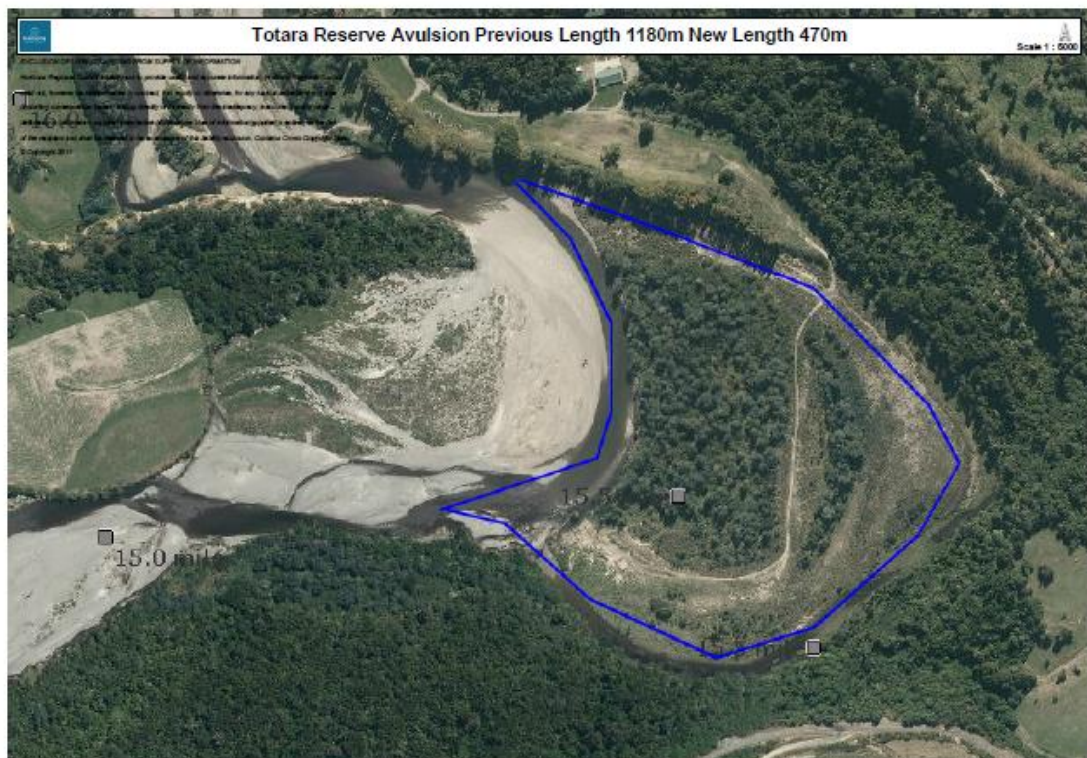
In 2008 a major river avulsion occurred, cutting off the long bend immediately downstream of the camping area. The breakthrough quickly developed into a channel of normal width, while re-vegetation rapidly took place over the abandoned channel reach. Refer photograph 8. The river bend lost almost 700 m in length. At the prevailing river grades this represents a mismatch in riverbed levels of around 3 m, so significant riverbed level adjustment would be expected to occur – maybe over a period of several years.

**Photograph 8: Totara Reserve avulsion**

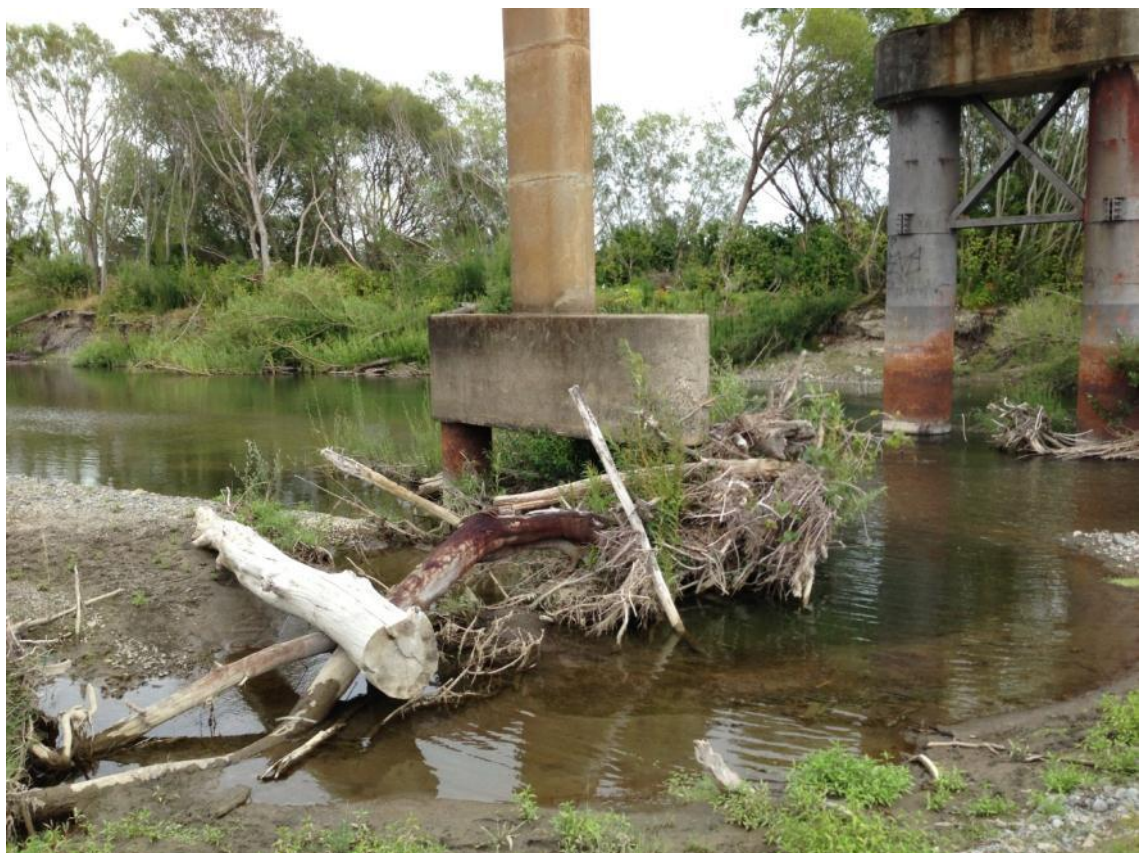
The degradation at the bottom of the Pohangina is a worrying trend as it has the potential to undermine bridges as well as bank protection works. Furthermore, the degradation is starving the, already degraded, Lower Manawatu River of an important gravel source.

**Figure 15: Rail Bridge abutments**

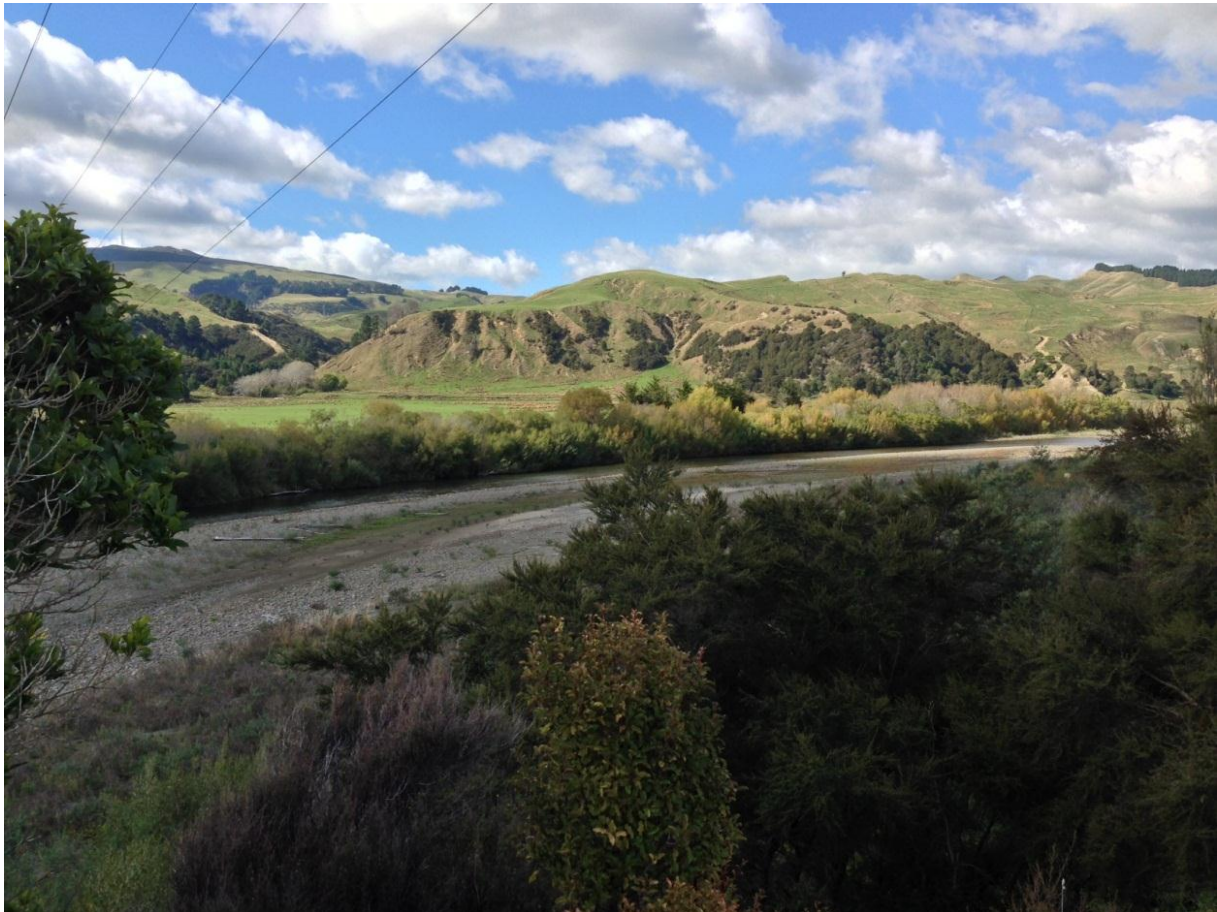
The Pohangina River is right on the desired alignment on the outside of bend left bank. Hugh Akers has installed several competent groynes, predominantly *Macrocarpa* (Photograph 1).

**Photograph 1:** Stable left bank opposite with Akers groynes from pylon 4 to 4.8 km

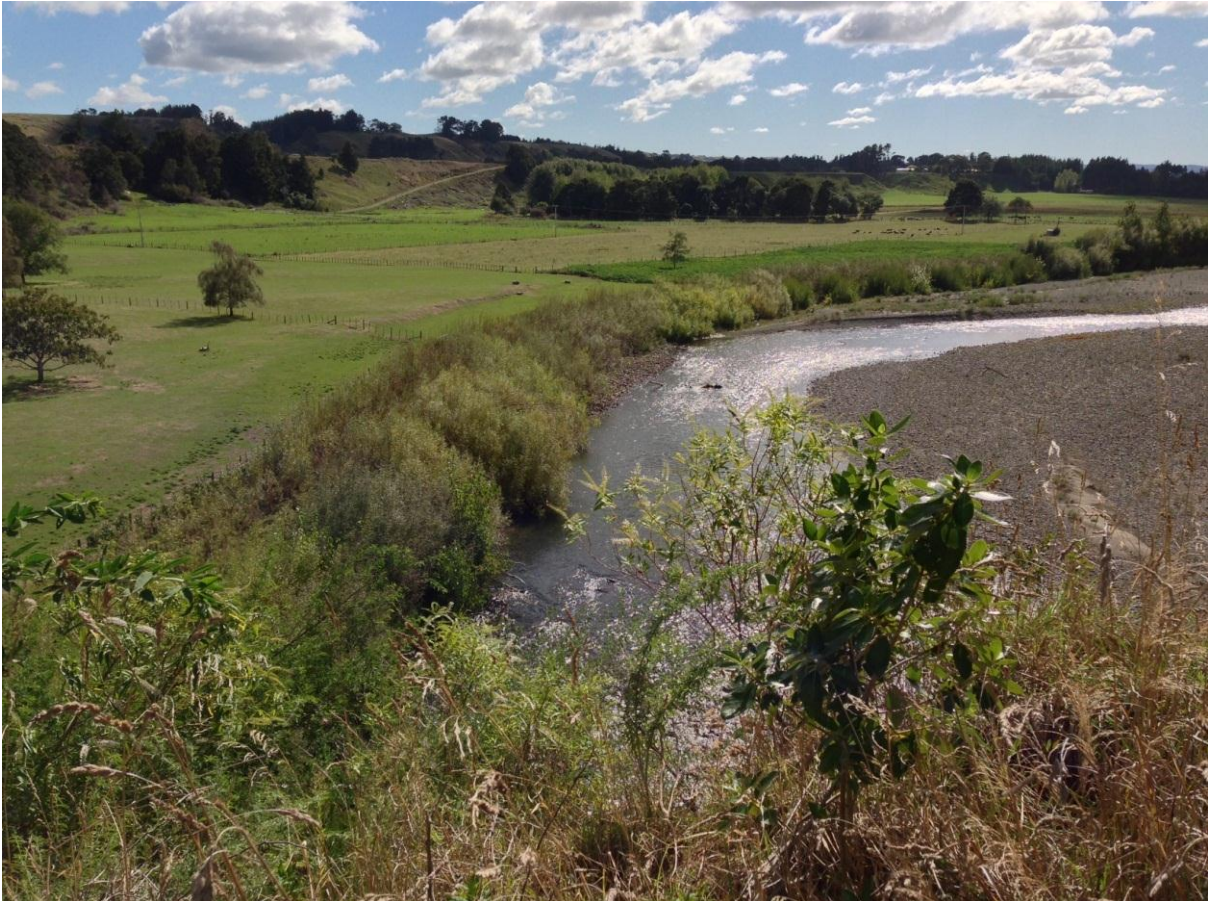
Currently, the riverbank is protected by plantings and a small buffer zone and these are establishing well with good growth. It will be most important to increase the width of this buffer zone, to ideally the design width of 30 m, and periodically layer the willows. This is the best practical option affordable.

**Photograph 2:** Plantings establishing well on right bank at Helen Johnson's 5 km

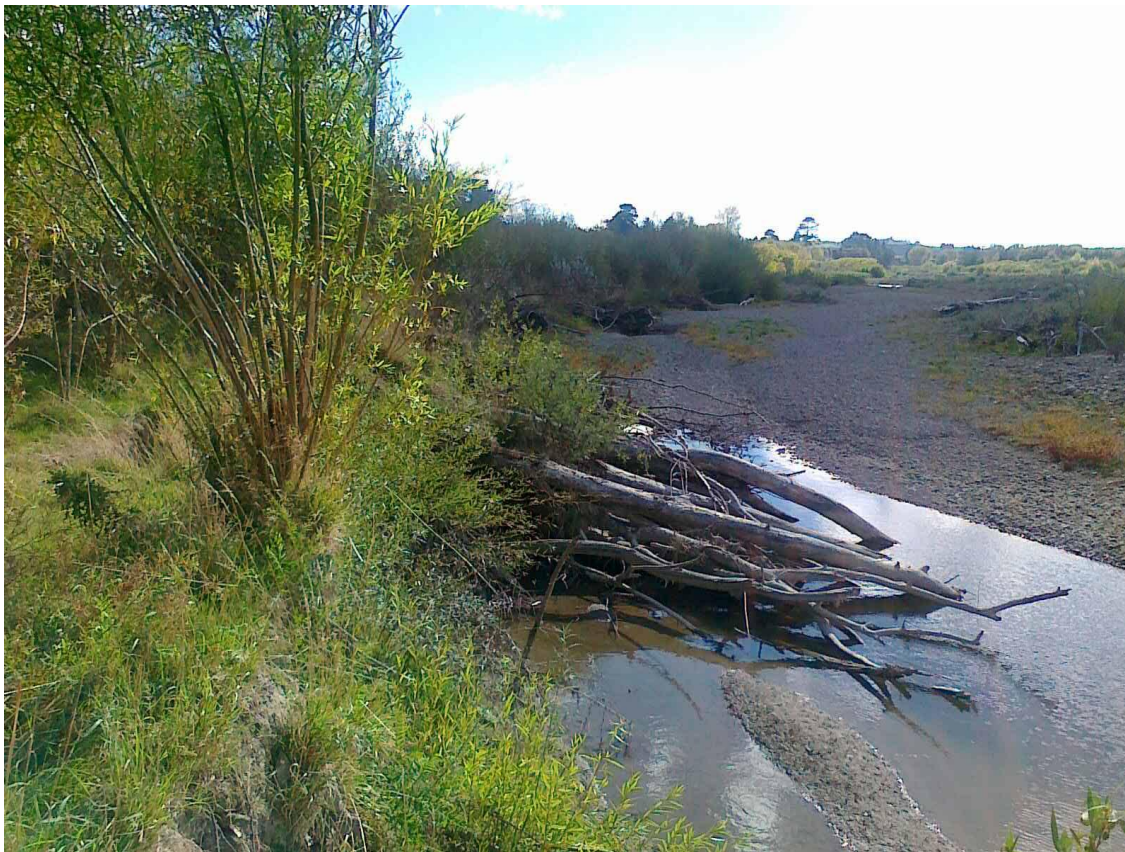
Interestingly the design channel form recommended by Williams widens to the 180 m Fairway Channel for around 1 km upstream of this point; thence returning to the flow dominant channel. The exact positioning and type of channel through this reach is a bit arbitrary and where the channel is outside the design channel is not a threat to the accretion land. The important point will be to monitor this reach closely.

**Photograph 3:** Established tree groyne on right bank at 7.2 km.

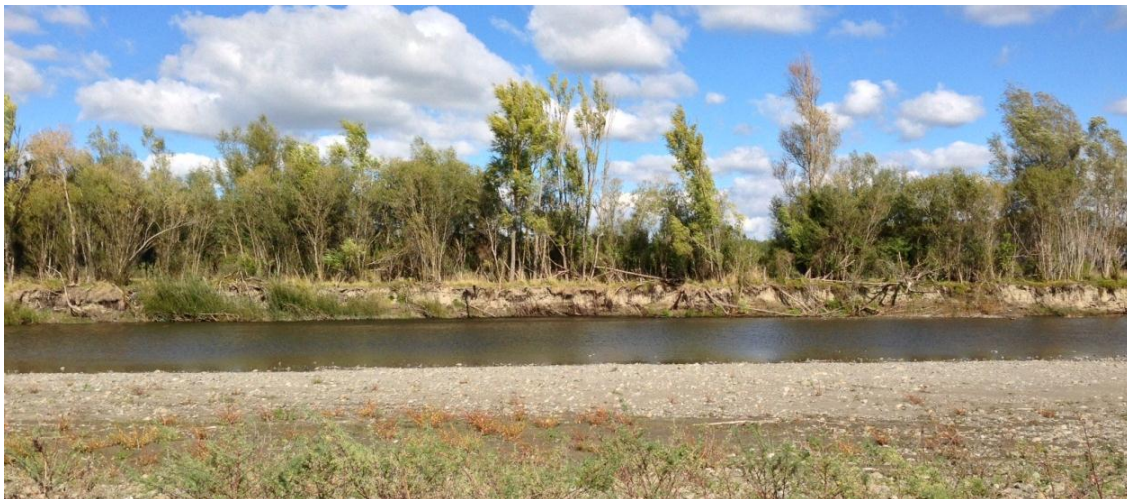
**Photograph 4:** Erosion on left bank at McDonald river distance 14.6 km

It will take a concerted and cooperative effort between landowners on both banks here to attempt to mitigate this erosion. The erosion on the left bank is shown in Photographs 4 and 5.

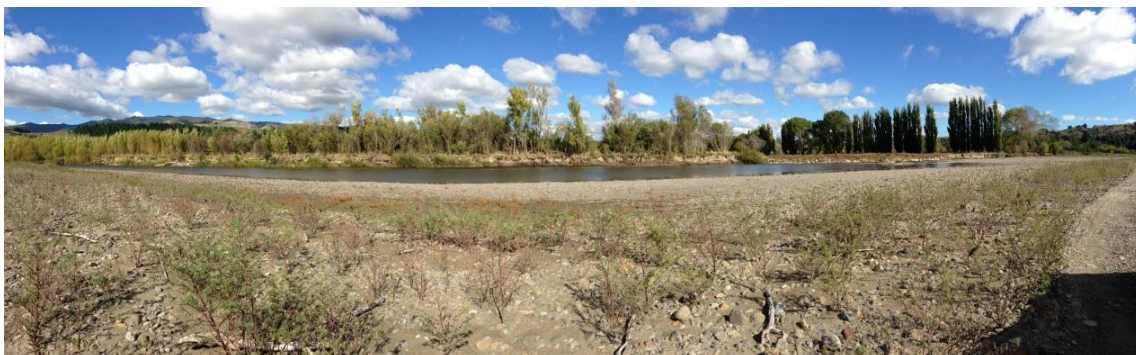
**Photograph 5:** Panorama of erosion on left bank at McDonald river distance 14.2-14.8 km

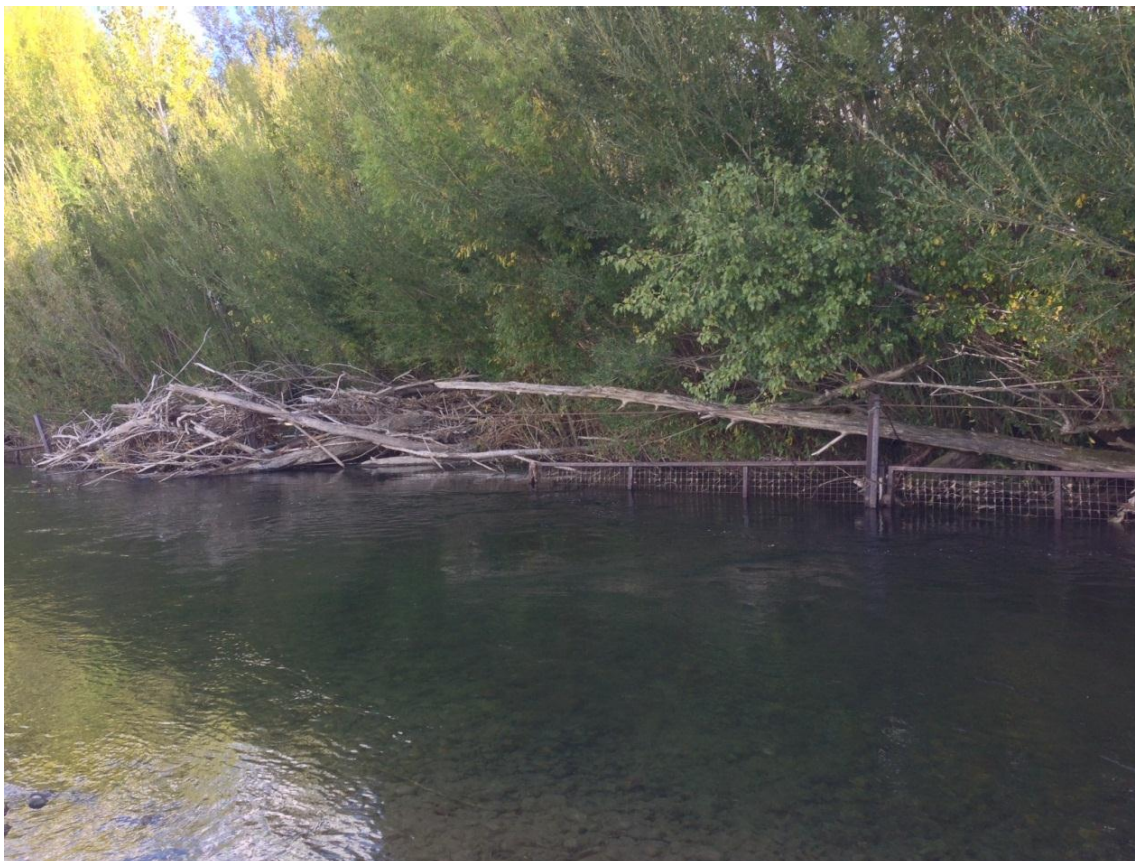
**Photograph 6:** PMU units and the very good vegetative swathe established behind at river distance 15.2-15.6 km

A high beach opposite the PMUs should be lowered.

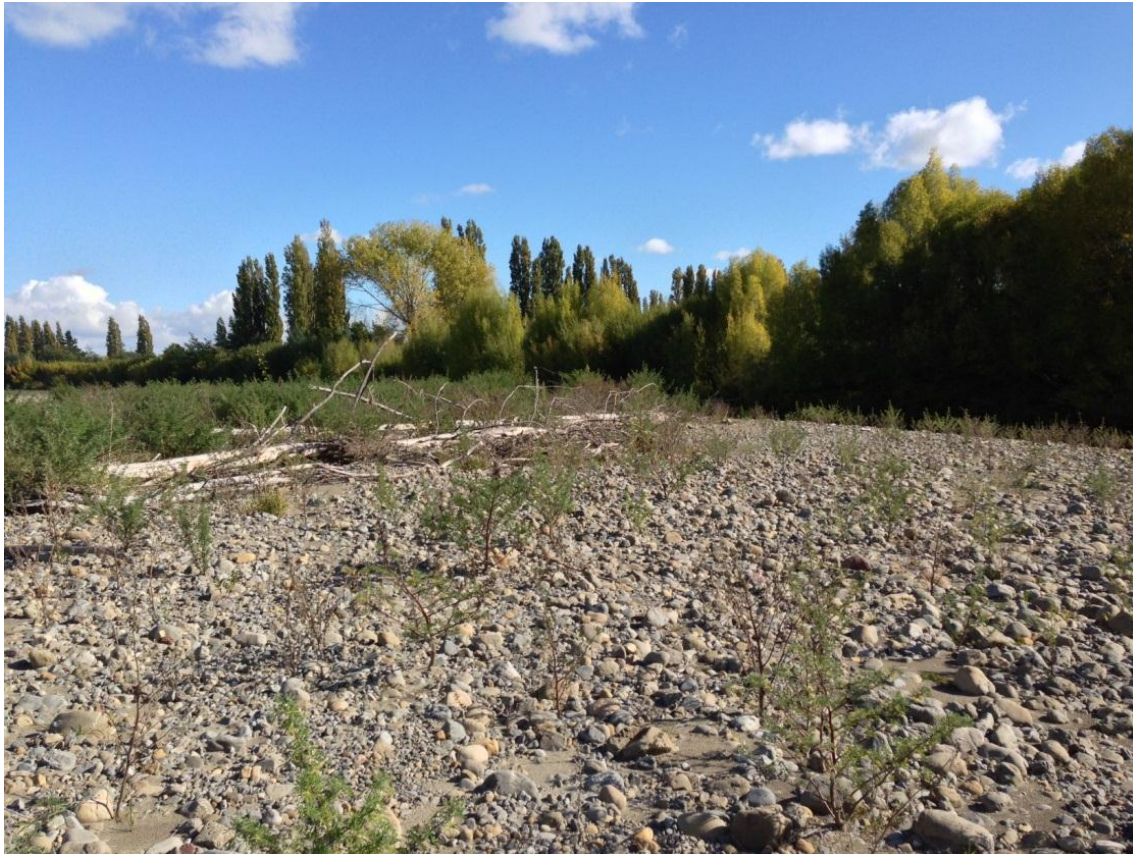
**Photograph 7:** Higher beach that requires clearing and lowering at river distance 16.3 km

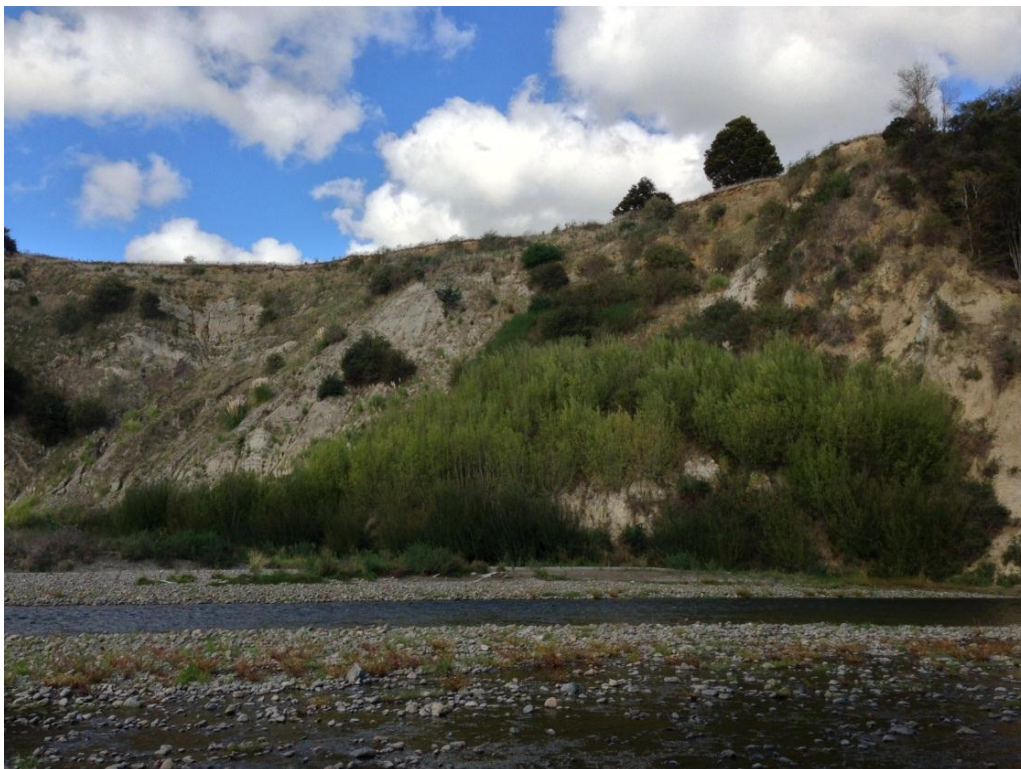
The river alignment is outside the design channel by the big slip on the left bank. The slip appears stable at present and is unlikely to adversely affect the Pohangina River in the foreseeable future.

**Photograph 8:** Currently stable slip on left bank at river distance 17.2-17.3 km

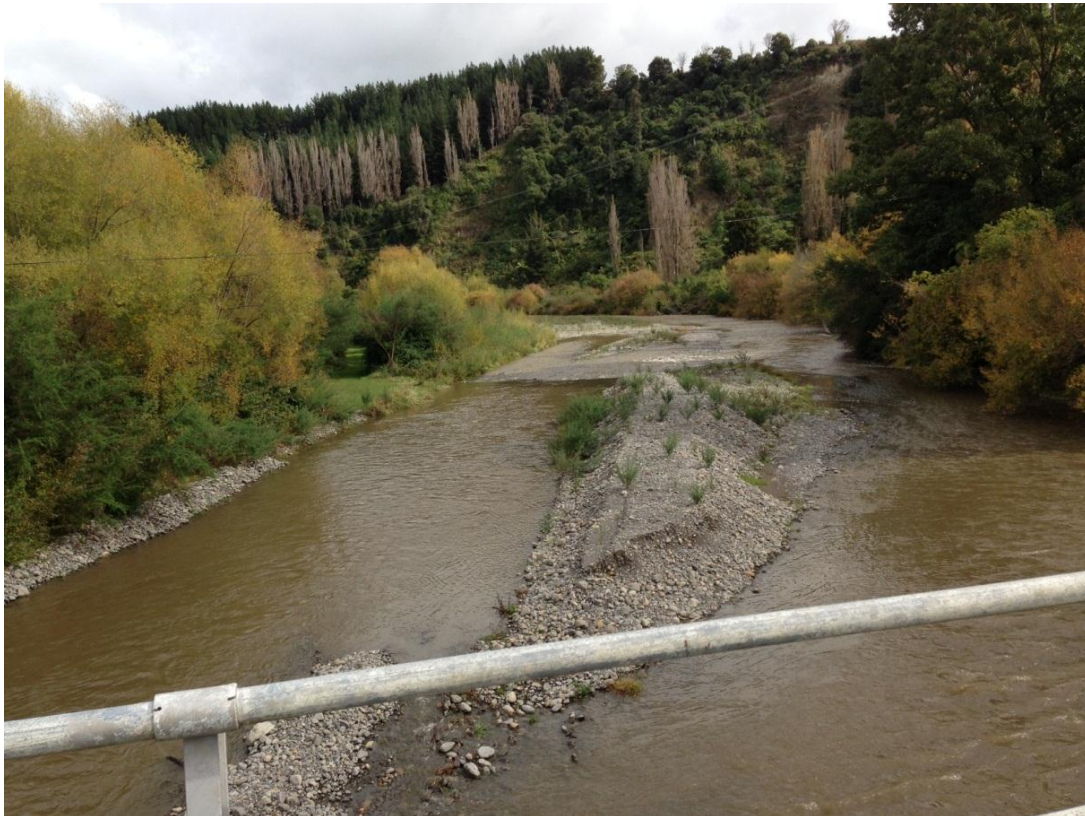
**Photograph 1:** Looking downstream from Londons Ford Bridge. MDC water intake on left bank in channel that is periodically cleared and gravel redistributed. River distance 40.7 km.

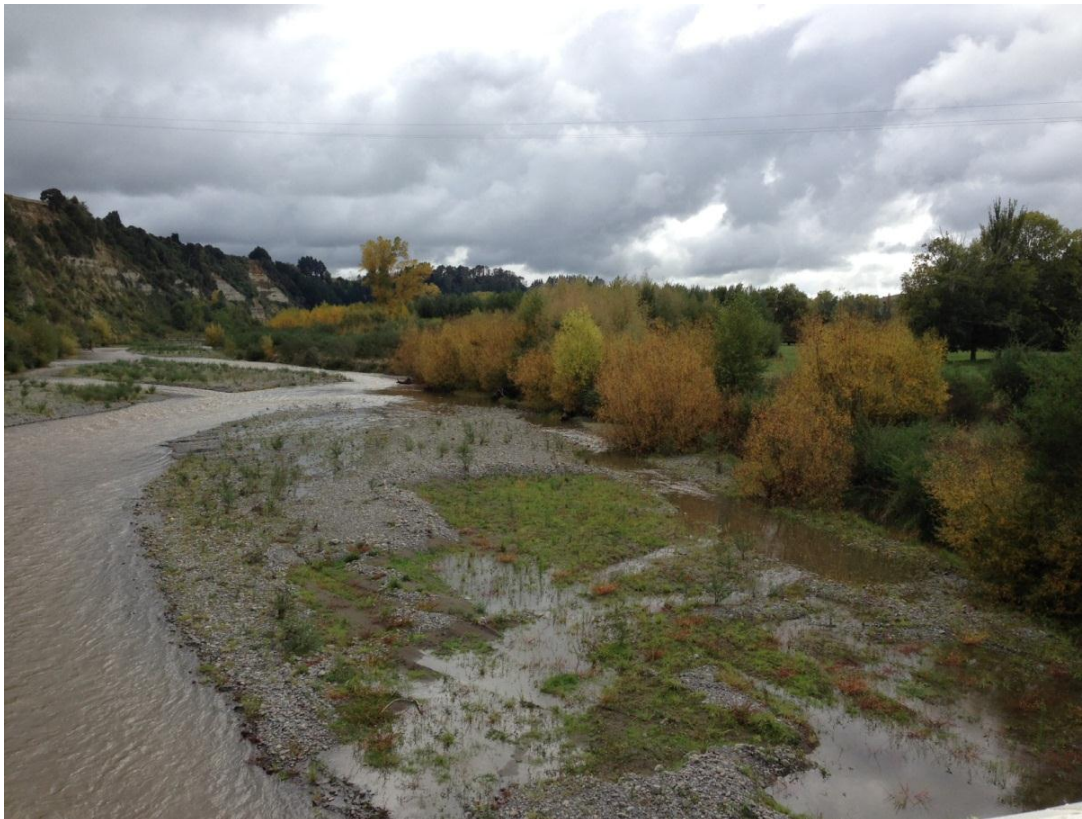
**Photograph 2:** Aggraded beaches 39-40 km reach. Need to be kept clear of vegetation and lowered.

The Oroua River bed levels are frequently high in this vicinity and flooding of the right bank is accentuated in places. It will be important to keep the beaches clear and where possible, extract some gravel to lower the beaches. Refer Photograph 2.

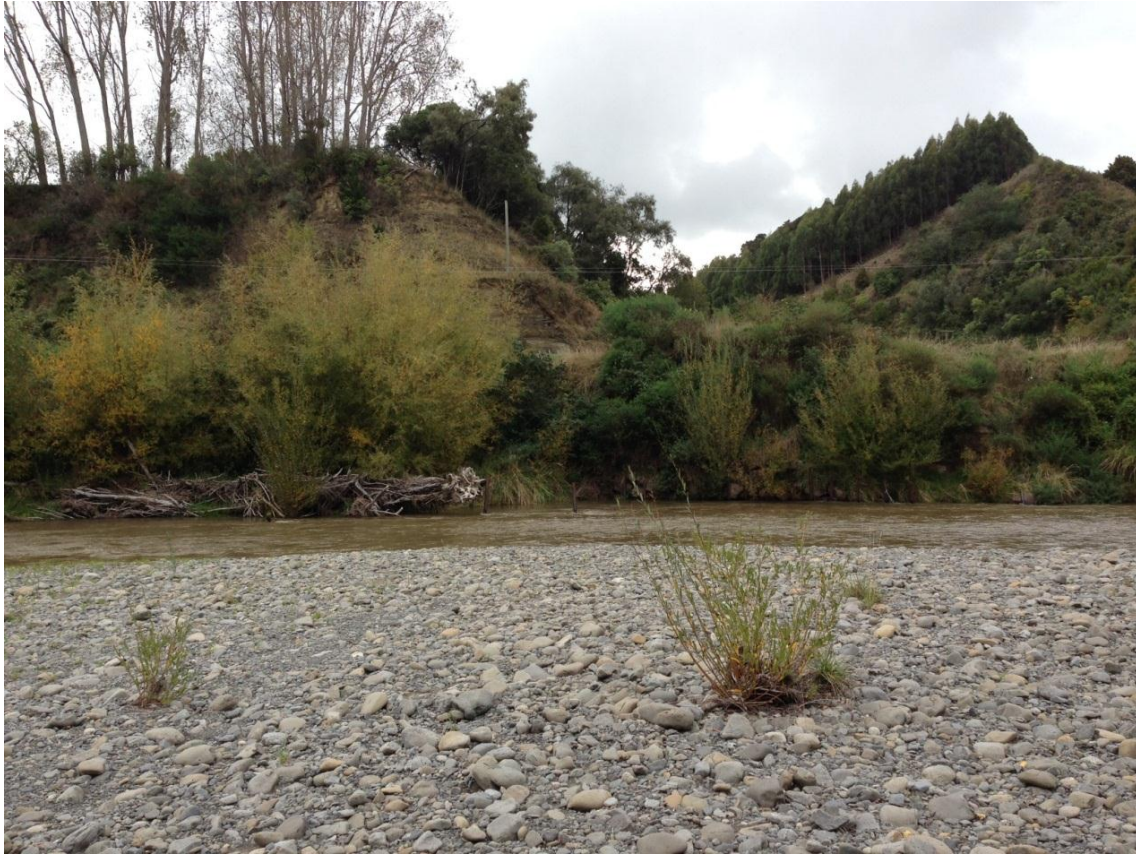
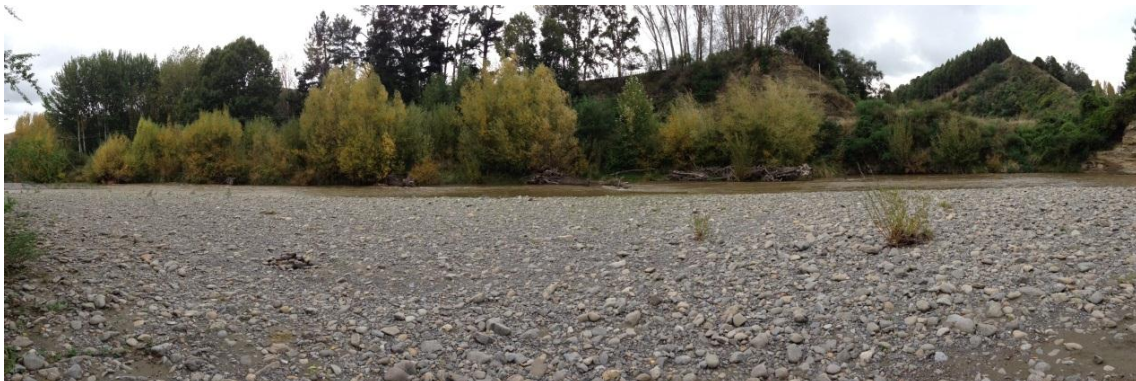
Permeable rail iron groynes are also located on the right bank at distance 36.4 km and appear to be in reasonably good condition.

**Photographs 3 and 4:** Permeable rail iron groynes opposite Bartletts Reserve protecting road.

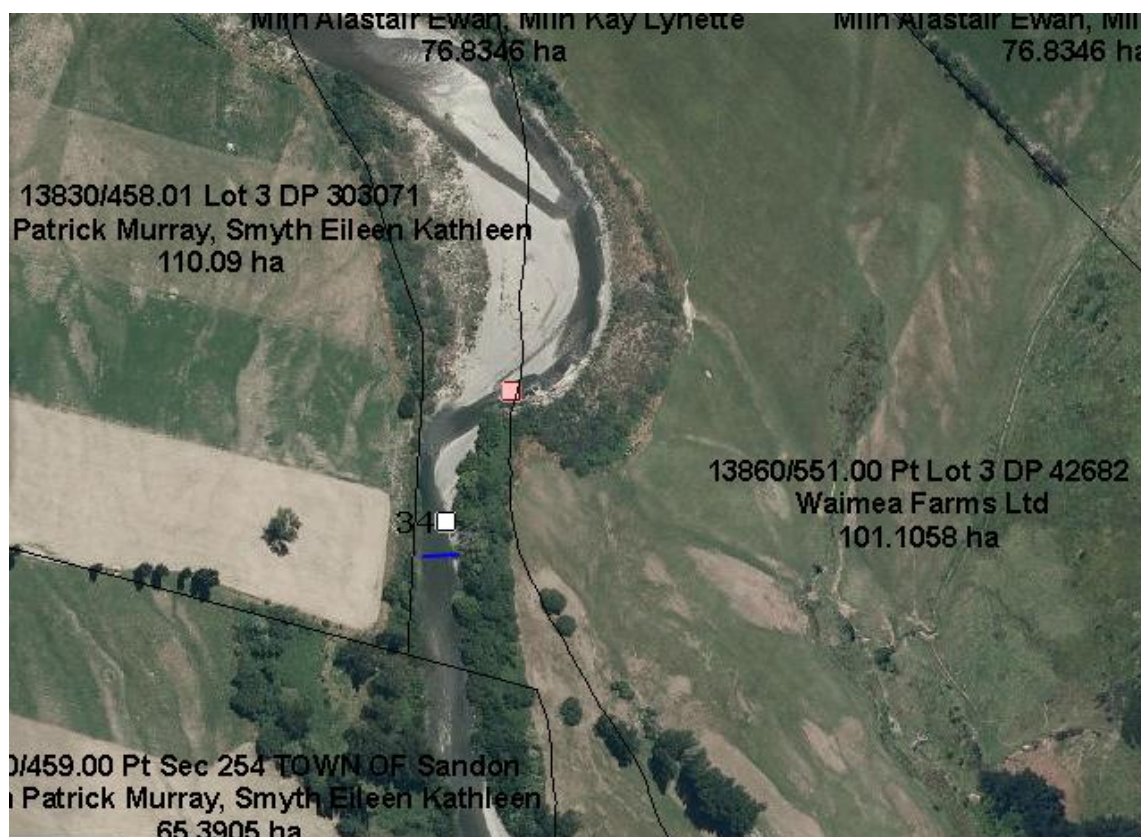
There is a high beach on the right bank in this reach and this is putting pressure on the opposite riverbank. However, the root cause is the very narrow reach immediately downstream. This reach is as narrow as 20 m wide and is a major obstruction to flow. The consequence is that the throttled river slows down and deposits on the beach upstream, with consequent erosion on the opposite riverbank (refer photo imagery).

**Photograph 5:** Aggrading beach upstream of 34 km and narrow reach throttling flow (blue line)

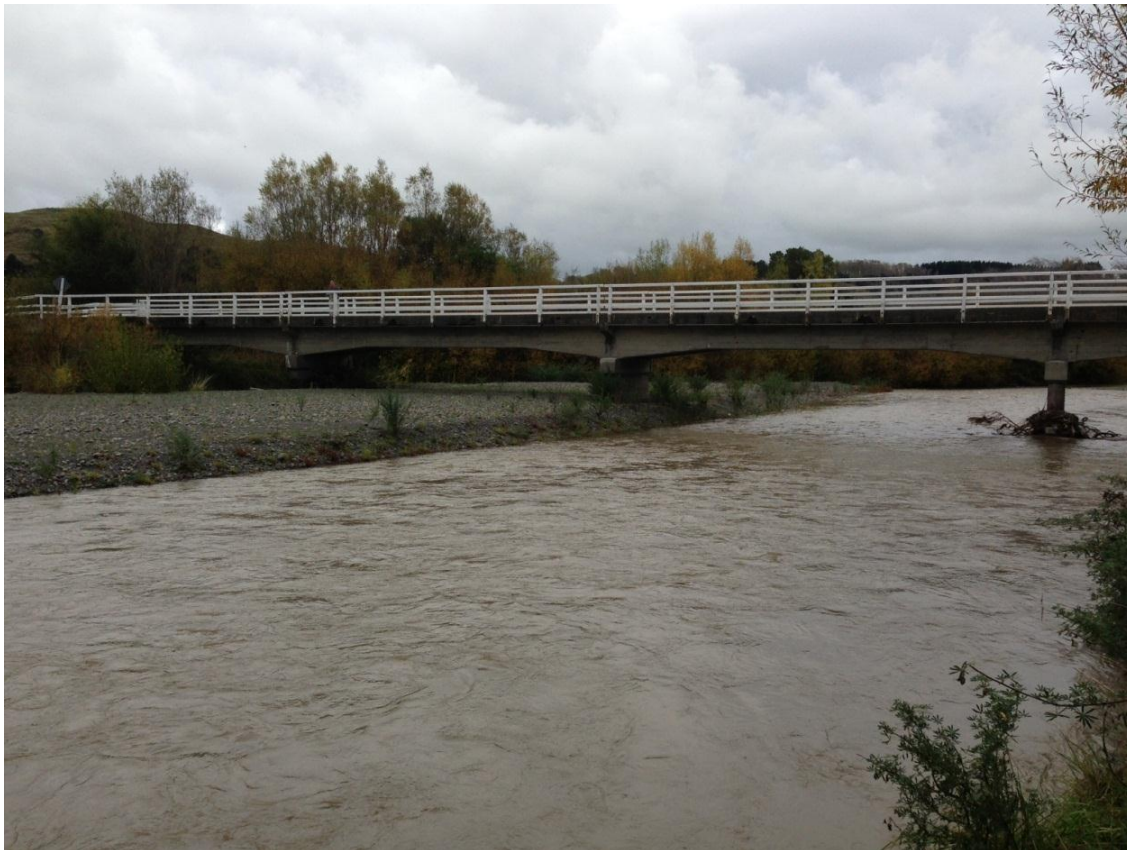
The river is significantly aggraded at Coulters Line Bridge. In years past there was plenty of clearance for passage of vehicles underneath, but that is impossible now – refer Photograph 8.

**Photograph 8:** Significant aggradation at Coulters Line Bridge 25.9 km

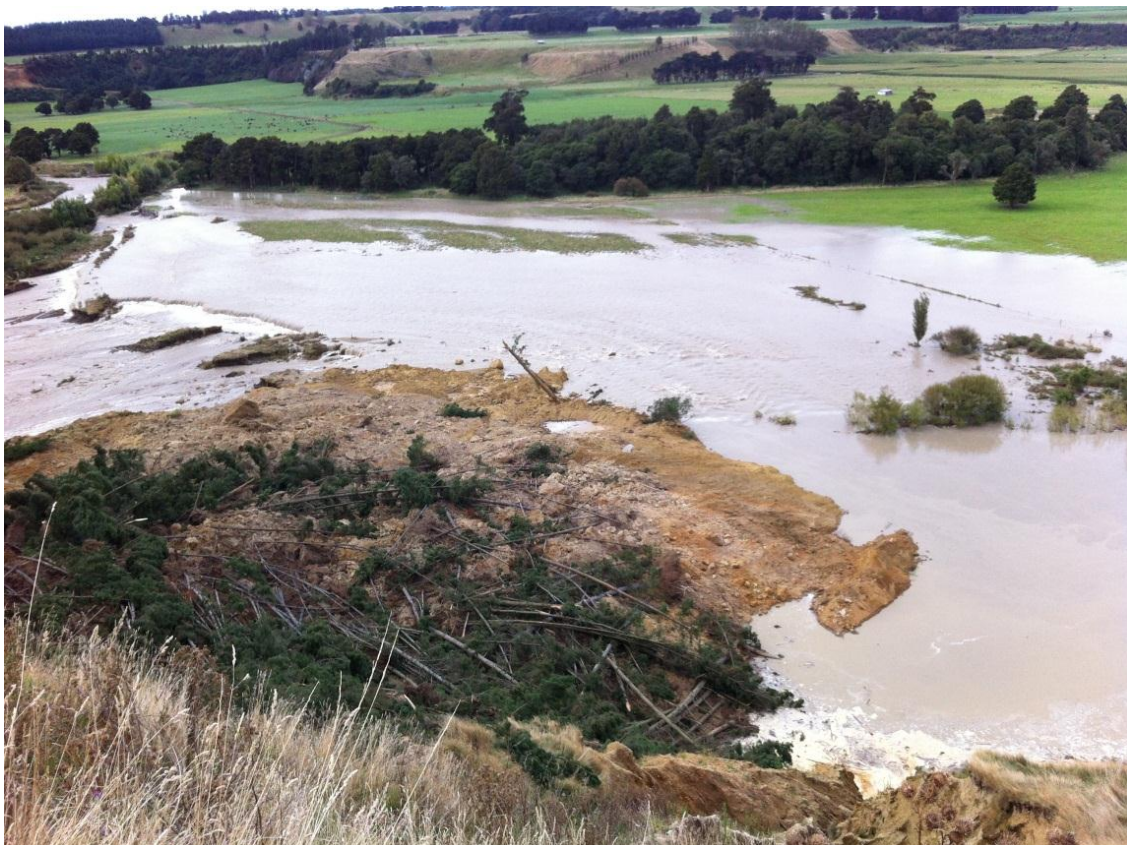
storm on 20 and 21 March 2012, this slip had a substantial collapse and completely blocked the river. The Oroua River was forced to travel across the adjoining pasture on the right bank, until a diversion channel was cut to return it to the old course. The flood event was 170 cumecs - almost exactly a mean annual flood.

**Photographs 9 & 10:** Large slip off forestry block at river distance 20 km

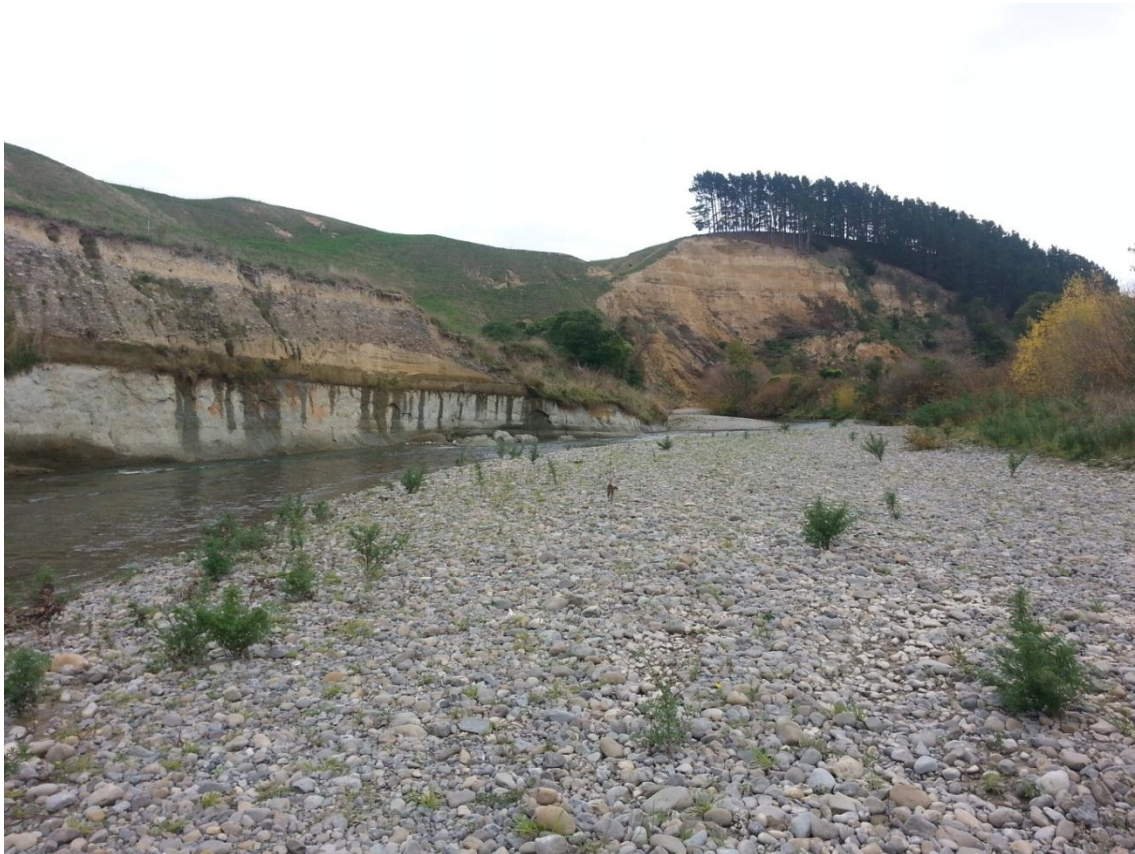
The face of the slip still appears most unstable, with tunnels evident also. There could be several modes of failure possible. Upstream of this slip a layer of papa is visible, but it appears to dip underneath the river and provide no support at the slip - refer Photograph 11. It is important that the current planting at the base of the slip is continued, to provide the best possible defence against undermining of the toe of the slip.

**Photograph 11:** Dipping papa layer upstream of large slip at river distance 20 km
