**HORIZONS REGIONAL COUNCIL**

**POHANGINA-OROUA SCHEME AUDIT**

**JULY 2013**

Report No: 2013/EXT/1316

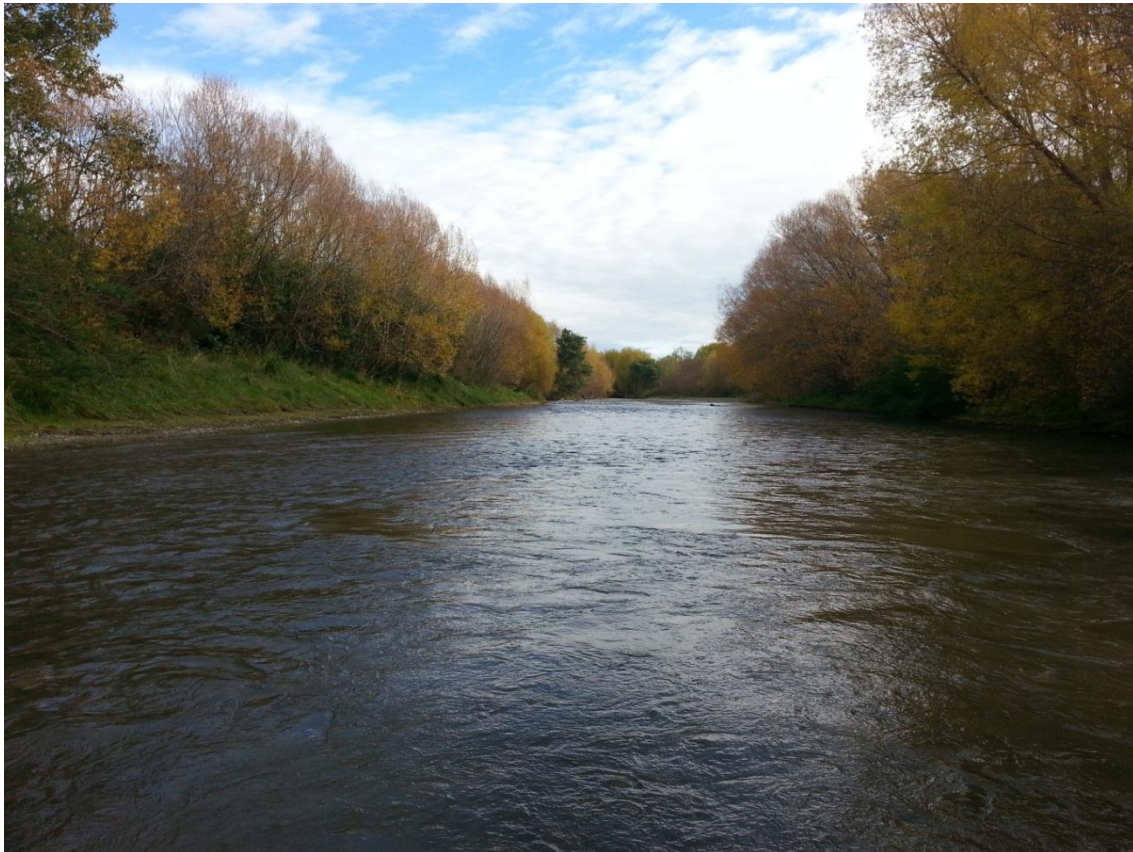
Through this reach the Scheme Manager reports that there are few areas of erosion and again the reach appears to be in very good condition. The riverbanks very commonly grade easily down to the riverbed and erosion potential is low. Edge protection willows are well established throughout the reach. The below photograph shows the typical condition of this reach.

**Photograph 12:** Scheme in very good condition looking downstream from Almadale Road at river distance 12 km

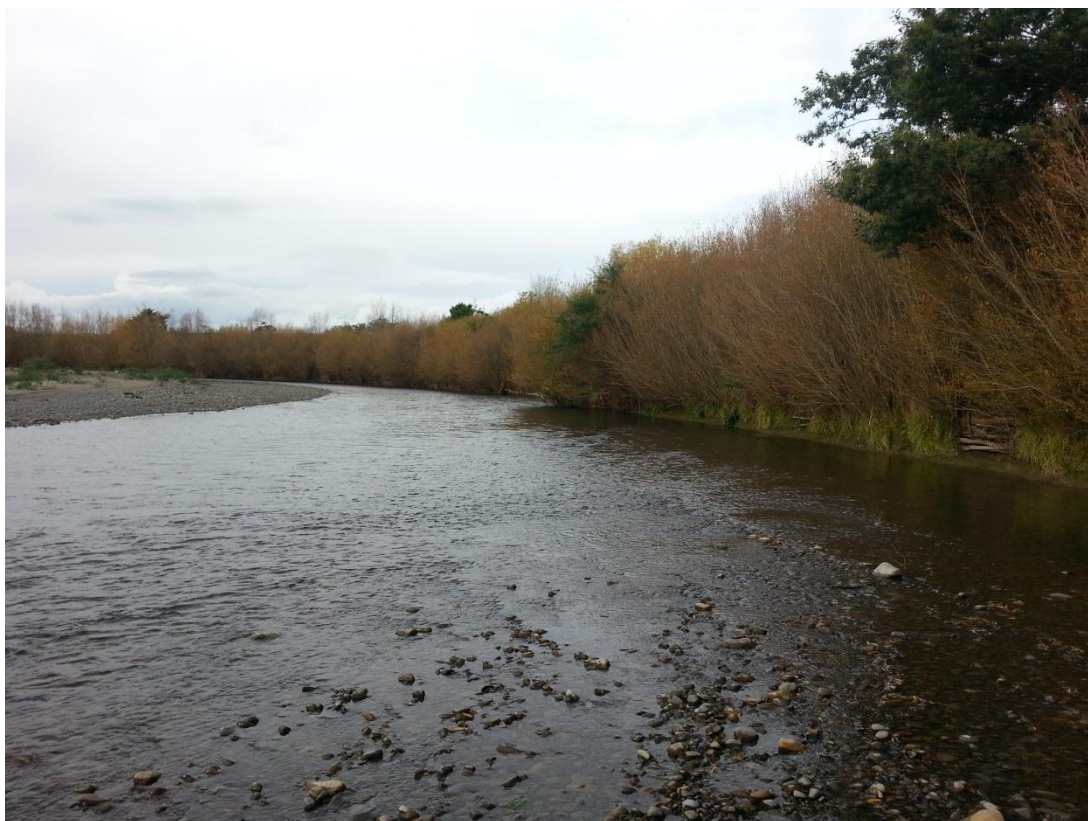
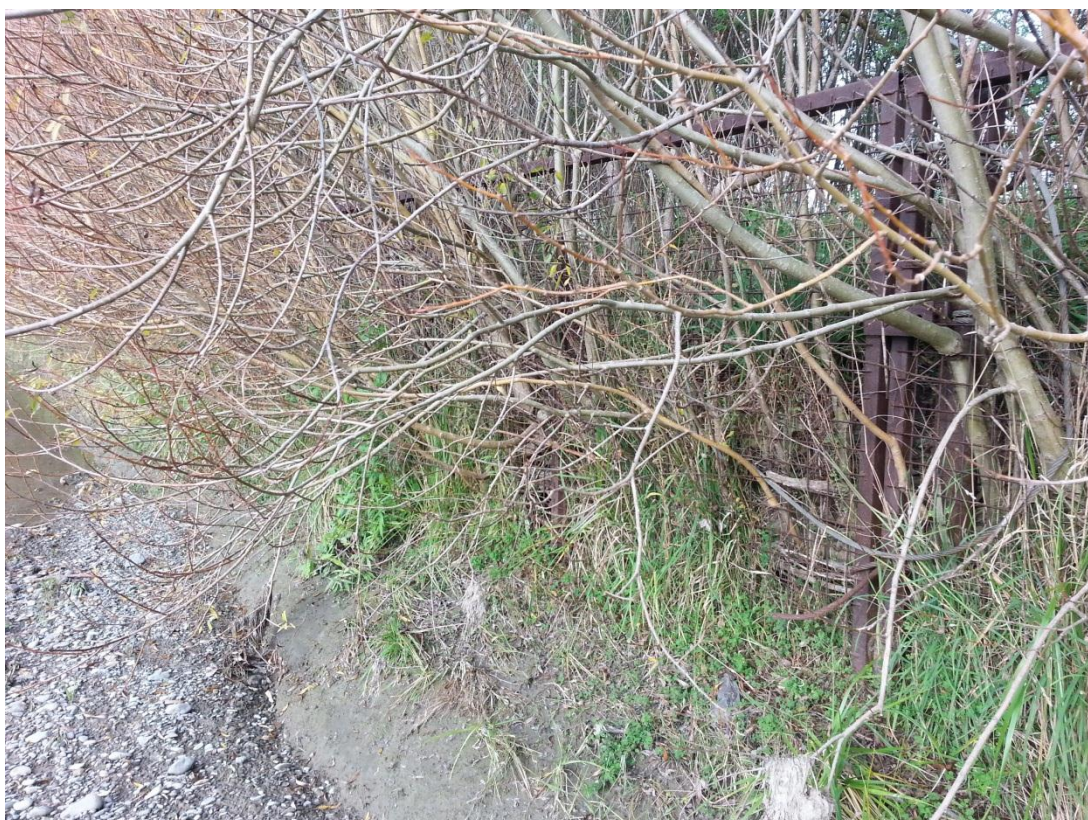
**Photographs 13 & 14:** PMUs providing good riverbank protection on left bank river distance 9.5 to 9.8 km

Gravel levels on the beach on the left bank at river distance 9.5 - 9.8 km are maybe slightly above optimum and the rear portions of this beach could be lowered – refer Photograph 13.

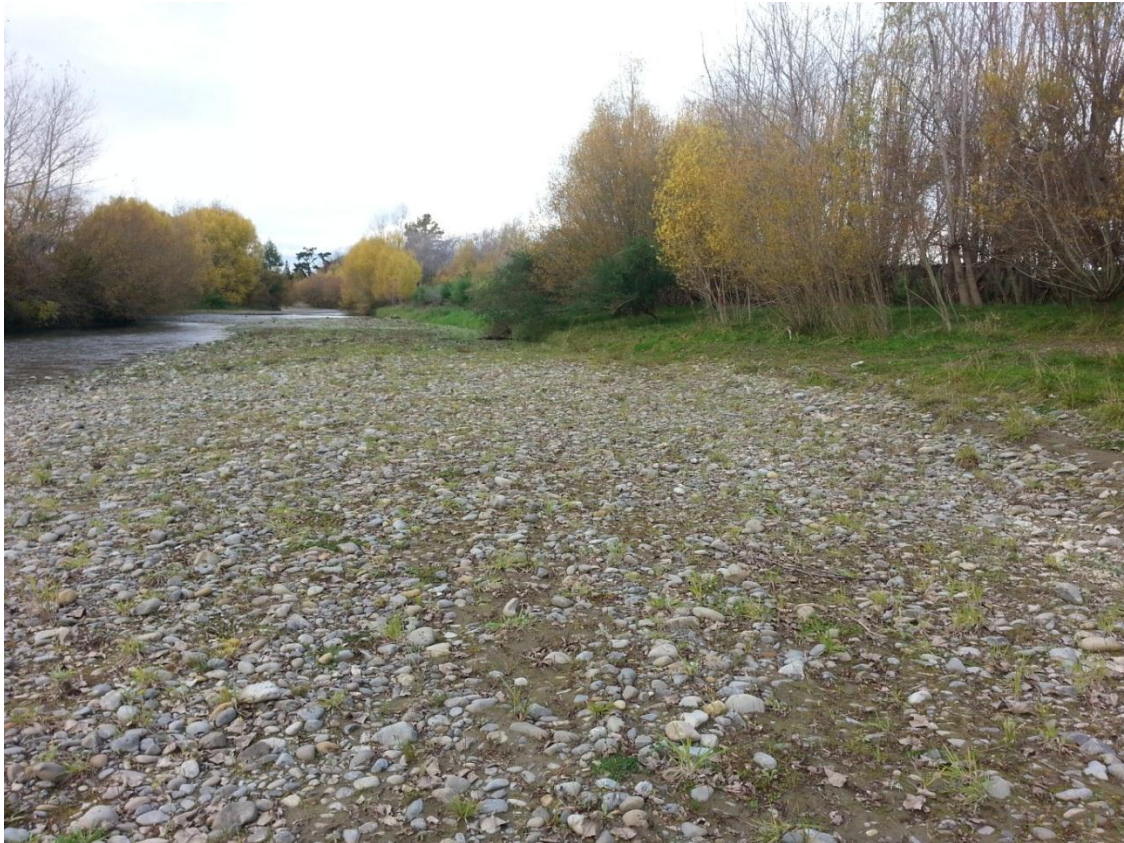
Again, through this reach, the Scheme Manager reports that there are few areas of erosion. Again many places the riverbanks grade easily down to the river and erosion potential is low. Refer Photograph 15.

**Photograph 15:** Looking upstream at river distance 7 km - riverbanks grading easily down to the river with low erosion potential
