Lower Manawatū Gravel Study

Natural Character Index (NCI) and HQI Report

September 2024

September 2024
Report No: 2024/EXT/1879
ISBN: 978-1-99-106188-1

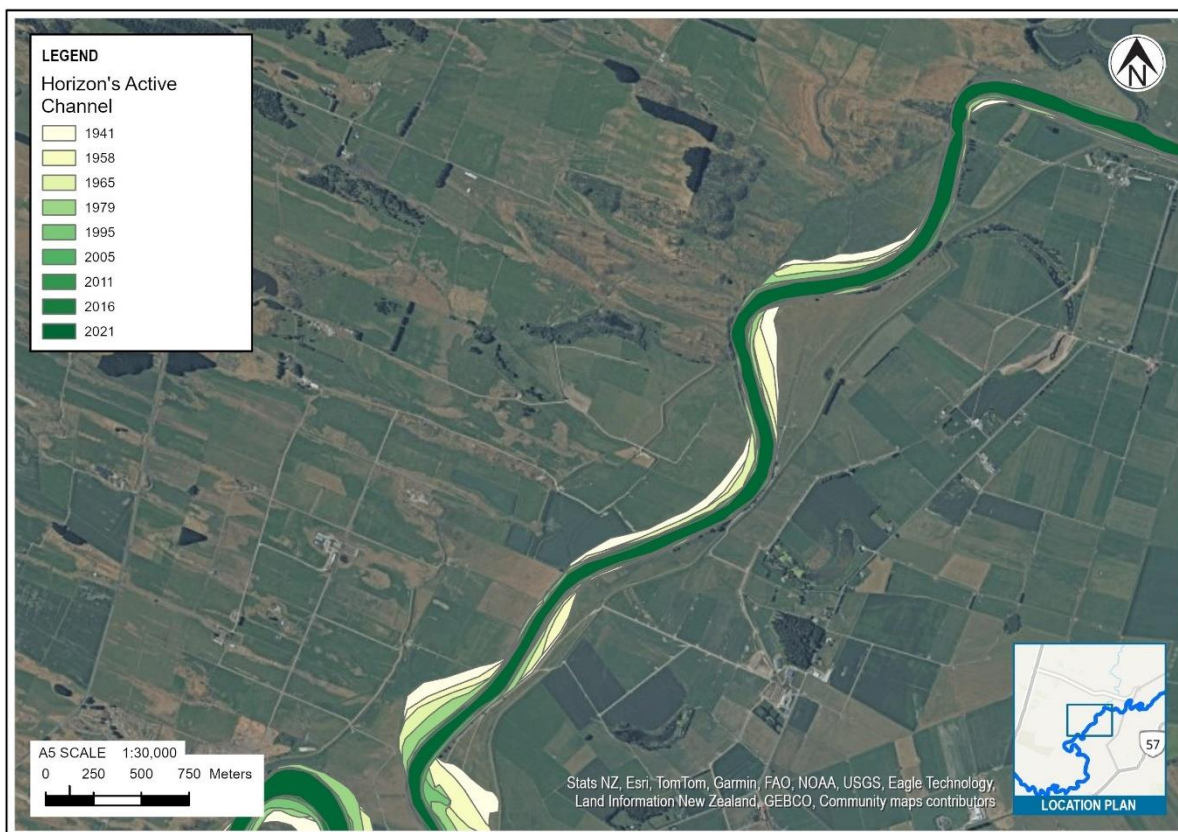
Figure 5.4: Comparison of HRC active channels for each year of aerial imagery, showing lateral meander migration for a reach downstream of Ōpiki.

Figure 5.4 shows a change to the river channel which modifies the active channel envelope but does not show a reduction in the geomorphic character. This is a situation where there is a lateral migration of the channel through natural erosional and depositional processes. Although this change does not affect the natural character of the river, it shows that any management lines or delineated river corridor needs to account for natural channel migration and the dynamic equilibrium of the geomorphology, as well as any potential disequilibrium caused by anthropogenic drivers.

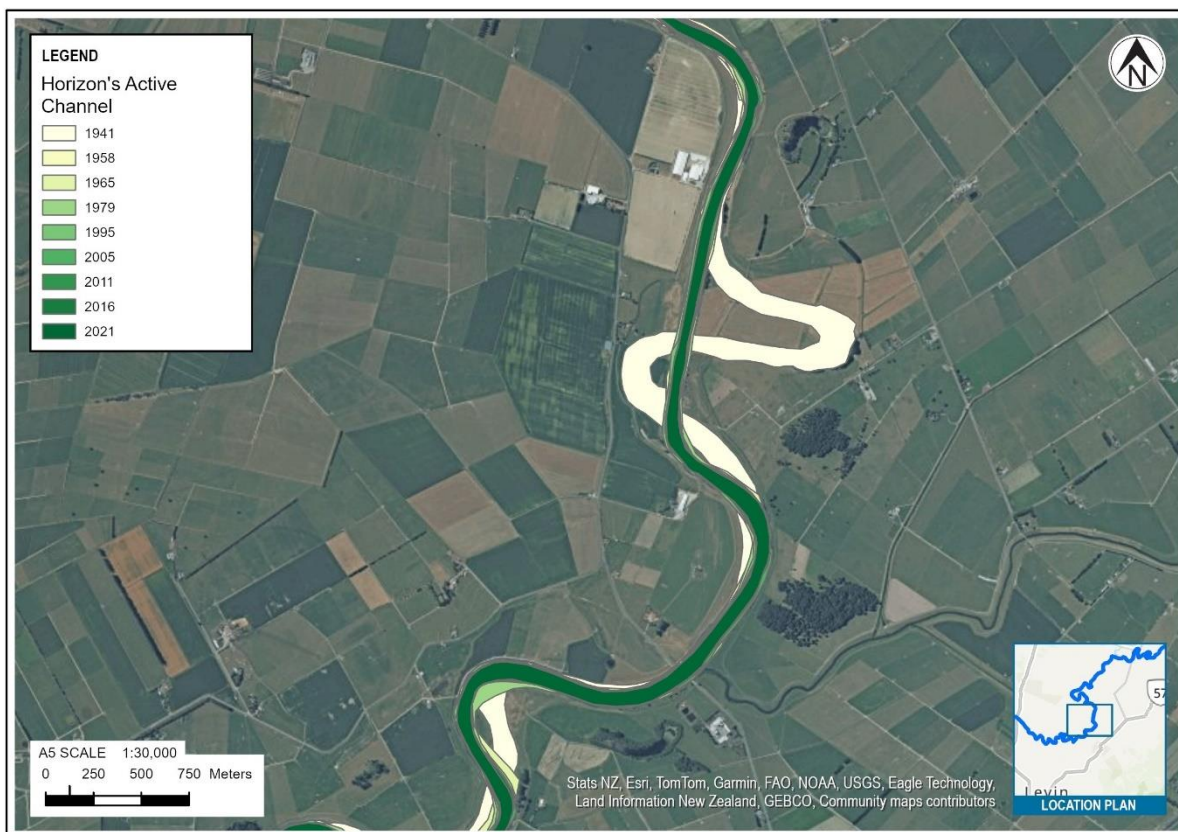
Figure 5.5: Comparison of HRC active channels for each year of aerial imagery, showing river modification works causing meander cutoff for a reach downstream of Ōpiki.

Figure 5.5 visualises how some of the channel change likely reflects direct river modification works. Here, the bend appears to have been artificially cutoff, between the 1941 and 1958 imagery. This has led to a much narrower, slightly steeper, and (presumably) a more incised channel.

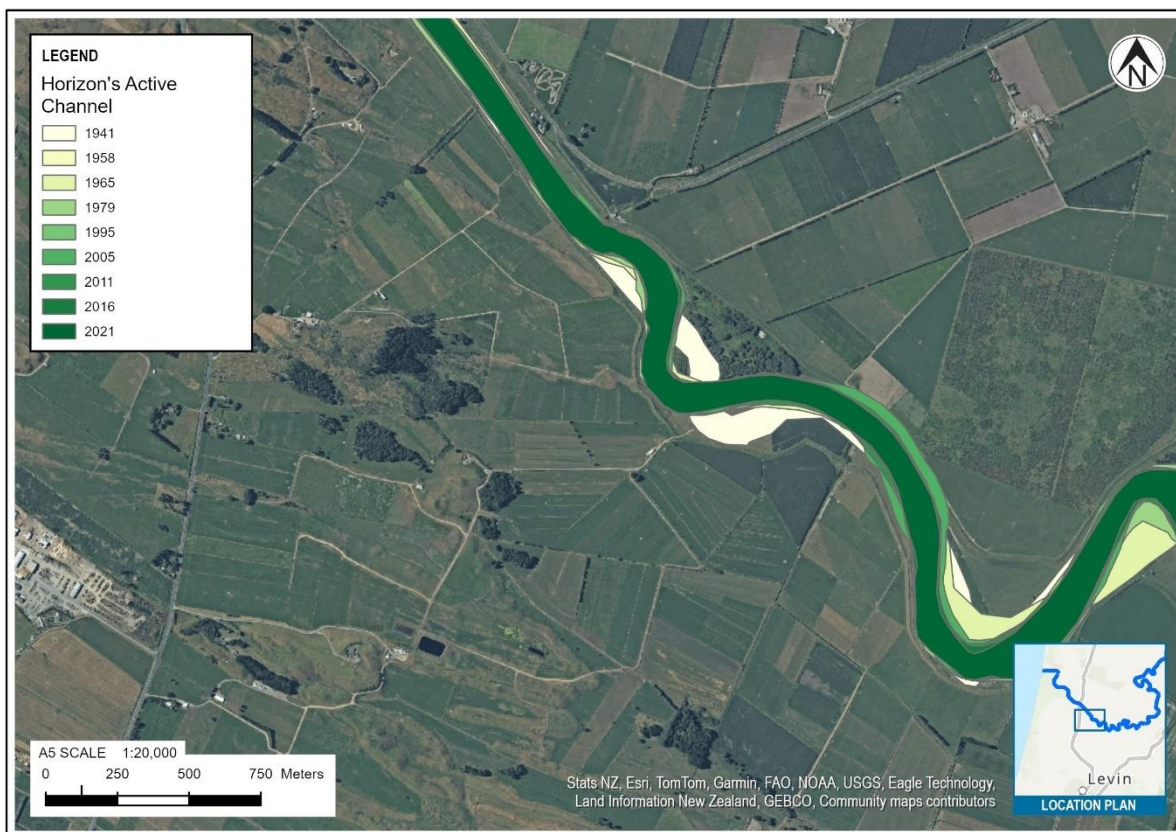
Figure 5.6: Comparison of HRC active channels for each year of aerial imagery, showing meander development in a sand-bed reach just upstream of the Foxton loop.

In some situations, however, the river is continuing to evolve and re-work new floodplain. Figure 5.6 shows a meander forming in the lower section of the river, forming slowly through erosion of the sand banks and deposition on the inside of the bend. Despite pressure on the room for the river, it continues to evolve geomorphically.
