Restoration Plan for Lake Horowhenua

Collation of inter-related projects

January 2012
Report No. 2012/EXT/1223
ISBN 978-0-927189-35-4

NIWA Client Report No: HAM2012-004
Report date: January 2012
NIWA Project: HRZ12204

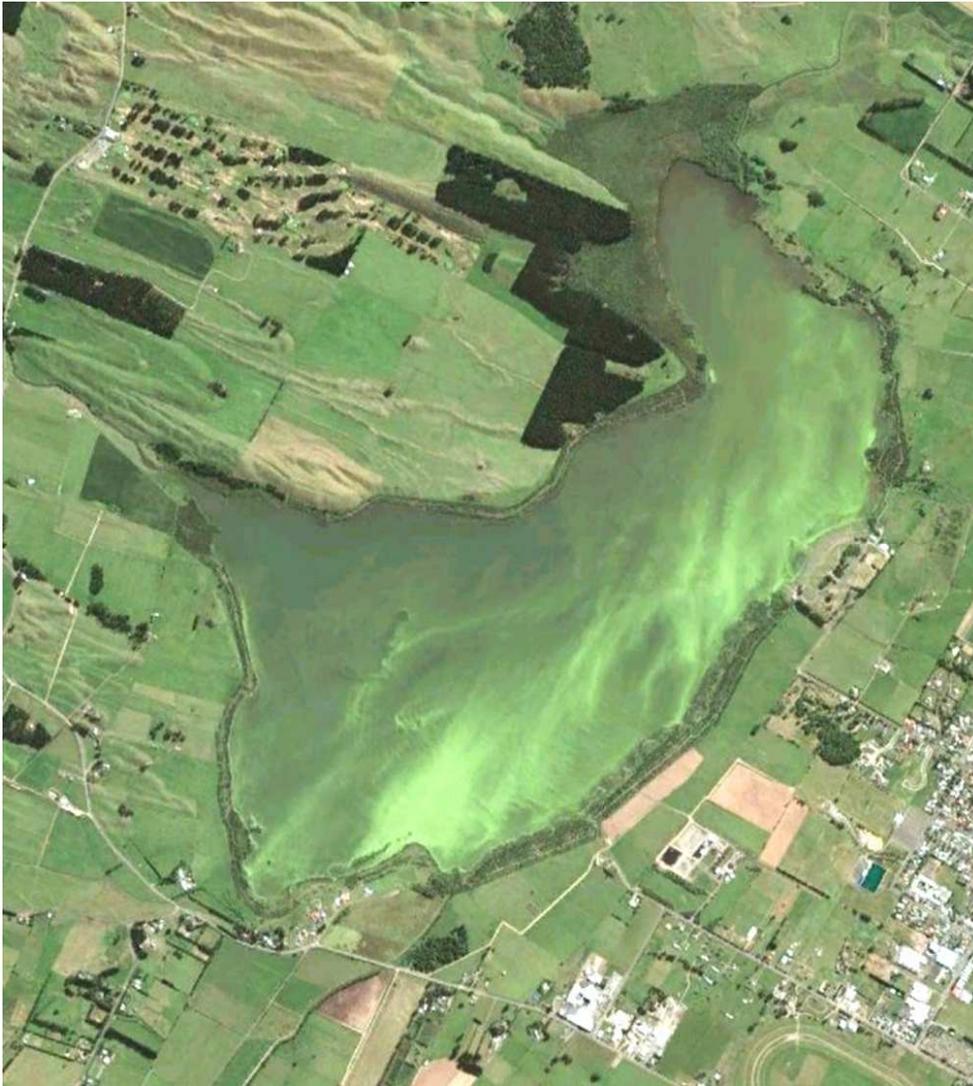
Figure 1-1: Lake Horowhenua with cyanobacteria bloom. The bright green patches are a cyanobacteria bloom drifting across the lake with the wind. [Image from Google Earth, 9 March 2011].

- It has a substantial lake weed problem and experiences cyanobacteria blooms in summer (Figure 1-1). Cyanobacteria (blue-green algae) blooms are smelly and release toxins which cause skin irritation and other health issues, can be lethal to dogs and, in extreme conditions, could be lethal to small children¹. Consequently, cyanobacteria blooms cause the lake to be closed.

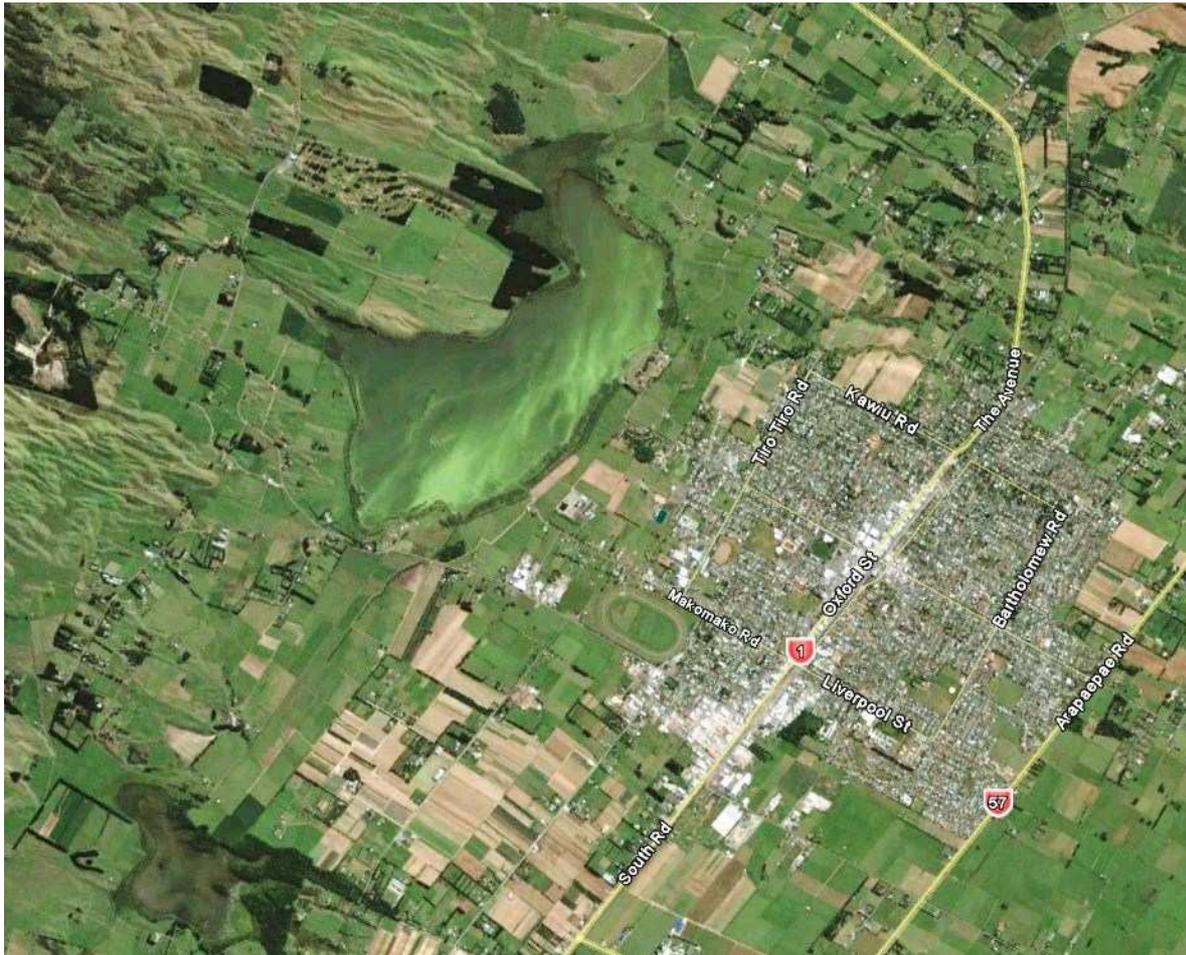
Figure 1-3: Lake Horowhenua catchment land use. Extensive areas of bare land associated with market gardening occur near the Arawhata Stream at the southern end of the lake but also occur throughout the catchment east of the lake. [Image from Google Earth; 9 March 2011].

The increase in stream phosphorus loads is as particulate material which is consistent with more bare land being available for erosion (wind and water) as the area in cultivated land for market gardening increases. Much of the market gardening increase has been near the Arawhata Stream but cultivated land extends across much of the catchment (Figure 1-3).

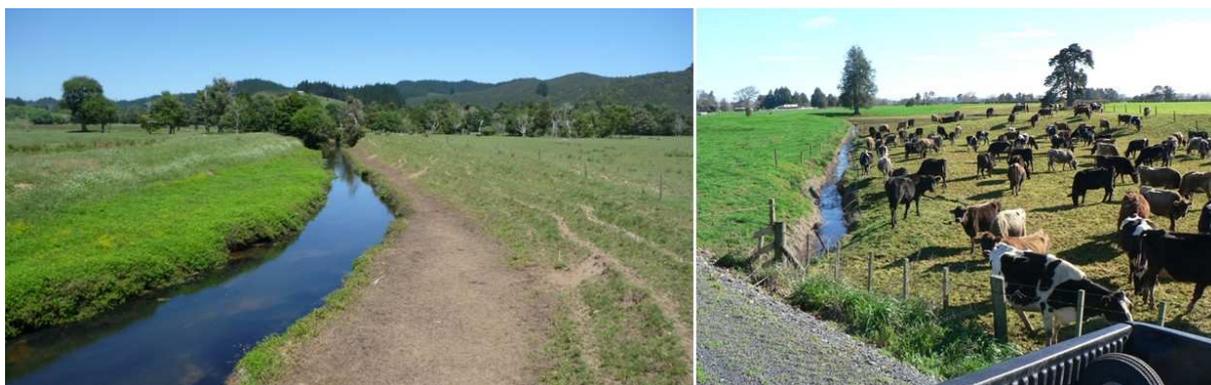
Figure 2-1: Stock exclusion fencing. The stock exclusion zone needs to be 5 m wide to keep the stock and their excrement and sediment from getting into the stream. For example, these North Island streams are fenced but the fences are unlikely to be effective because of the farm management strategies.

1. Excluding stock from direct access to the lake and all permanent streams with 5 m wide, fenced, buffer zones planted with native plants (Figure 2-1). A recent review of international research on buffers for sediment retention in agricultural landscapes (Yuan et al. 2009) found that removal efficiency increased with buffer width and decreased somewhat with land slope. This analysis found that the sediment trapping efficiency was at least 80% for all buffer widths of greater than approximately 5 m.

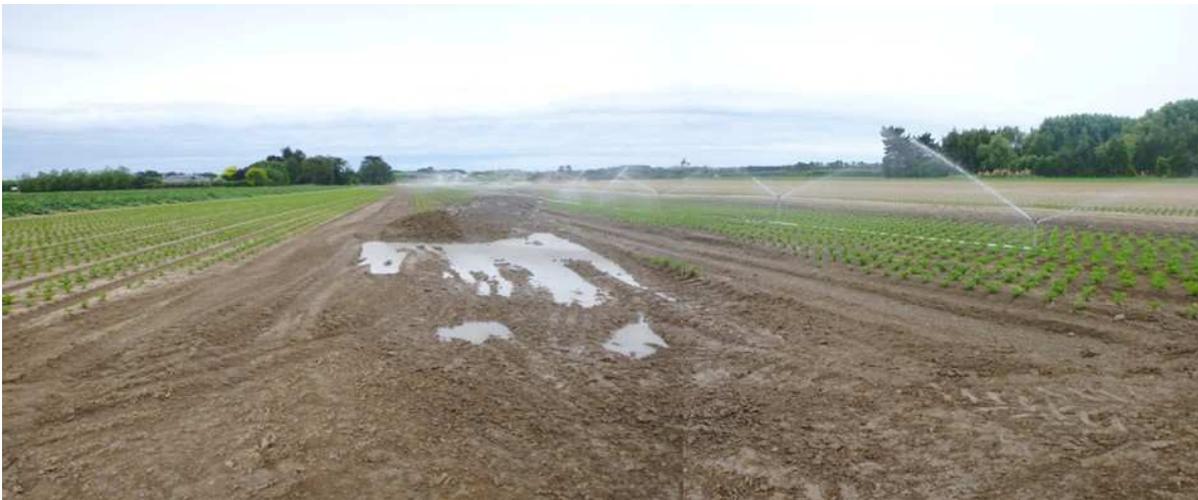
Figure 2-2: Crop-land erosion. High intensity rainfall can cause severe erosion even on almost flat land. Recovered soil from erosion path through the new planting shown in centre of photo. [From CD Farm Road 14/12/2011]

5. Replacing the practice of clearing drainage channels by digger with the use of sprays to control grasses and weeds. Both clearance methods leave bare soil exposed to erosion in rainy weather but the soil disturbance caused by the digger results in higher erosion rates than the undisturbed soil left after spray clearance.
6. Installing sediment retention ponds on the down slope extent of market gardens. This will trap much of the sediment that is washed off the cultivated land in rain storms and allows this valuable fertile soil to be returned to the field rather than be carried into the lake (Figure 2-2).

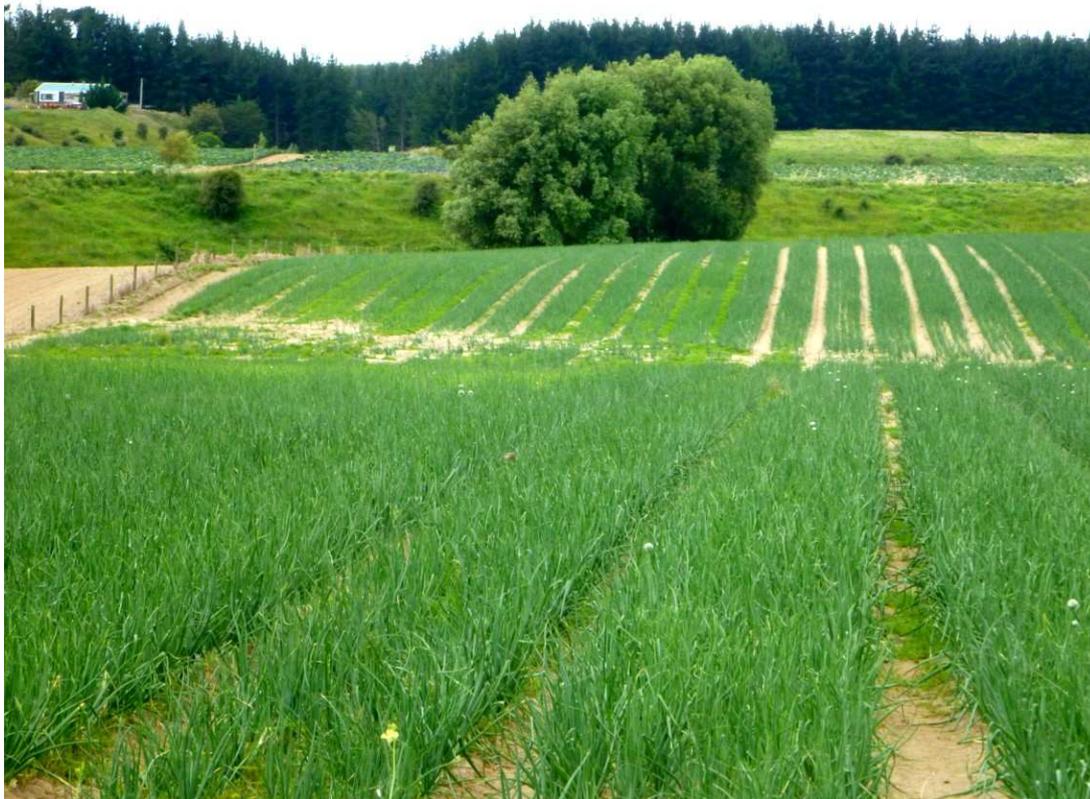
Figure 2-3: Soil erosion from furrows between crops. The clean furrows allow water velocity to increase down slope exacerbating erosion. Tilling across the slope would reduce the water velocity. [Photo from Kawiu Road 14/12/2011].

7. Till across the slope rather than down the slope (Figure 2-3) and leave grassy swales to transport the runoff water. This reduces the velocity of the runoff water on the cultivated land while the grassy swale armours the ground against erosion.

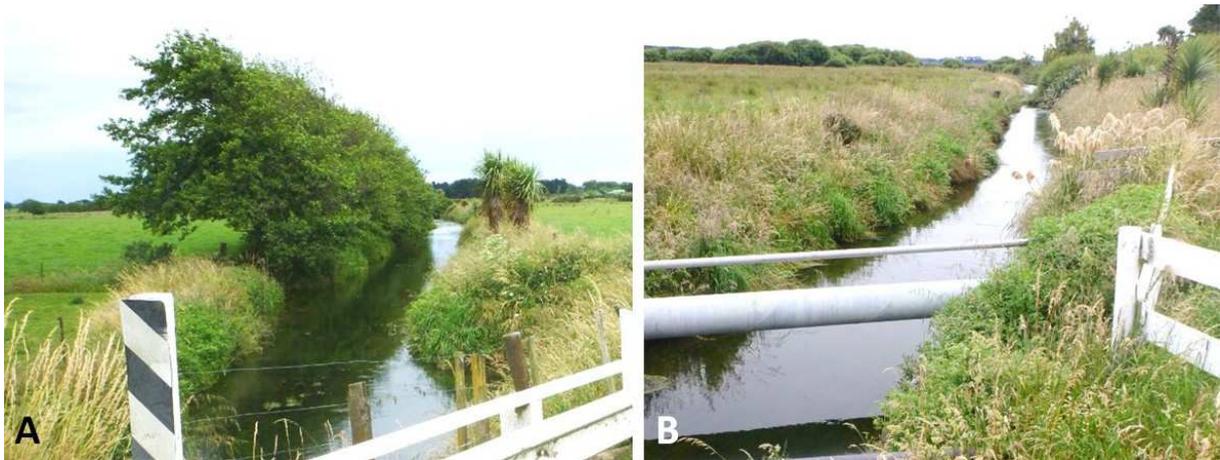
Figure 2-8: Arawhata Stream from the Hokio Beach Road. A) View south and B) view north, showing the lack of shade in the lower reaches of the stream. Trees on the eastern side (A) offer no shade to the stream. [Photos 14/12/2012]

The Arawhata Stream currently has riparian trees along its south-eastern side for 1 km south of Hokio Beach Rd, but the north-western side lacks tall riparian vegetation (Figure 2-8). Consequently, the stream is unshaded resulting in high temperatures, high plant biomass/metabolism and low night-time oxygen.

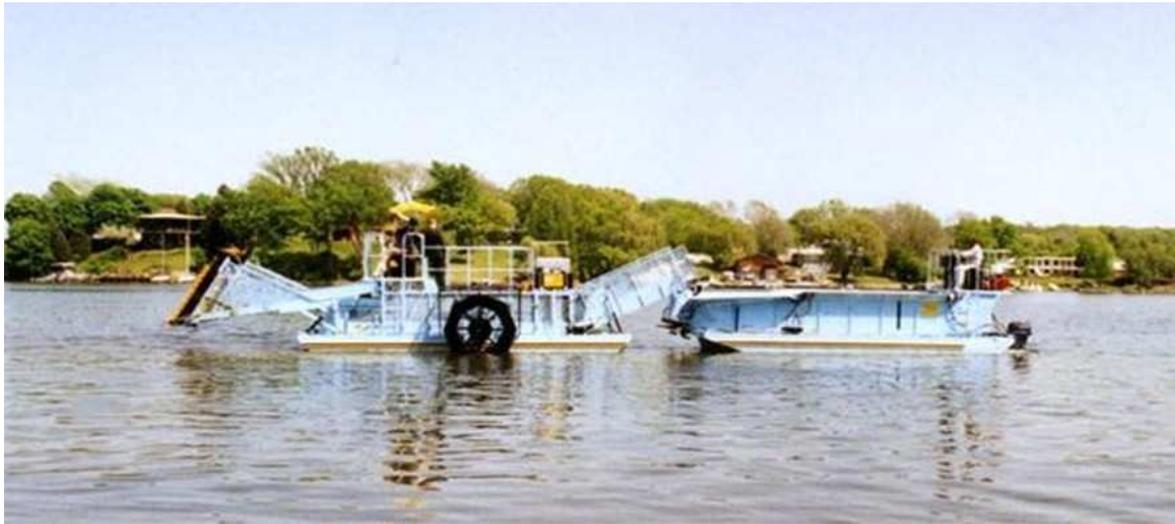
Figure 2-9: Weed harvester. Small weed harvester (left) is driven by paddle wheels with a cutting speed of 2 to 4 km/h – cutter assembly at front (left). It has a hold capacity of up to 10 t wet weed (depending on model). The unloading conveyer ramp at the back can off-load to a truck at the landing or into a transport barge (right) to allow it to continue working while the transport barge shuttles the weed to shore. Generic photo from web.

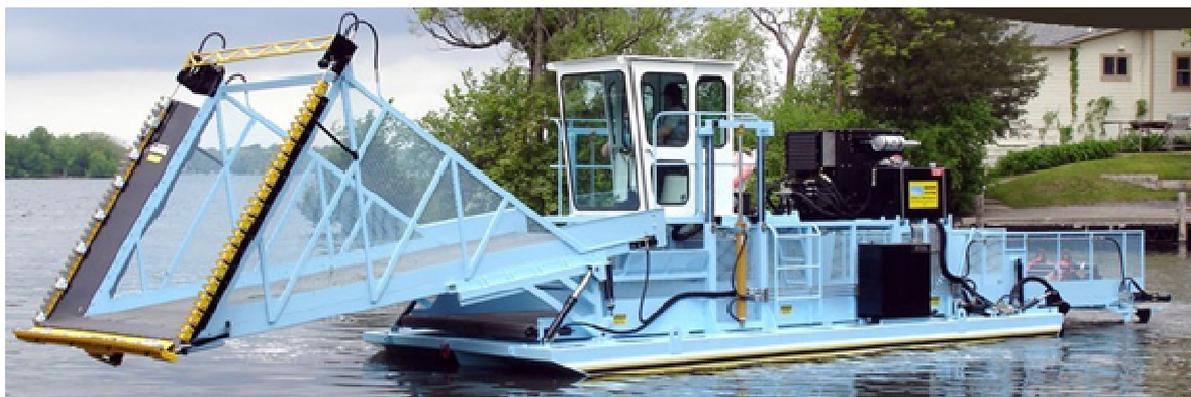
Figure 2-10: Weed harvester cutters. The cutter blades are about 2 m long on both sides and across the bottom with the cutter head able to be raised and lowered to adjust the cutting depth. The ramp behind the blades draws the cut weed into the hold of the harvester. This image shows a harvester without the paddle wheels attached, as would be needed for road transport. (Generic photo from the web).

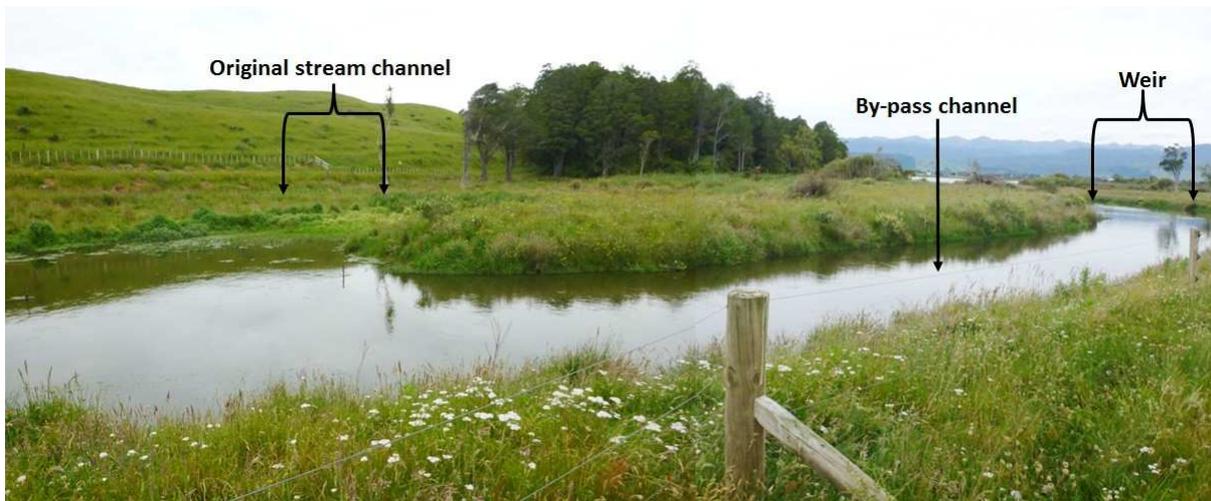
Figure 2-12:Hokio Stream at the confluence of the by-pass and original stream channels downstream from the weir. The original stream channel flowed on the left side of the photo (true right bank). [Photo 14/12/2011].

There are two options for this, either modify the existing weir or construct a new weir in the original out-flow channel. When the weir was built, a channel by-passing the natural outlet stream was built to allow the weir to be built on dry land. The out-flow water from the lake was then diverted through the by-pass channel to the weir and the original outlet channel was closed (Figure 2-12; Figure 2-13).

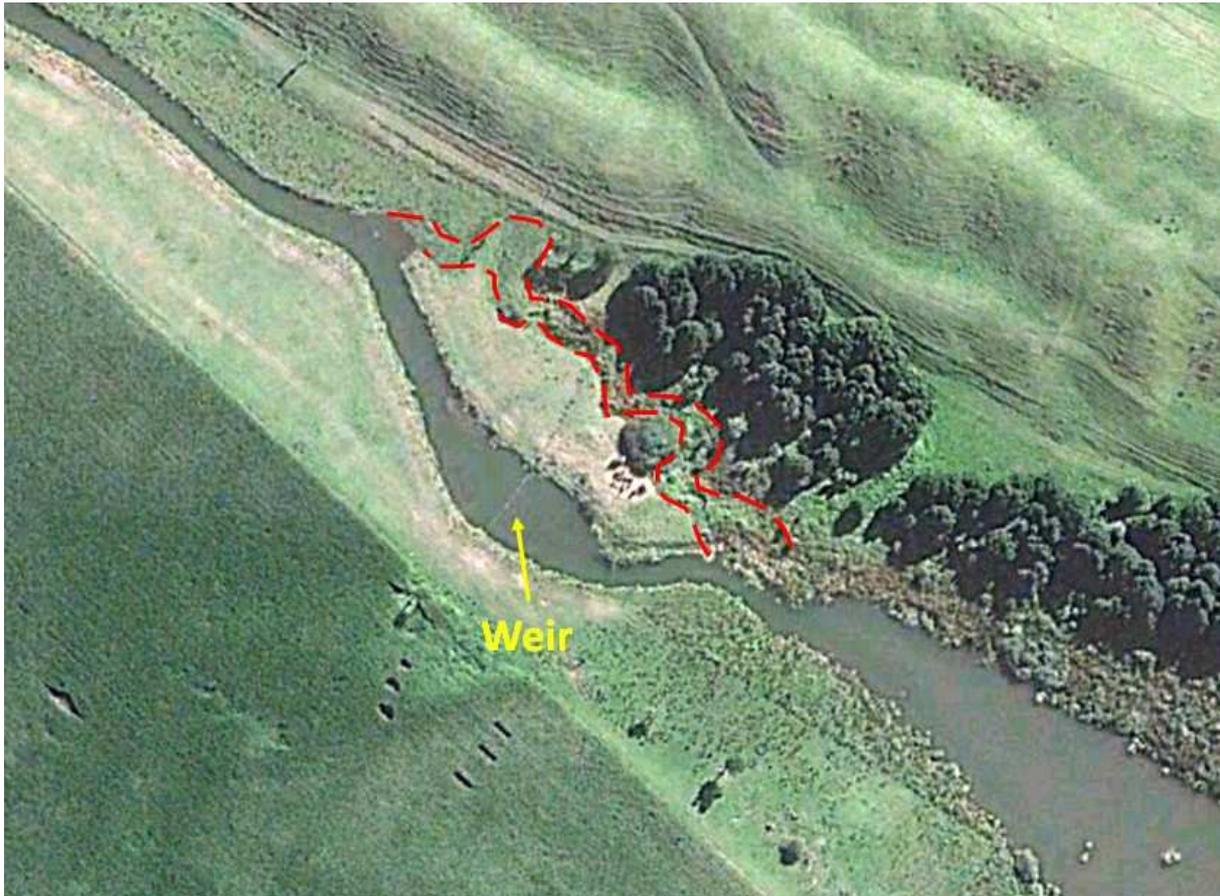
Figure 2-13: Lake outlet and weir. The original stream channel is indicated with broken red lines. [Photo from Google Earth; 9/3/2011].

Installation of a new control structure in the original outlet channel (Figure 2-13) would require the channel to be straightened. The control structure would use a moving gate system up to the width of the outlet from the lake or narrower. The original weir would be raised to a level equivalent to the maximum desired level in the lake to provide flood protection during heavy rainfall events.

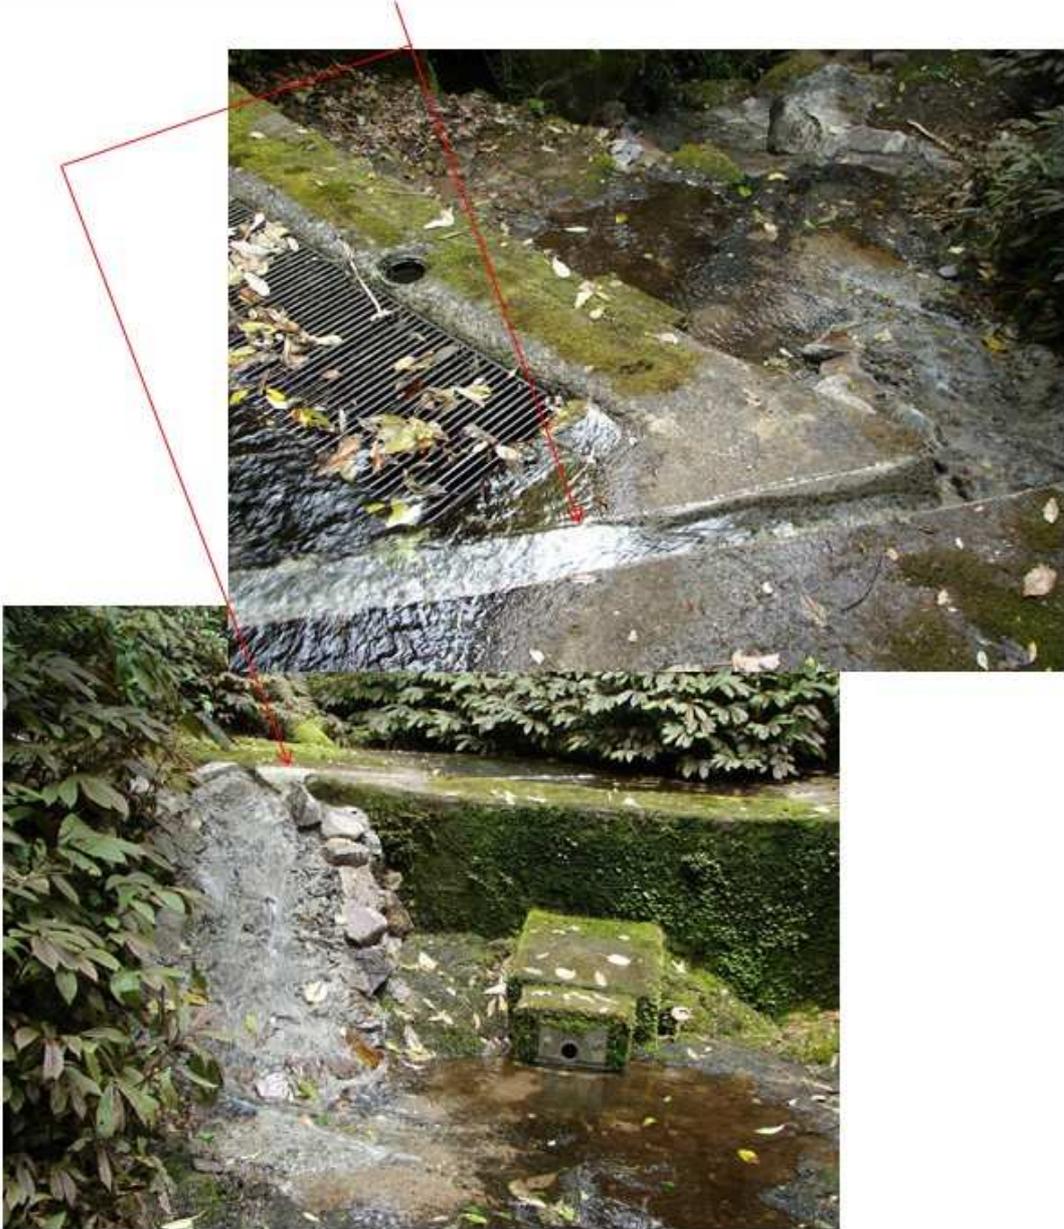
Figure 2-17:Example of a fish pass at Te Aroha. (Text and Photos: Cindy Baker, NIWA)

Side channel created to maintain a set flow over the ramp at all stream discharges. This is take one that required modification as the control channel should have been V – shaped with 45° sides to allow for elver passage, but it is thought that the concept could work on the Hokio Stream depending on what the site looked like.

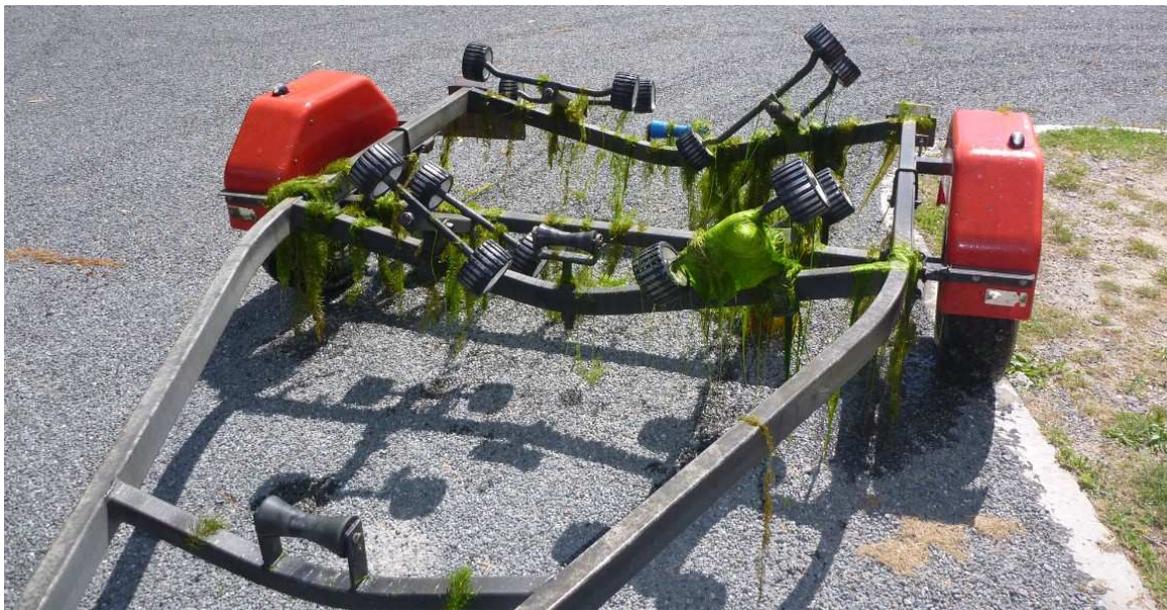
Figure 2-18: Weed can be transported between lakes on boat trailers. Hornwort and filamentous algae festoon a boat trailer at Lake Rotoehu. Even a small piece of Hornwort will grow if left on the trailer when it launches the boat in the next lake.
