# Pukepuke Lagoon

**A summarising of reports and monitoring history**

**August 2026**

Report No: 2026/EXT/2065

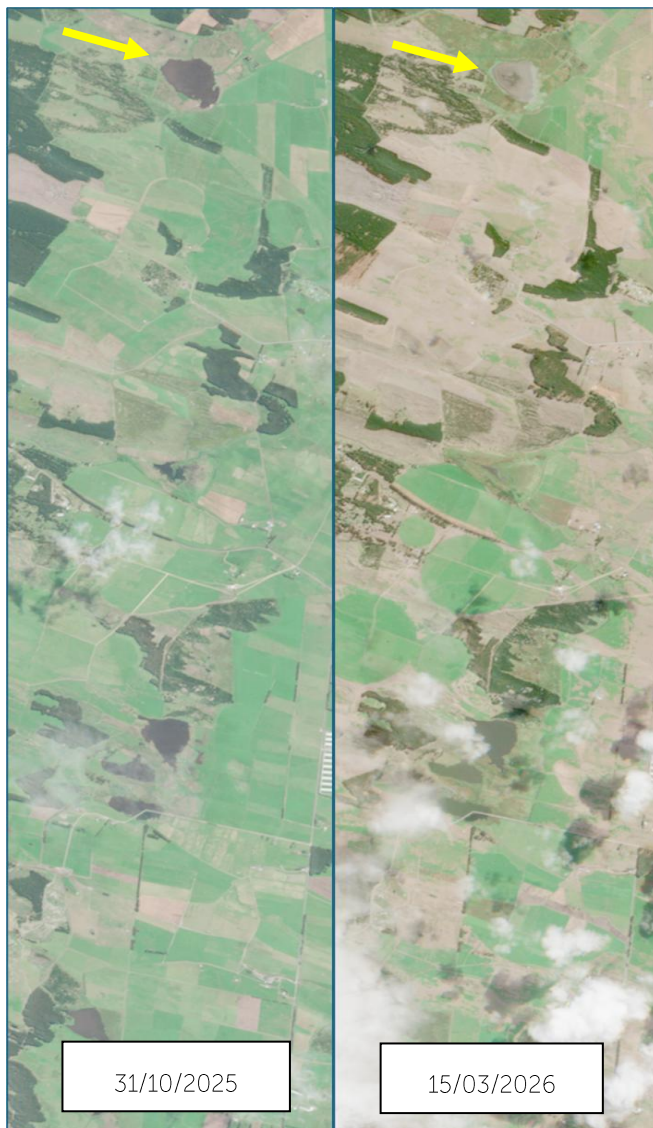
Figure 10: Satellite imagery of the Himatangi area in October 2025 and March 2026. Pukepuke Lagoon is indicated by the yellow arrows. The landscape is notably drier in the March imagery

When comparing the lake extent of Pukepuke Lagoon on satellite imagery (source: <https://browser.dataspace.copernicus.eu/>) from 31 October 2025 to 15 March 2026, the shape and colour of the lakes appear to have changed in a way that may indicate potential drying-out of open water and exposing lakebeds (Figure 10). Other lakes in the area do not appear to have had any similar changes visible from satellite imagery.

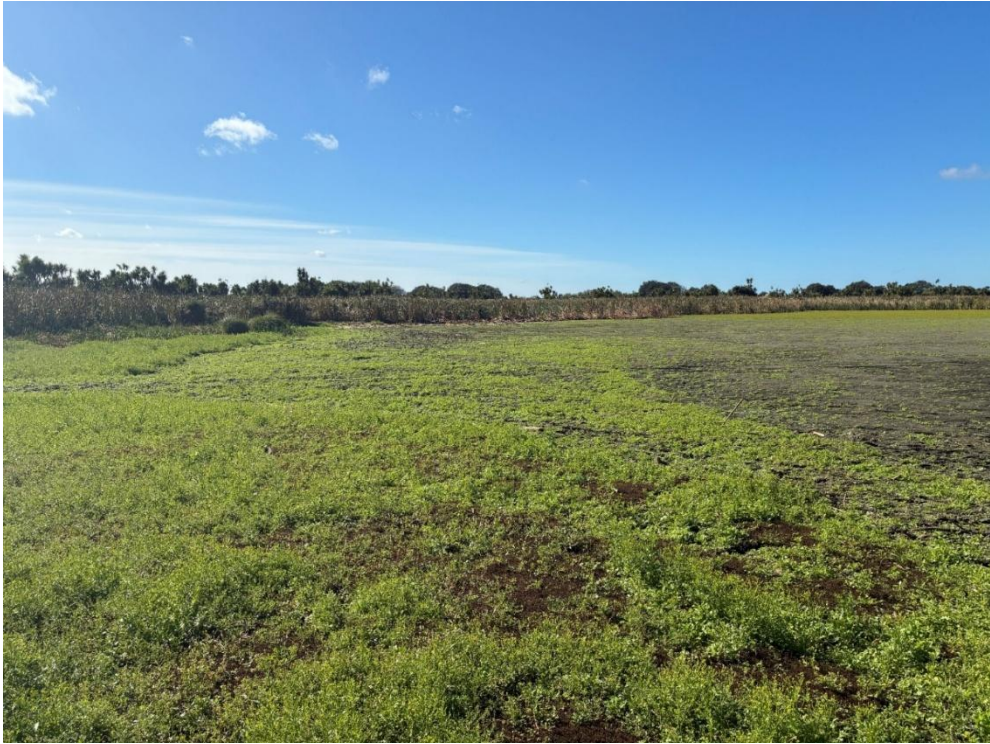
Figure 11: Herbaceous plant margin of main open-water habitat at Pukepuke lagoon

Pukepuke lagoon is characterised by one main shallow water lake and several smaller open-water habitats. Raupō reedland and herbaceous wetland plant species form the vegetated margin of the main lake. The main lake was found to have dried out fully exposing the bare sediment of the lakebed (Figures 11 and 12).

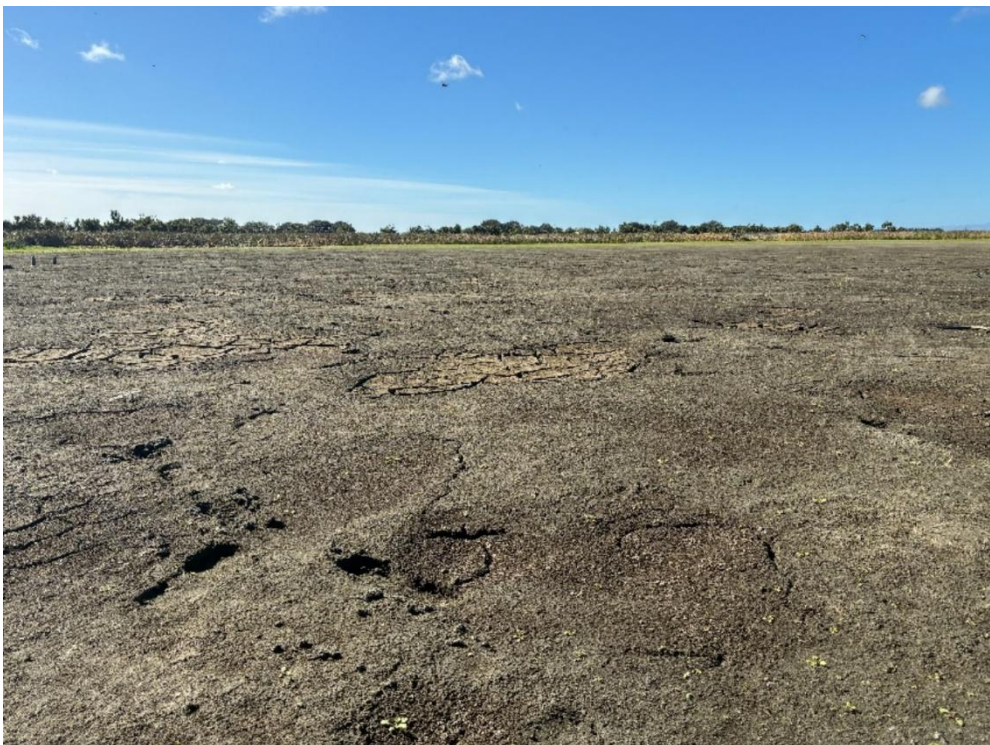
Figure 12: Dried out main lakebed exposing sediment. Scattered herbaceous plants have started to colonise mudflat

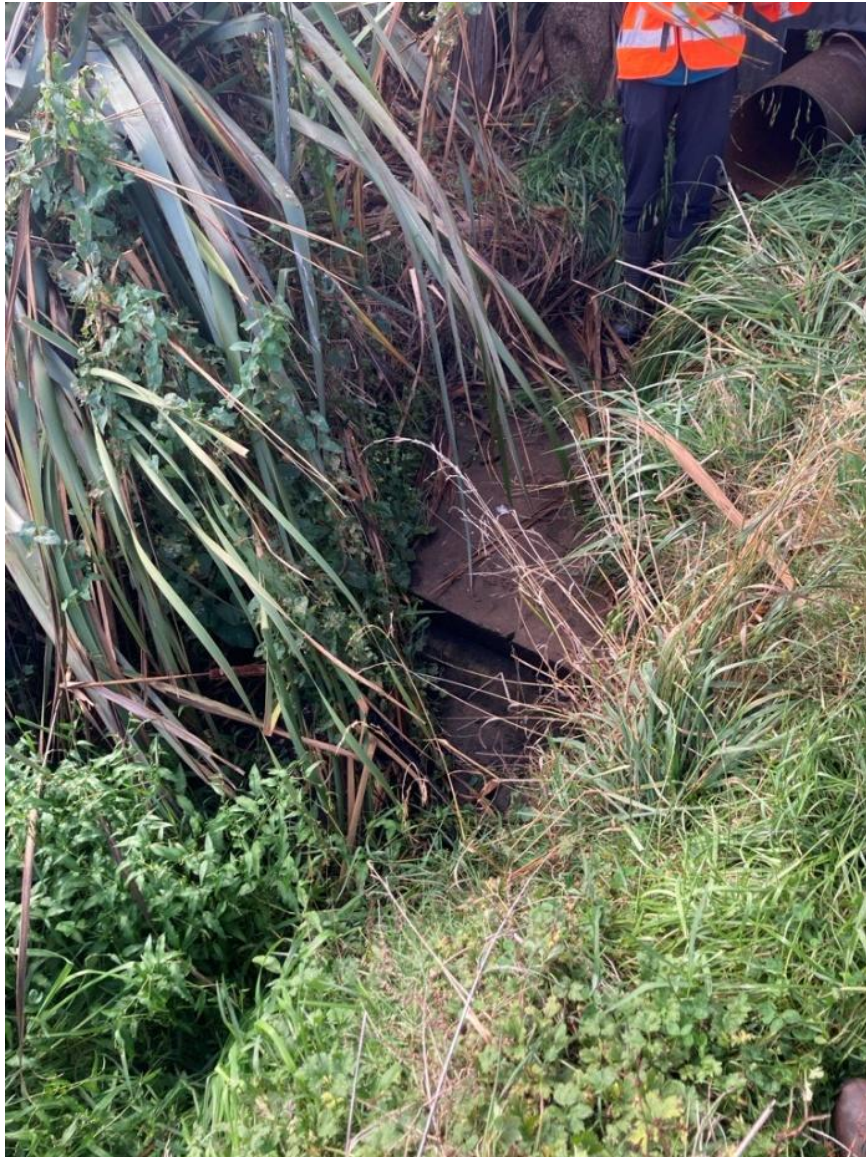
Figure 17: Pumphouse outflow on Pukepuke Lagoon on 13/4/2026

The pumphouse was briefly inspected with independent ecologists (associated with Iwi partners), present on the day (Figure 17). The area was overgrown, one cow print found in grass on margin banks but age could not be verified. If the pump has run to feed drain water into the lagoon from the neighbouring farm, it is unlikely the water could flow quickly through the vegetated channel.

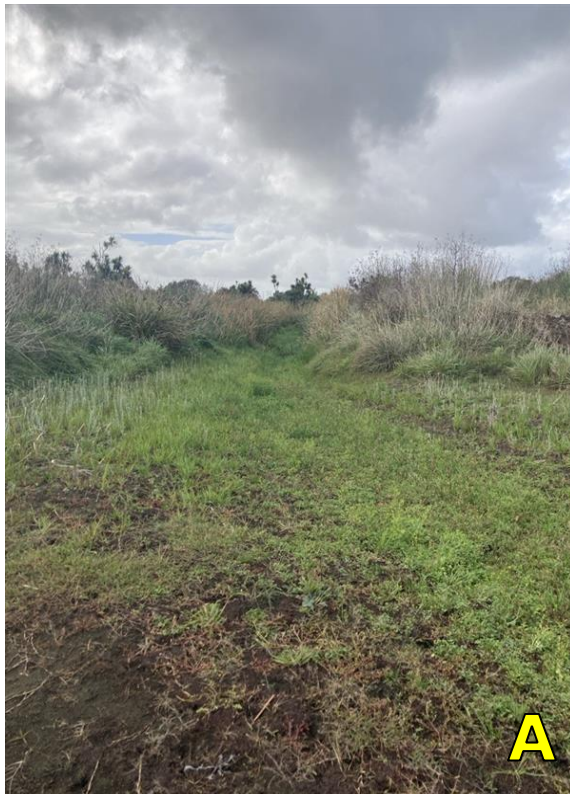
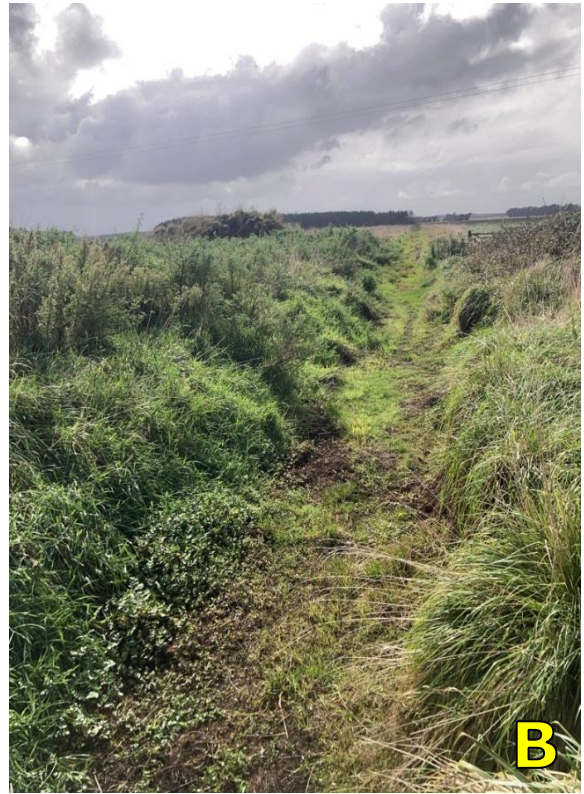
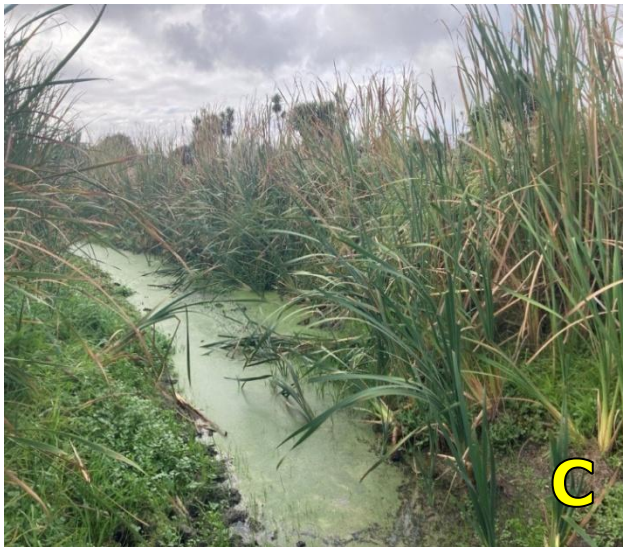
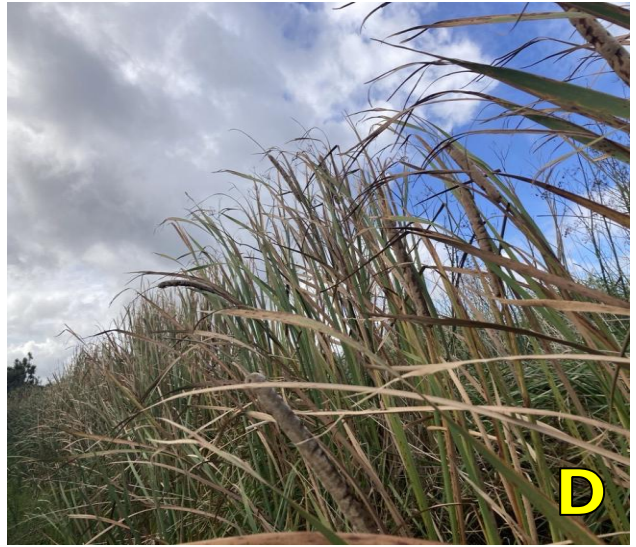
Figure 18: Photos taken on 13/4/26 showing the main inlet into Pukepuke Lagoon. The inlet is heavily vegetated (A) and frequently overgrown (B). While there are some isolated puddles (C), raupō tips are largely brown (D)

There is an inflow channel which drains farmland on the eastern border of the lagoon. This was walked by Horizons staff and an independent ecological consultant on 14/04/2026 at approximately 11am. The inflow channel was significantly vegetated (Figure 18 - images A and B), with only occasional patches of water (Figure 18 - image C). Tips of raupō in the inflow drain were dry and brown (Figure 18 - image D), suggesting an extended time without water available. The disconnected water puddles showed no signs of movement or flow, and were frequently constrained by vegetation. It would likely require a high initial flow and maintenance of the inflow channel to maintain a water flow into the lagoon.

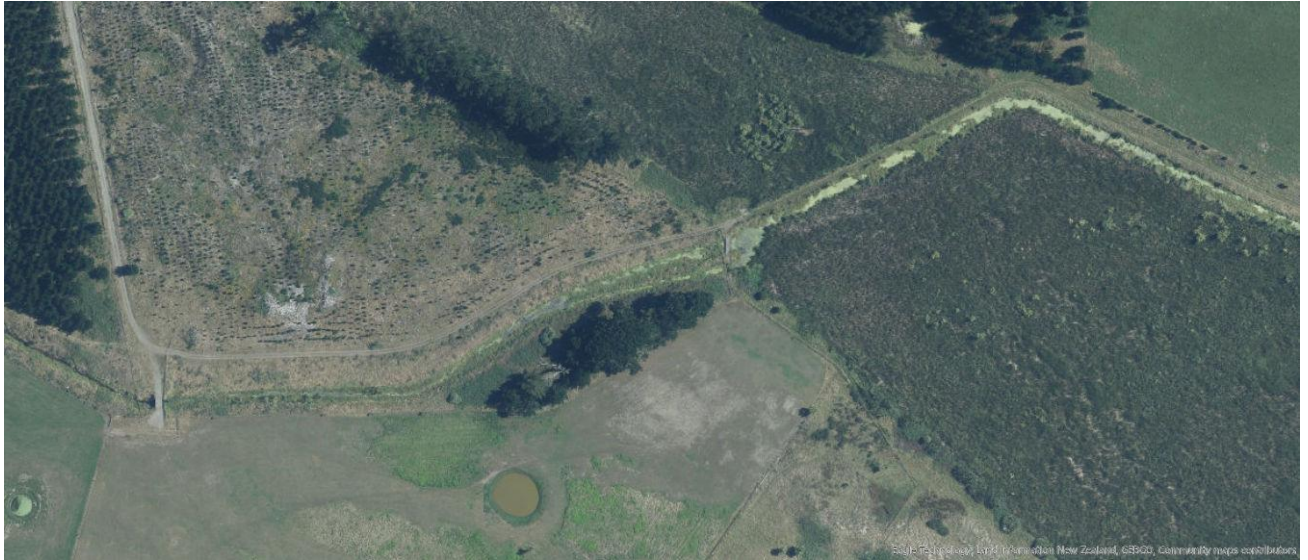
Figure 19: Drains and weir at north-west boundary of Pukepuke lagoon

Several drains are identified to run along the boundary of the wetland with several additional drains leading into the wetland and connecting to the main lake (see Figure 19 to Figure 24 below). Drainage channels appear dry, and to have been maintained to prevent blockage from raupō with only small herbaceous plants growing in the channel.

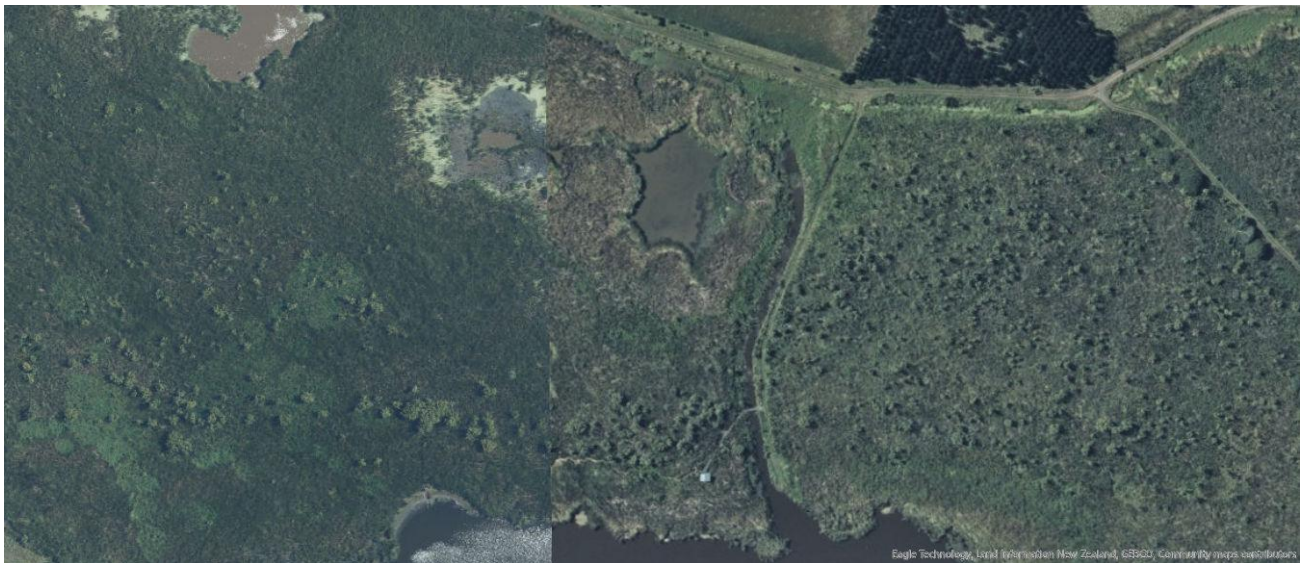
Figure 20: Drains leading north from open-water habitat at Pukepuke lagoon

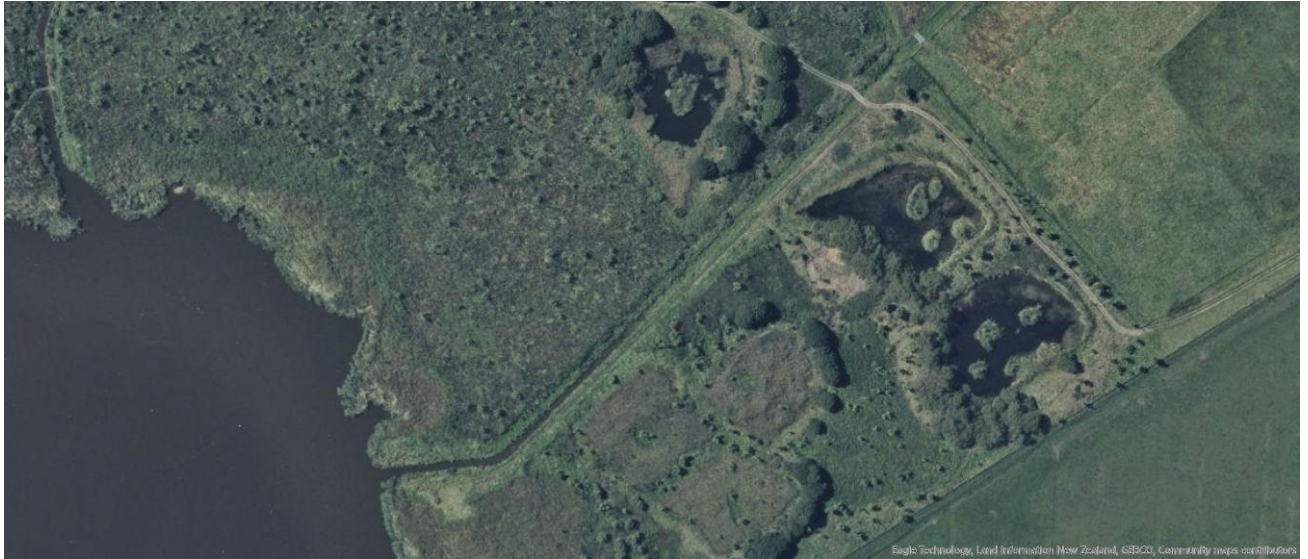
Figure 21: Drains along east boundary of Pukepuke lagoon

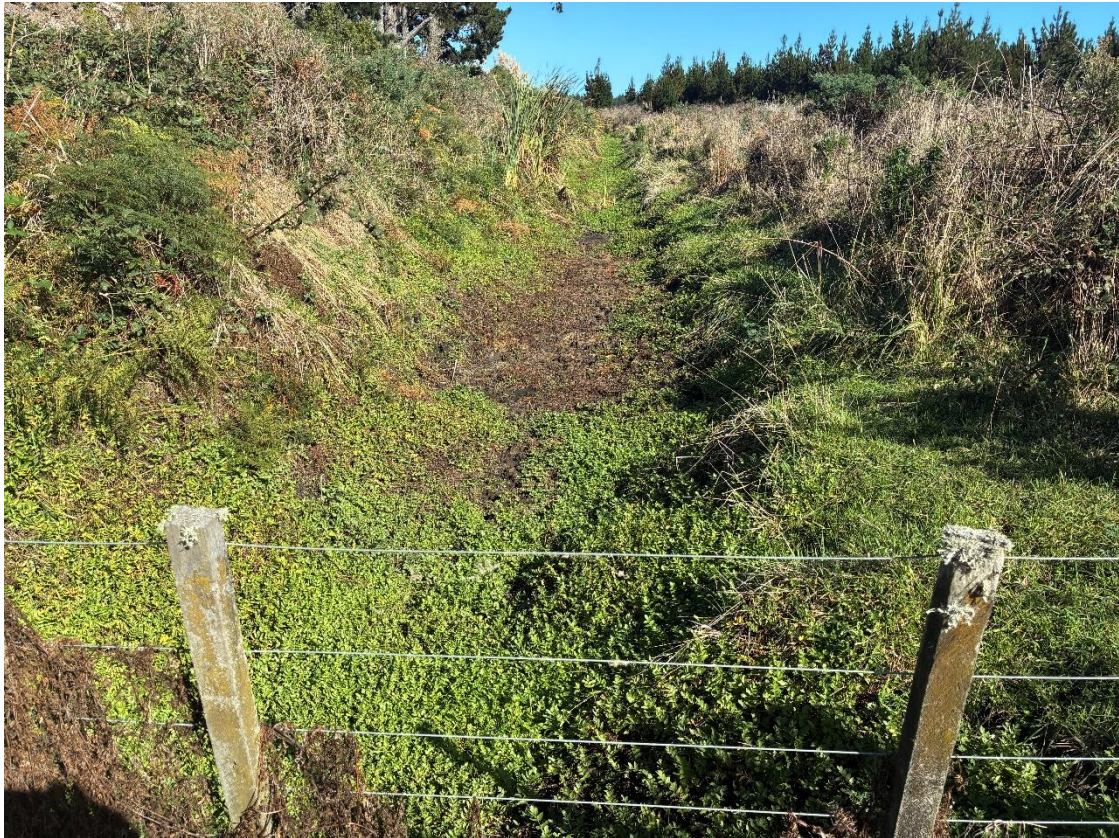
Figure 23: View along drain channel leading north-west away from weir

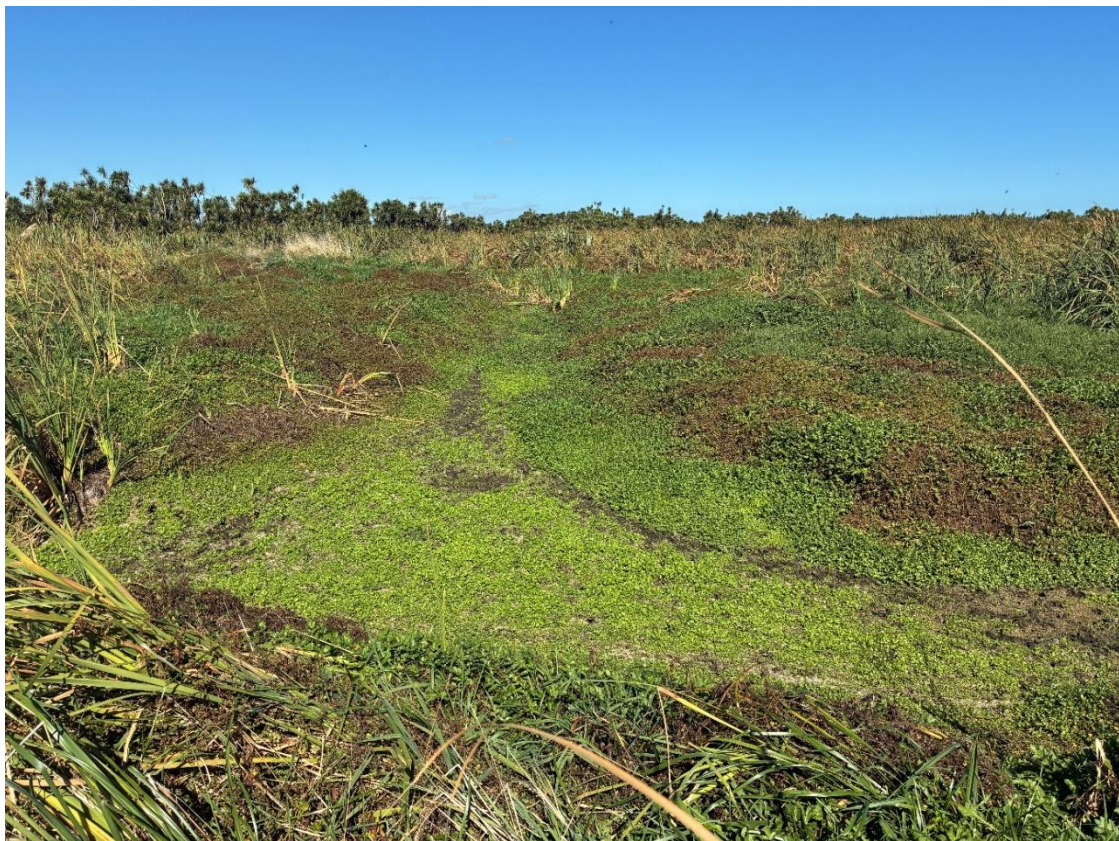
Figure 24: Drain junction along north boundary; drain connects to main open-water habitat

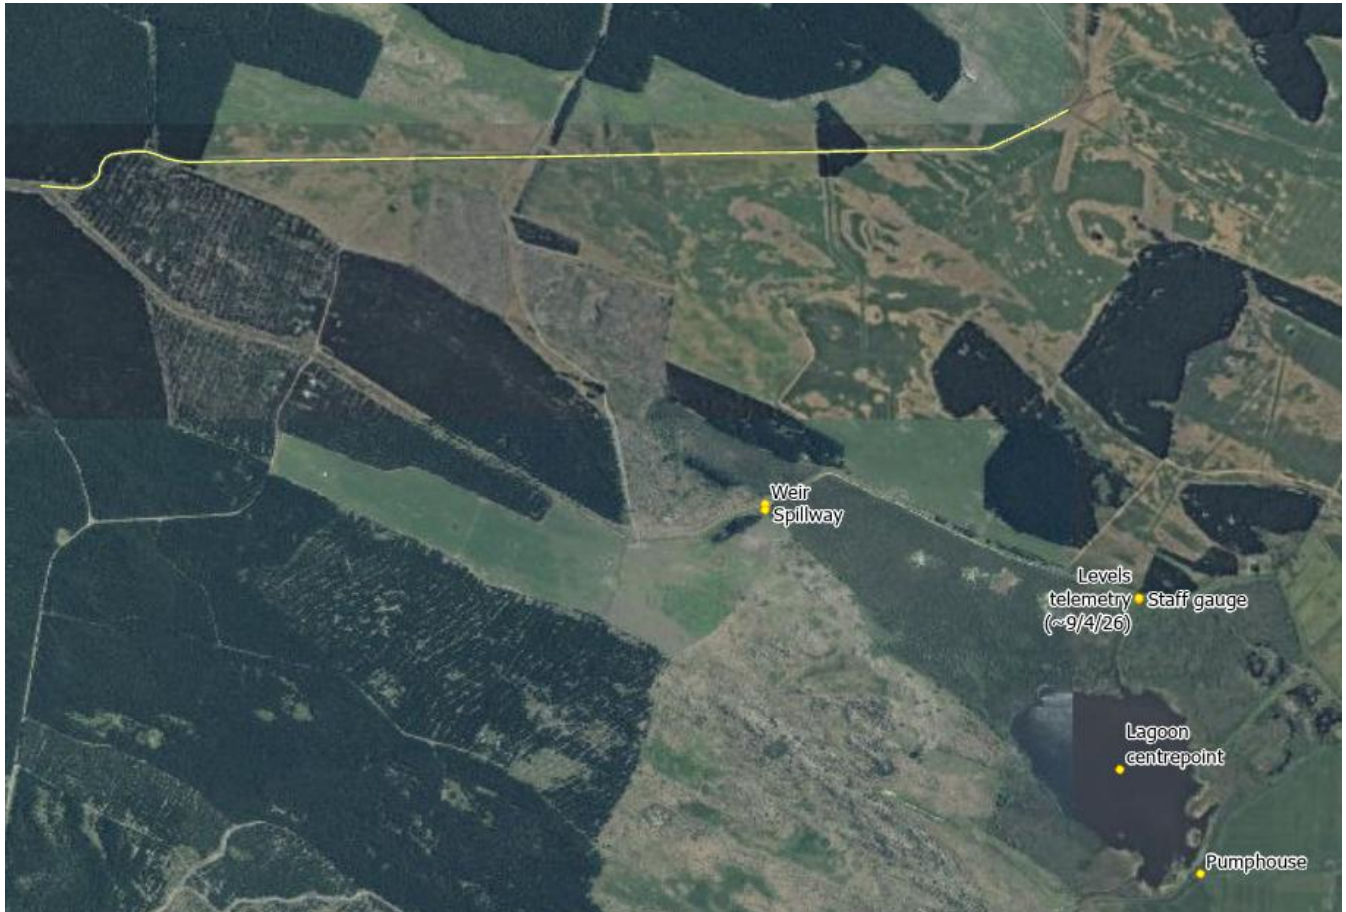
Figure 25: "Pāmu drain", as mapped in yellow from aerial imagery

Colloquially known as the “Pāmu drain”, located northwest of the lagoon (Figure 25). This is a significant drain that redirects water away from the lagoon further up the catchment. Some measurements were taken by Hana Rainforth on the day, however at time of writing drain depths have not been surveyed in detail. The drain is deep and wide (Figures 26 and 27).

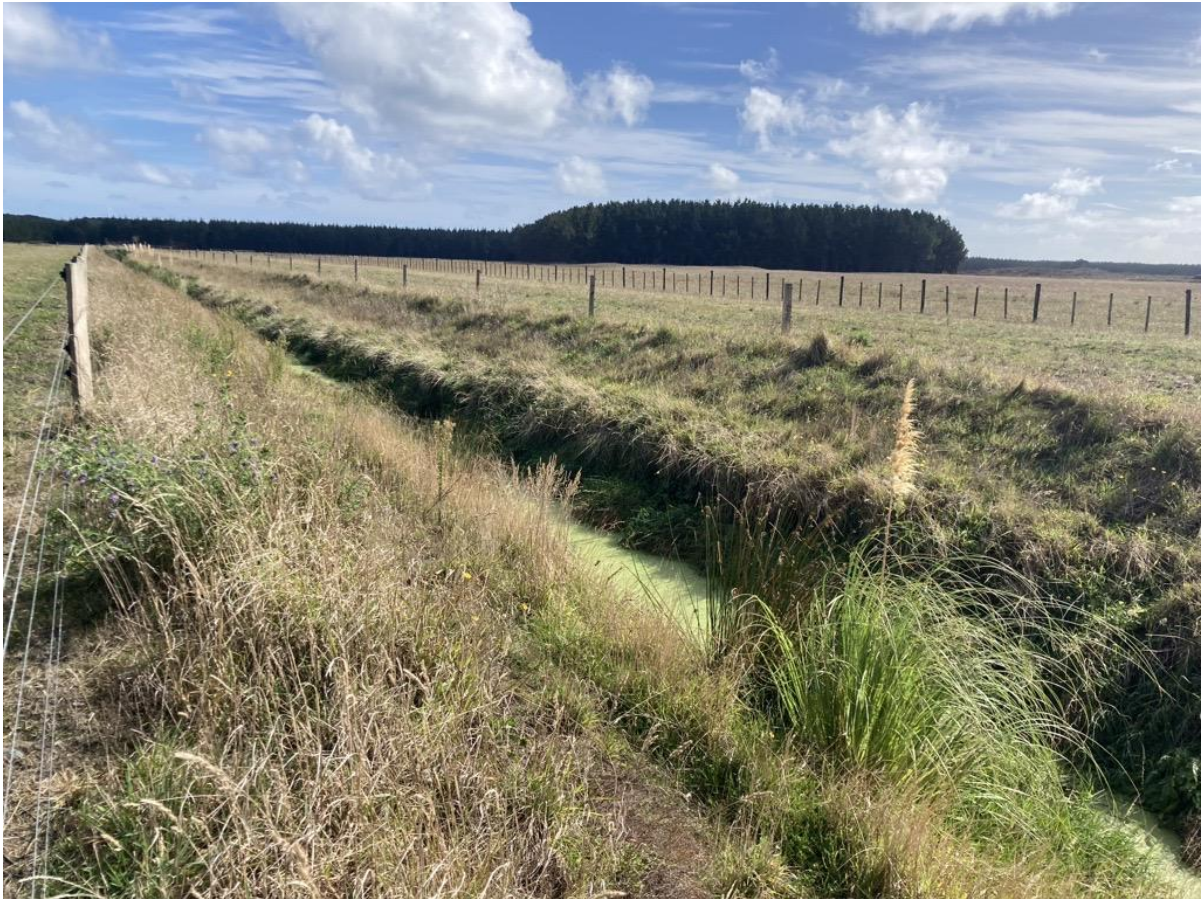
Figure 26: Pāmu drain, facing west

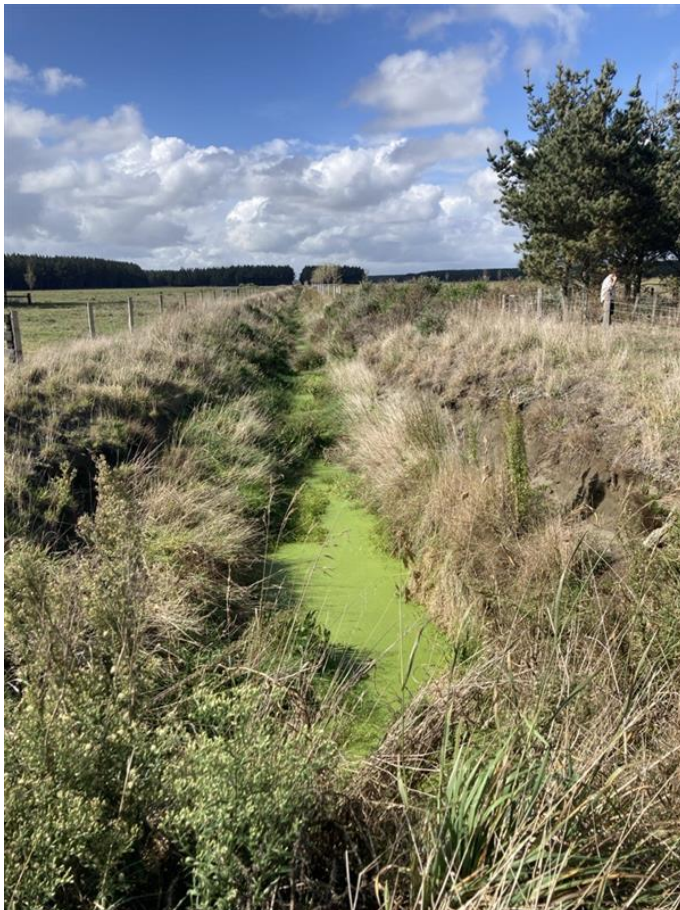
Figure 27: Pāmu drain, facing east

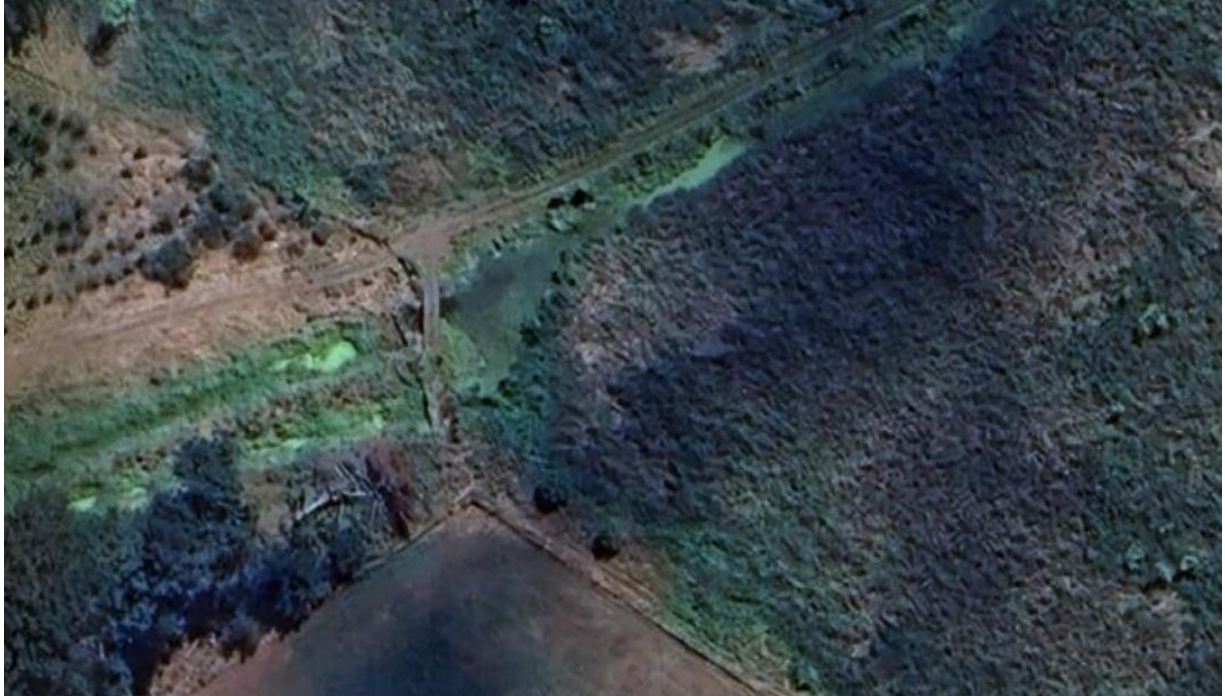
Figure 28: Aerial image showing weir and fort at north-west boundary of Pukepuke lagoon

The weir is located on the primary drain on the lagoon's northern boundary (Figure 28). The primary drain has two outlets – one is the weir constructed from railway sleepers and concrete bollards (Figure 29). No signs of tampering with weir. Weir area is overgrown.

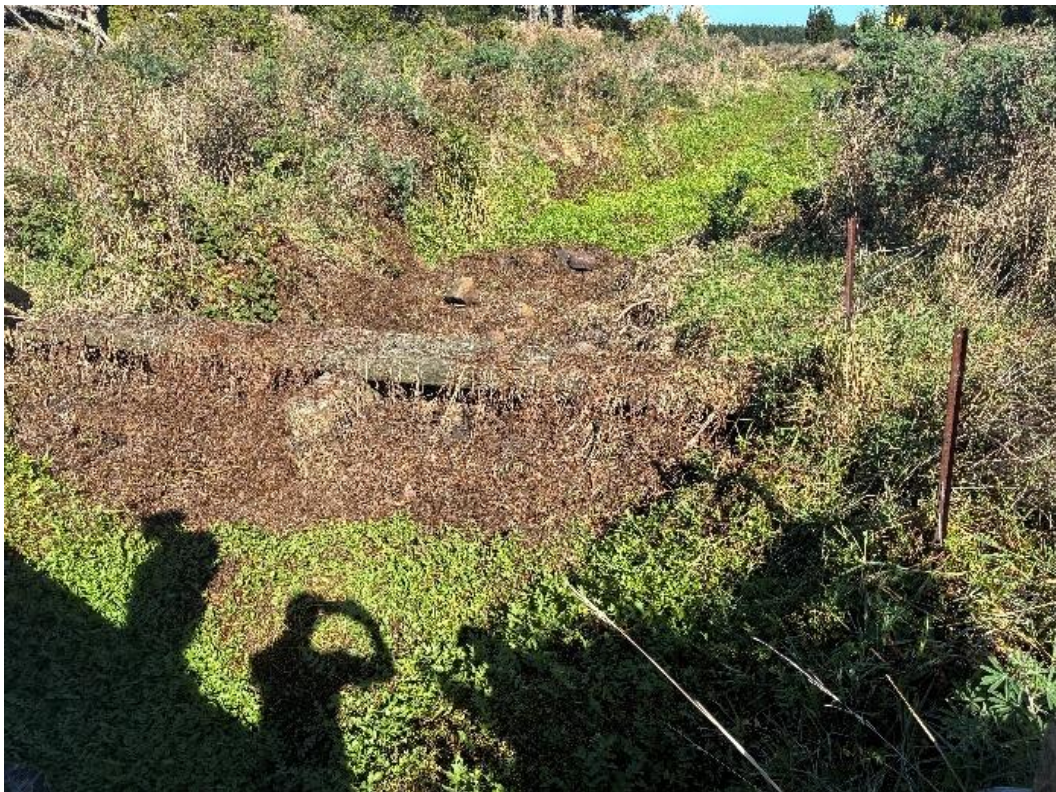
Figure 29: Overgrown weir at north-west boundary of Pukepuke lagoon

Weir damage is regarded as unlikely to have caused the drying. There was no immediate evidence that the weir had been tampered with, and the structure was still intact, as was the spillway.

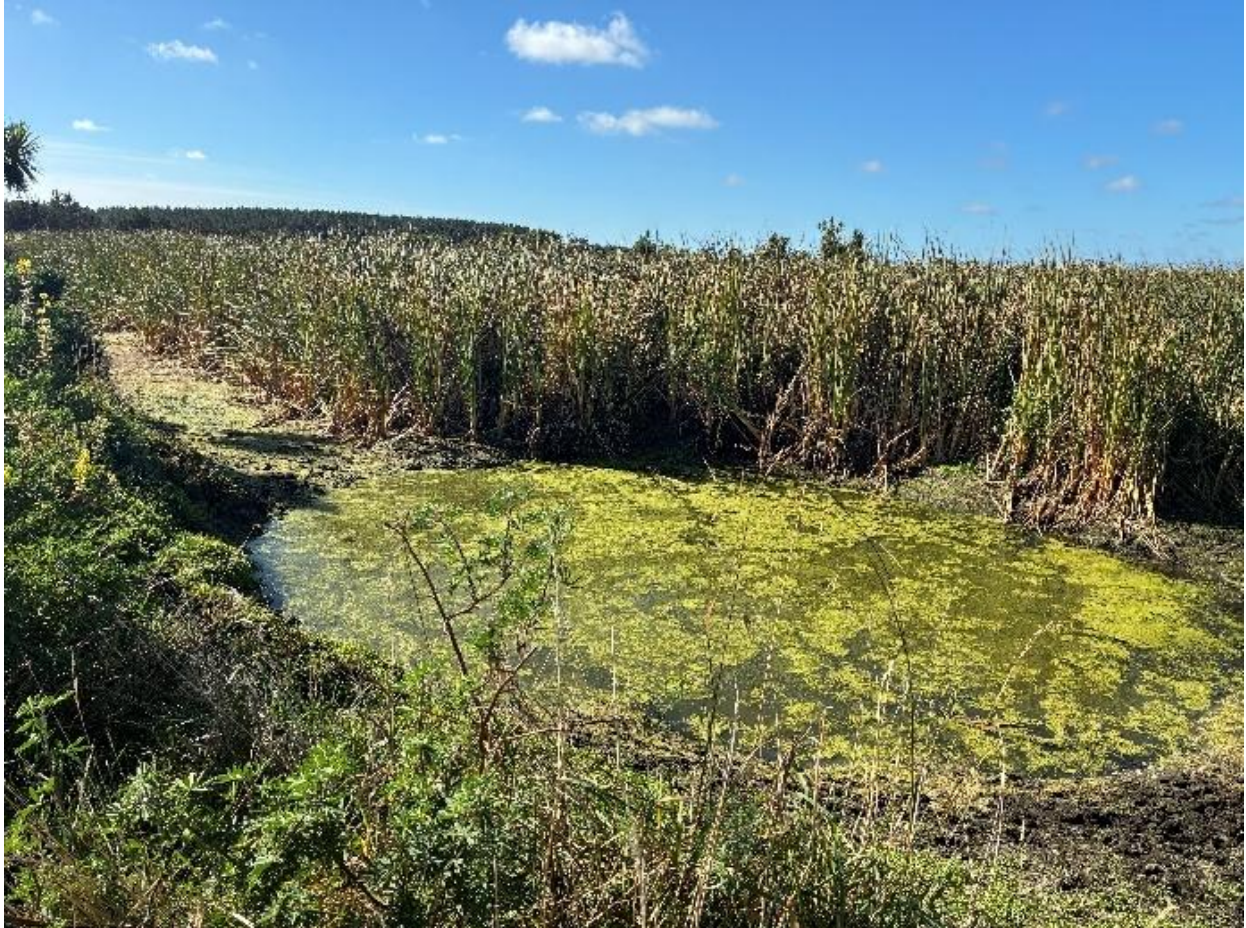
Figure 30: Monsoon bucket pool dug upland from weir with standing water

At the time of visiting the site any areas of open-water habitat throughout the lagoon appear to have been reduced to only the lowest lying areas remaining. Such areas include the monsoon bucket pool dug out near the weir (Figure 30).
