**Kowhai Park Stopbank Upgrading**

**Whanganui River**

**Geotechnical Assessment**

**Horizons Regional Council**

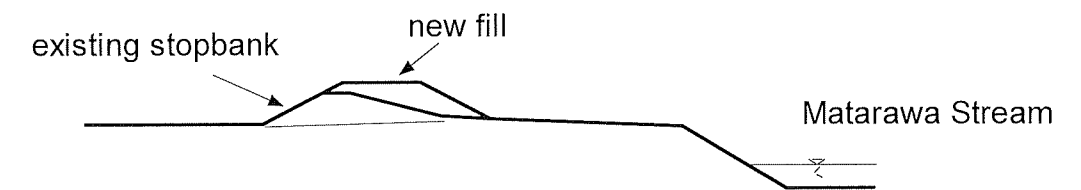
Figure 3: Typical Arboretum section

There are some tight places where there are large trees on each side of the stopbank and planter box construction may be necessary. It has been assumed that a total of 50m of planter box construction will be required in this section.

To minimise the disturbance to the Arboretum it is recommended that the stopbanks be raised by placing fill on the river / stream side (outside) of the stopbank where-ever the vegetation permits (Figure 3). There are some short lengths of open lawn in the Arboretum where fill could be placed on the inside of the stopbank if there are large trees on the outside.

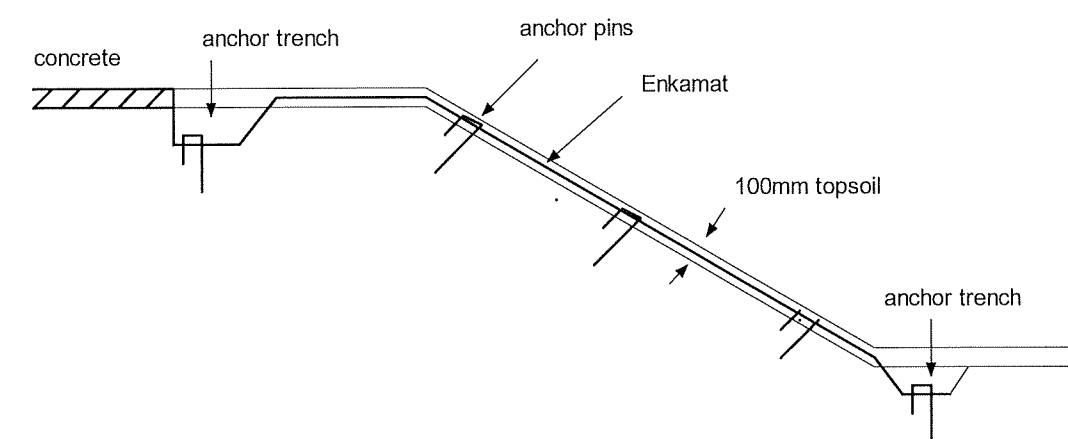
**Figure 4:** Skate board park area stopbank protection

At the skateboard park there is damage to the stopbank from high usage. This needs to be repaired and the area protected in future to prevent concentrated erosion occurring.

**Photo 16:** Stopbank damage near skateboard park

At the skateboard park the stopbank crest should be moved slightly towards the river, and the whole stopbank crest and face of the stopbank covered with a cohesive soil and a geofabric such as Enkamat to promote good grass root structure (Figure 4).

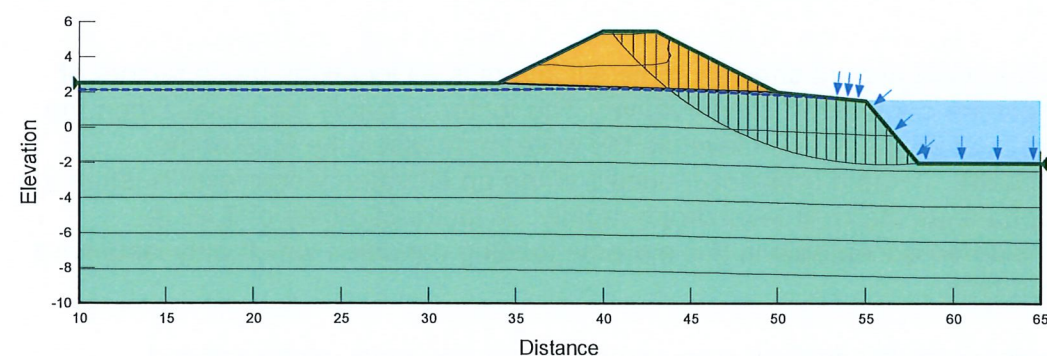
**Figure 5:** Slope stability assessment

High water pressures are not developed in the inland face of the stopbank due to the nature of the flood hydrograph, therefore only river side failures which reached the crest of the stopbank were considered. The lowest factors of safety are given in Table 5.

As the hand augers showed some silt layers in all locations these factors of safety are considered conservative. The factor of safety increases when the river is at the peak flood level as the water buttresses the face of the stopbank. Rapid drawdown occurs when an elevated water level is left in the stopbank as the river level drops rapidly. A factor of safety of 1.45 is considered acceptable in this extreme loading condition which only lasts for a short time.

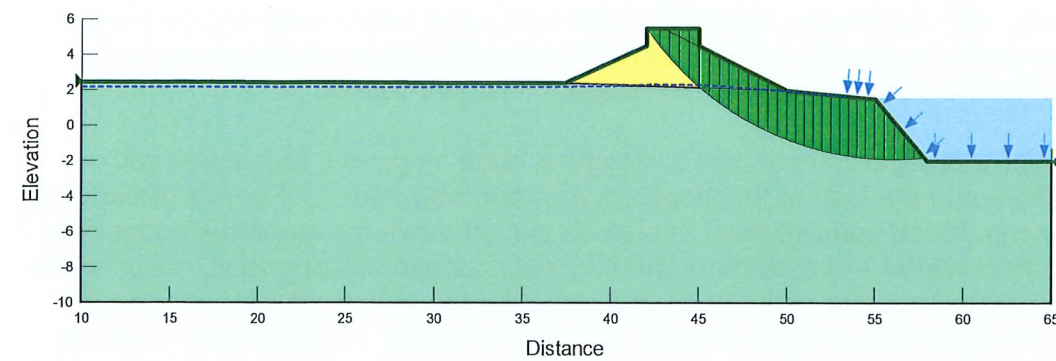
**Figure 6:** Planter box stability assessment

Another stability analysis was carried out for the sandy stopbank and foundation case with a 1.0m high, 3m wide planter box structure on top of 2H:1V batters (Figure 6). It can be seen from Table 5 that the factors of safety reduce from the stopbank option but they are still considered acceptable. Therefore no slope stability type problems are expected along the stopbank provided there is no excessive river bank erosion.
