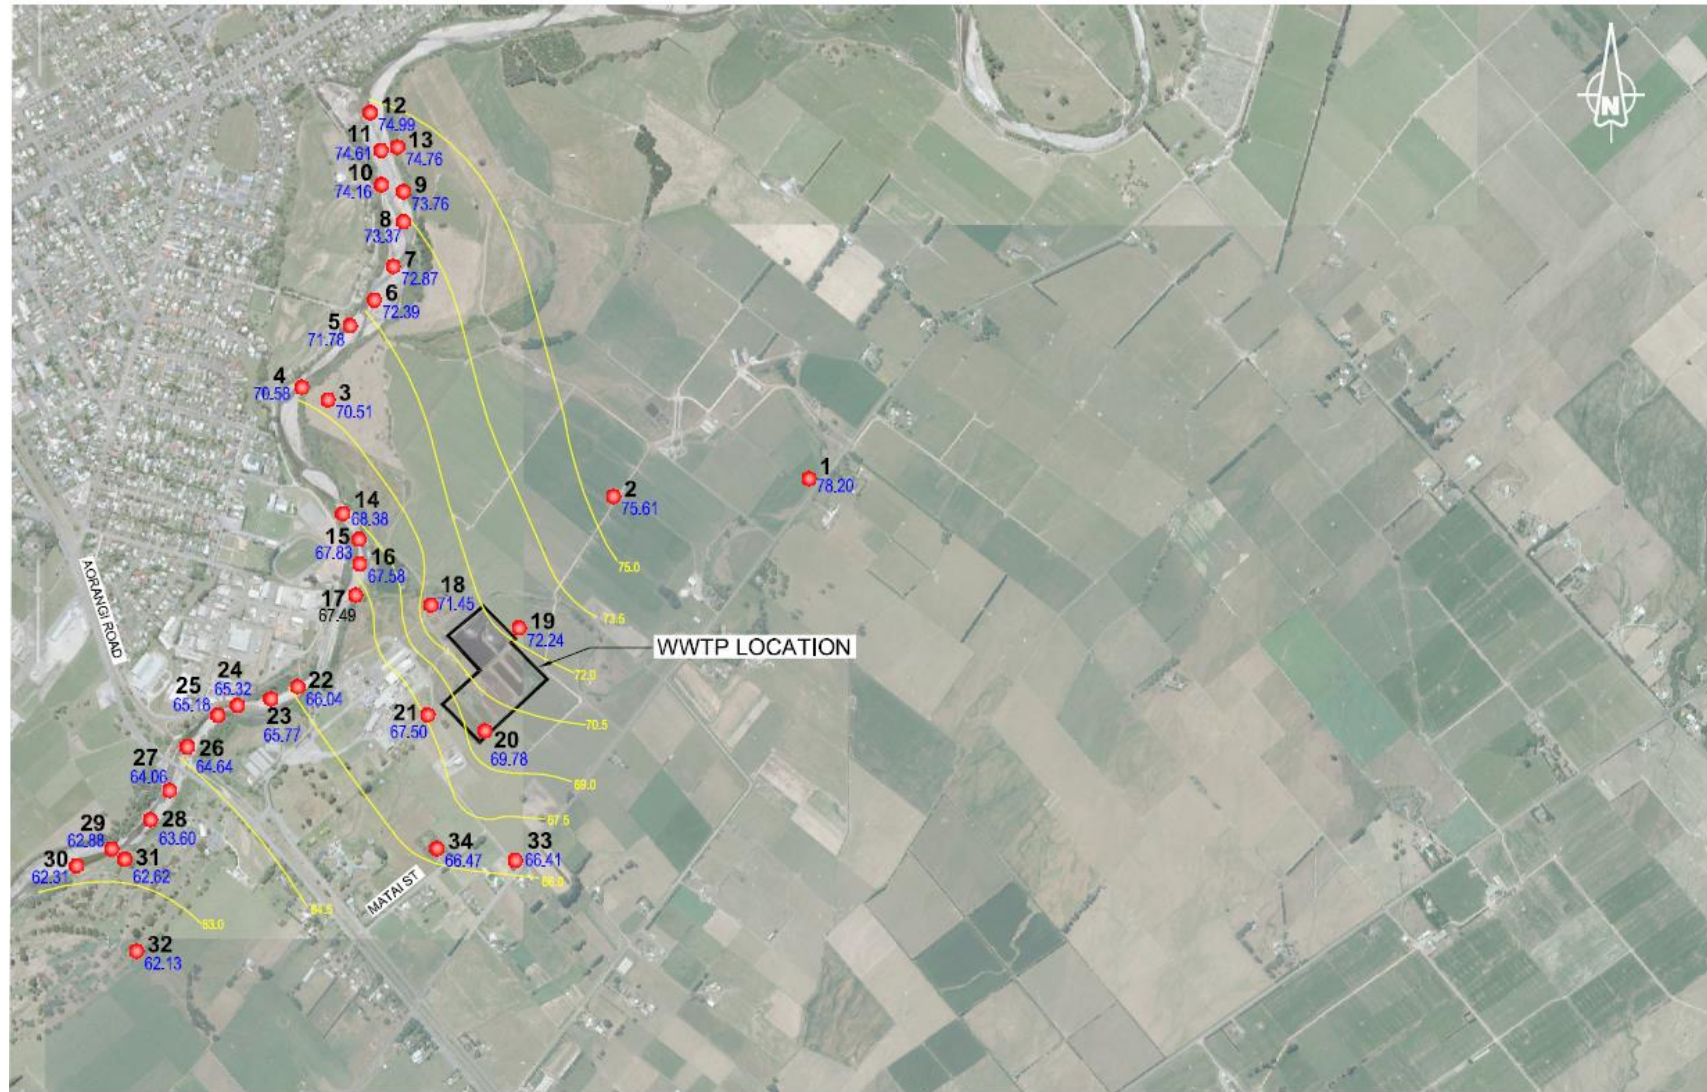
Figure 2: Shallow groundwater contours from June 2013 (Reproduced from LEI (2015))
